APPENDIX O. BISHOPVILLE TRUCK ROUTE PROJECT DRAFT CULTURAL RESOURCES ASSESSMENT

RE: Bishopville Truck Routes Alternatives Analysis, Lee County, South Carolina

Reconnaissance-Level Archaeological Survey of Bishopville Truck Route Segments

Phase I Architectural Survey of
**BISHOPVILLE BYPASS
ALTERNATIVES**

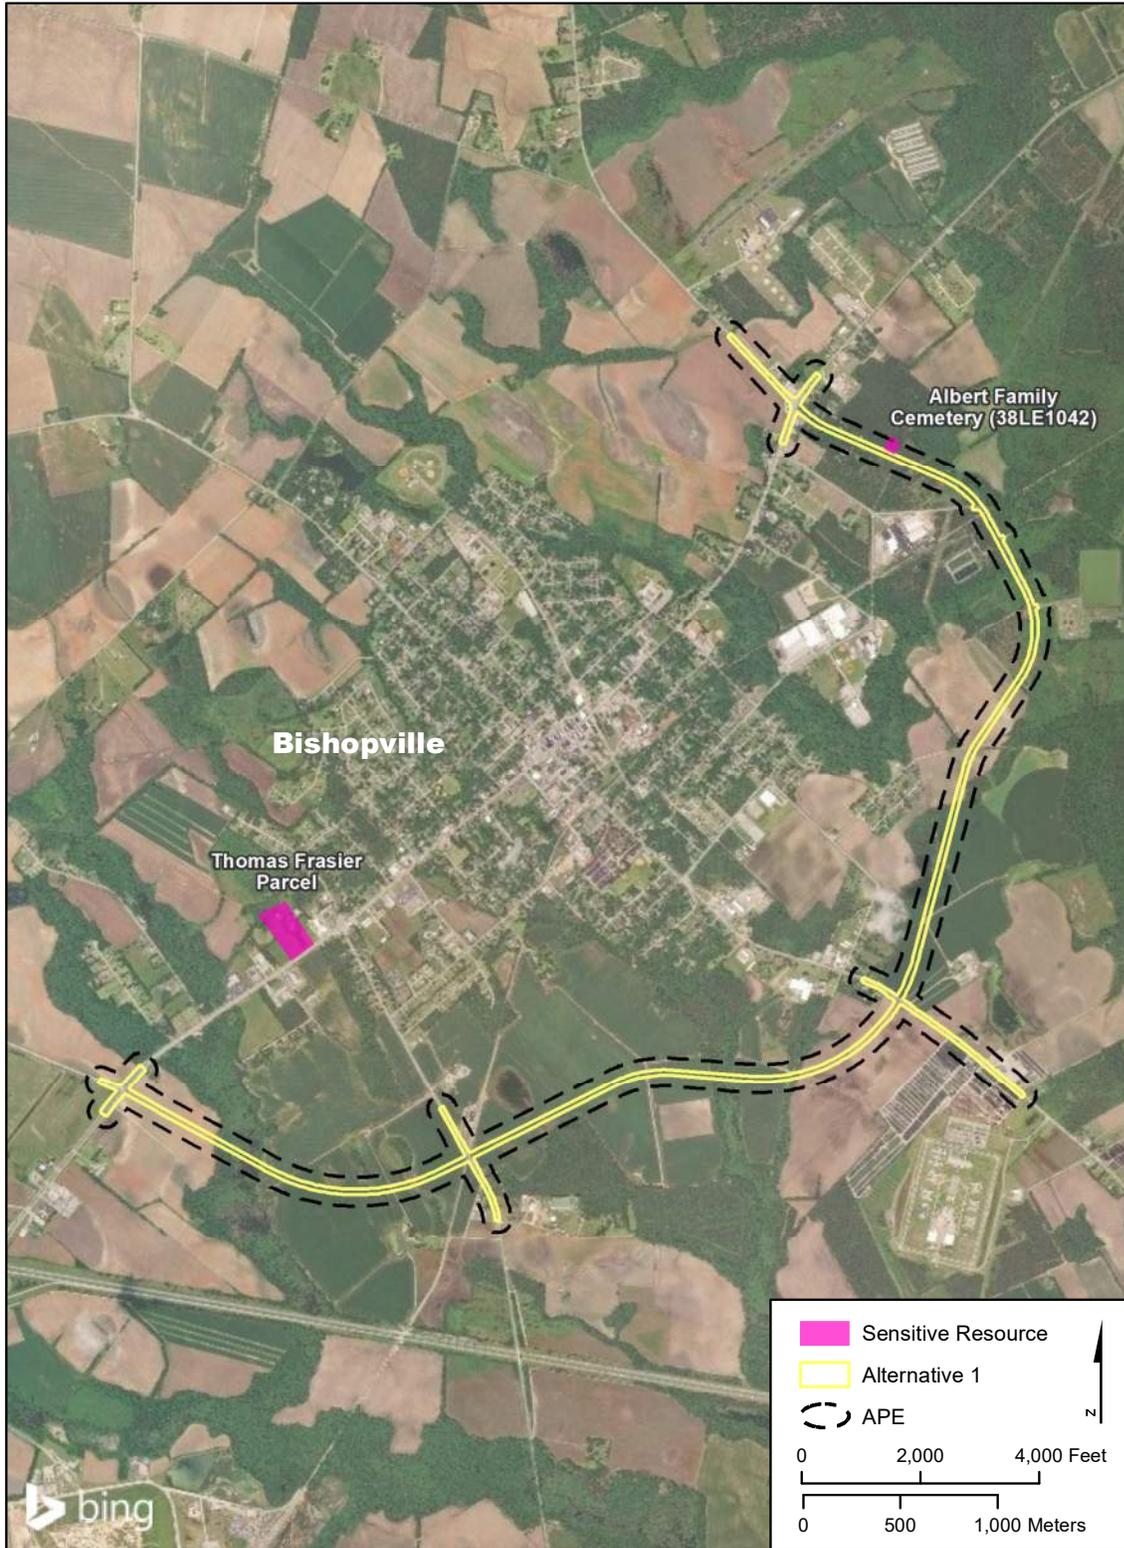
Figure 2. Proposed Alternative 1 and Potentially Affected Cultural Resources

Alternative 1 will not affect any identified historic properties (Figure 2).

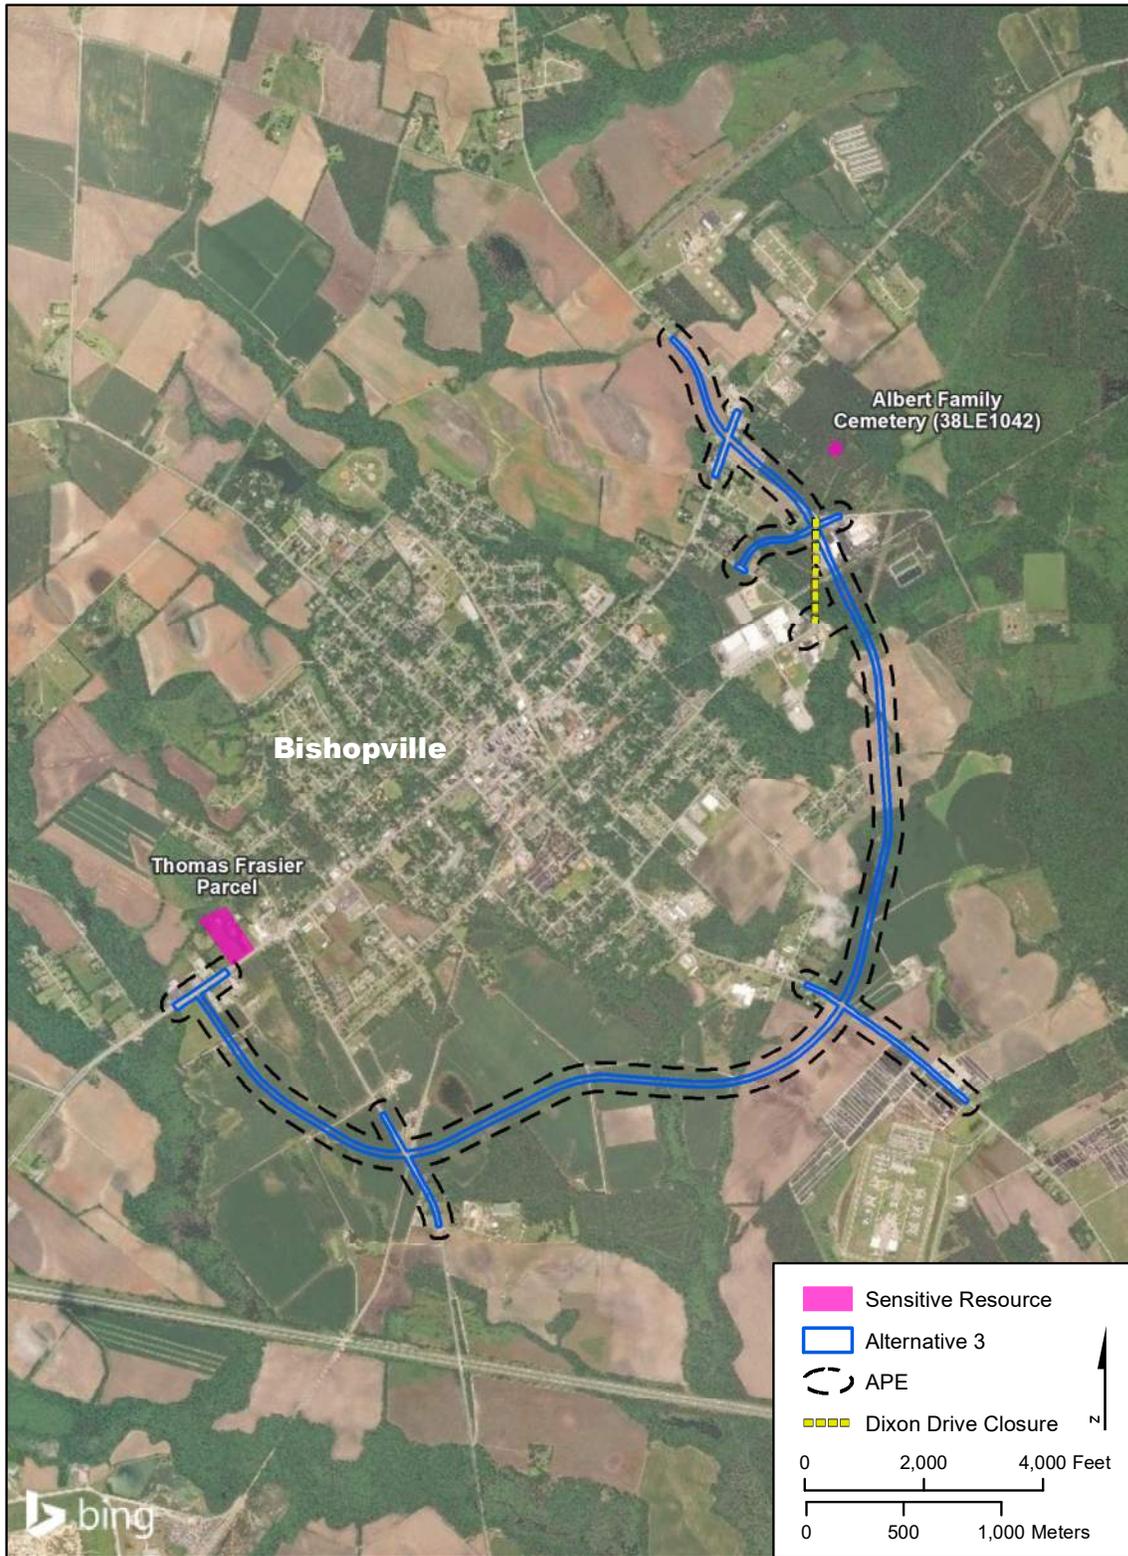
Figure 4. Proposed Alternative 3 and Potentially Affected Cultural Resources

Alternative 3 may potentially affect the viewshed of the NRHP-listed Thomas Fraser House property (Figure 4).

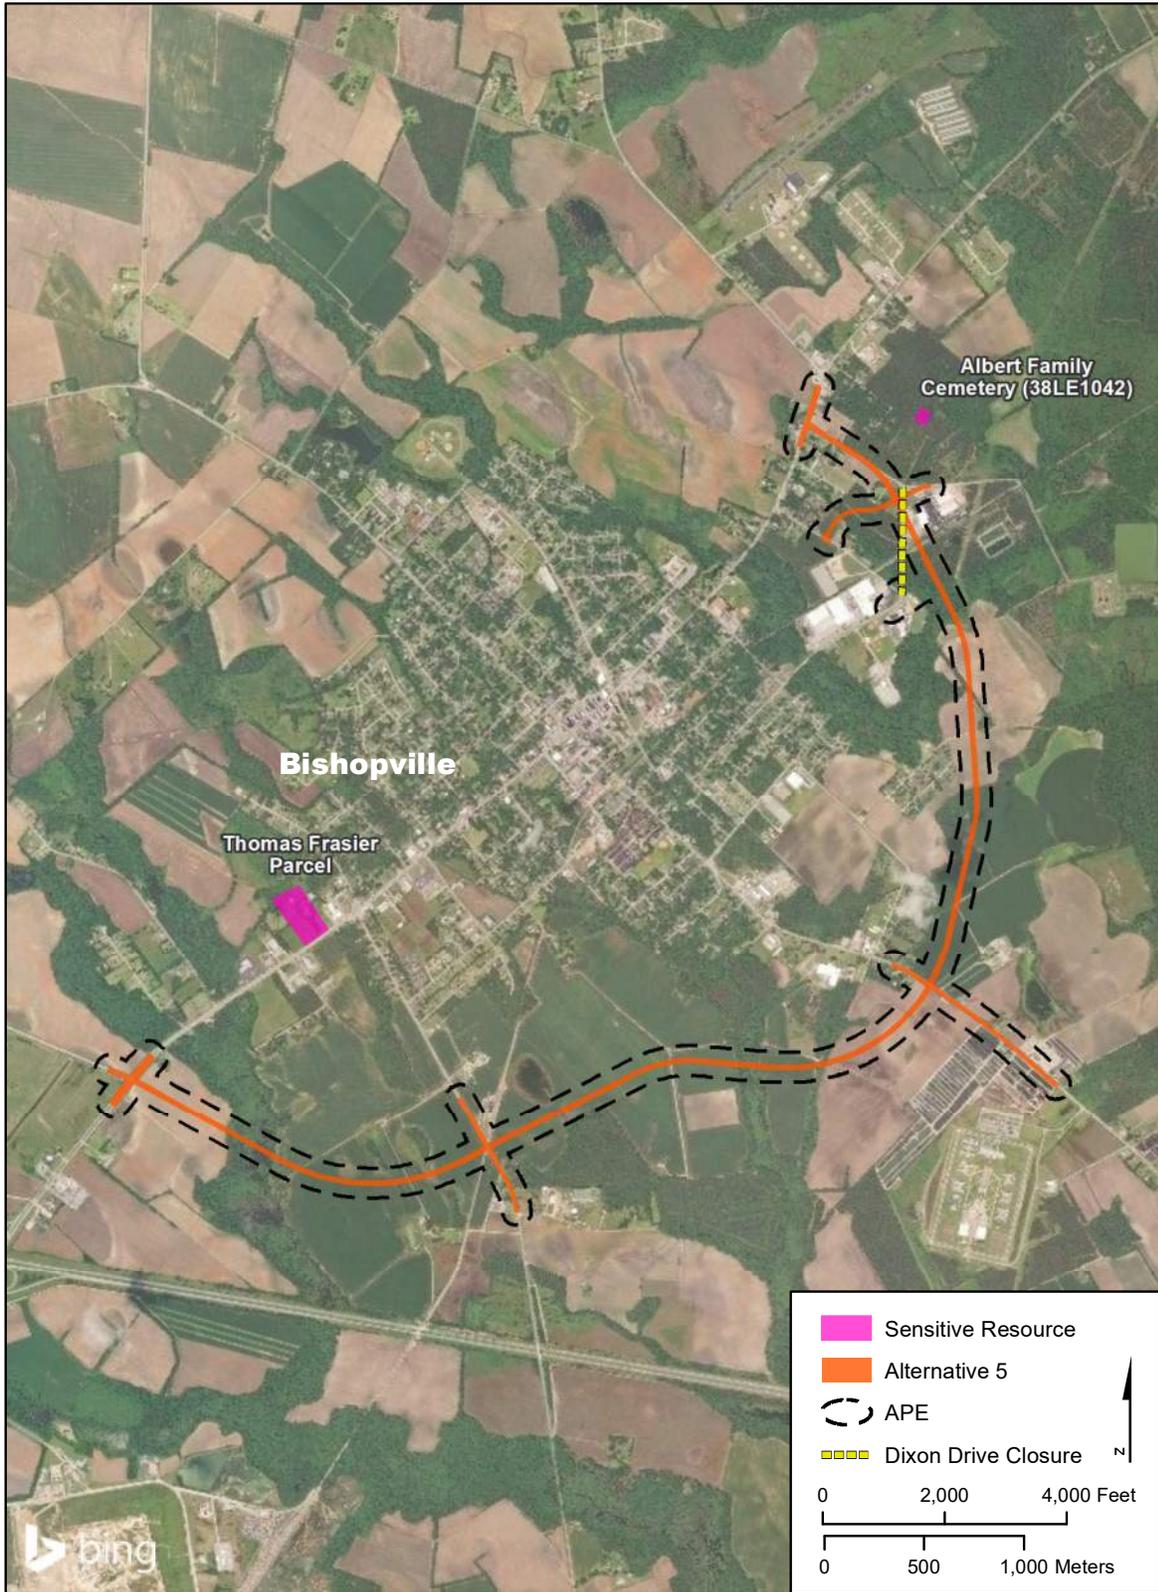
Figure 6. Proposed Alternative 5 and Potentially Affected Cultural Resources

Alternative 5 will not affect any identified historic properties (Figure 6).

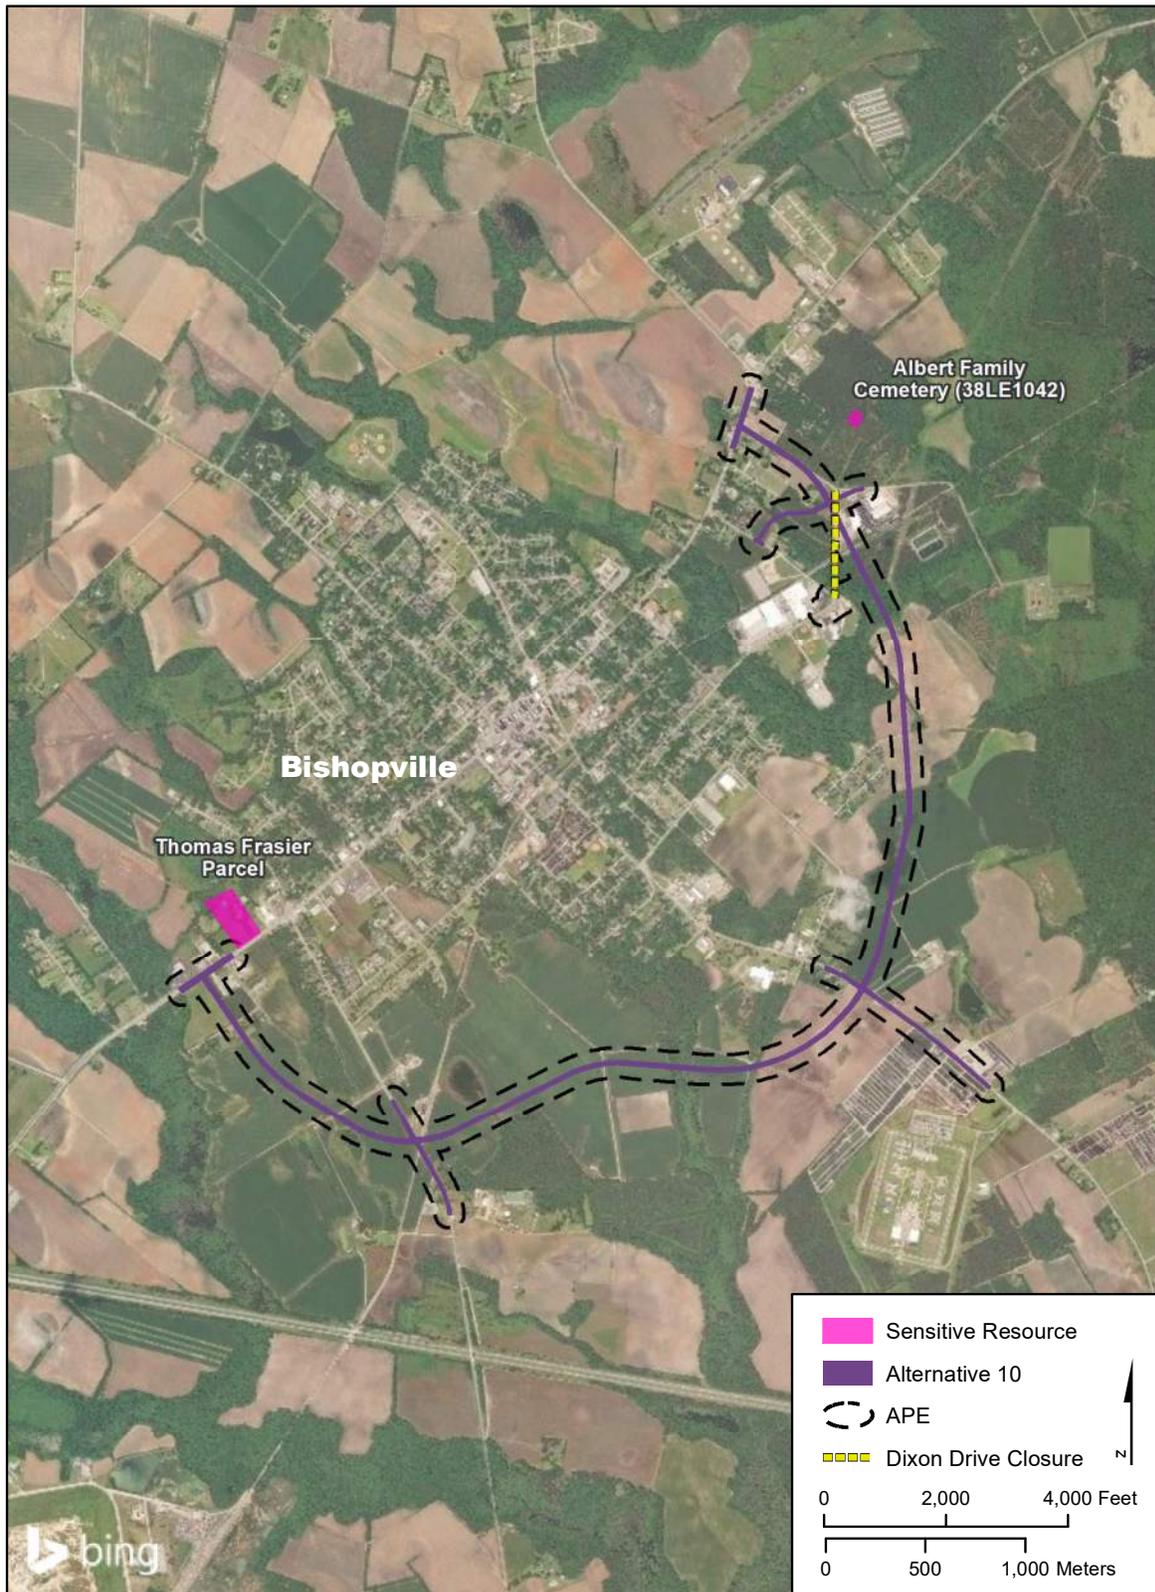
Figure 11. Proposed Alternative 10 and Potentially Affected Cultural Resources

Alternative 10 may potentially affect the viewshed of the NRHP-listed Thomas Fraser House property (Figure 11).

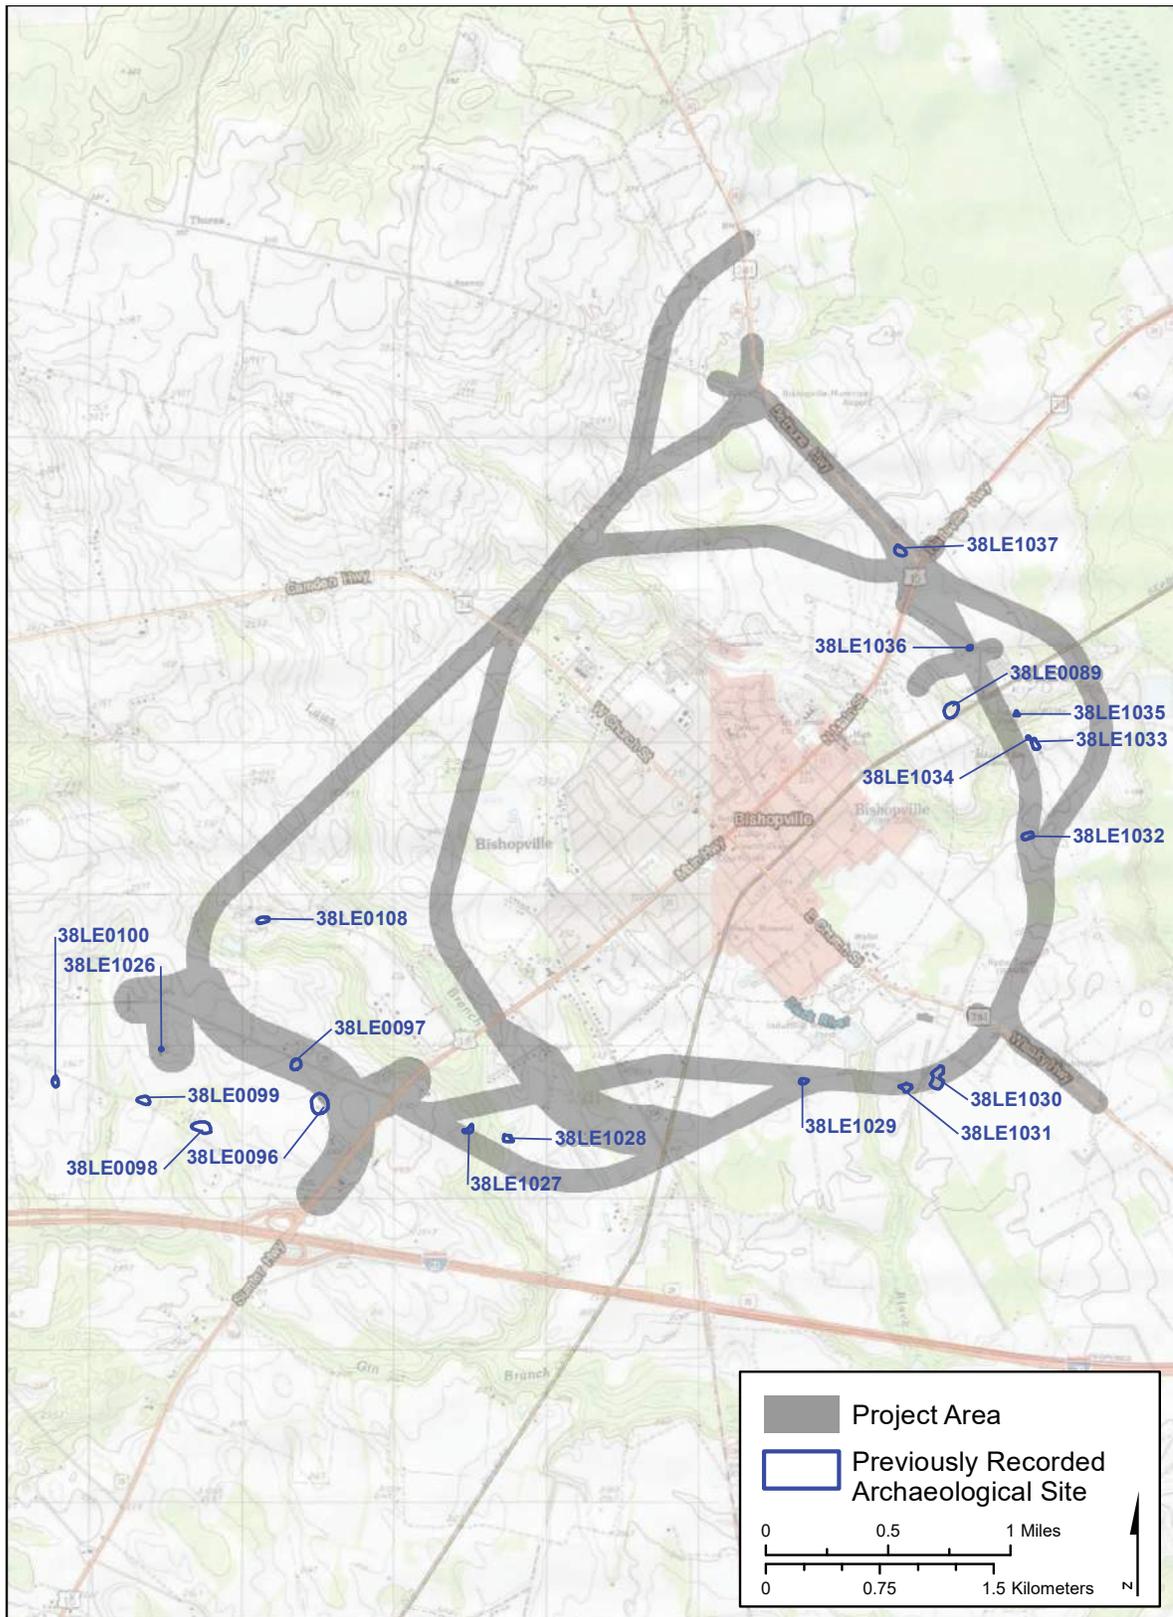
Figure 5.
Previously Identified Sites within 0.5 Mile of the APE

the project area. Site 38LE96 was a twentieth-century tenant complex measuring about 90x80 meters. It contained a house, shed, and artifact scatter. A total of 27 artifacts were recovered, including quantities of whiteware and glass, as well as redware and earthenware. The site was recommended not eligible for the NRHP and was destroyed by construction of the industrial site.

Site 38LE97 was a twentieth-century tenant site that measures approximately 60x40 meters. The site contained a scatter of bricks but no extant architectural remains. A total of 99 artifacts included container glass, whiteware, Bristol slipped stoneware, unidentified earthenware, wire and unidentified nail fragments, window glass, unidentified metal fragments, and textile fragments. The site was recommended not eligible for the NRHP and was destroyed during construction of the industrial site.

Site 38LE98 was a twentieth-century artifact scatter measuring roughly 60x120 meters. It was located on Gin Branch Road approximately 0.22 miles southeast of the current project area. A total of 17 artifacts were recovered from the surface and included whiteware, Bristol slipped stoneware, and container glass. The site was recommended not eligible for the NRHP.

Site 38LE99 was a twentieth-century tenant farm that measured about 50x70 meters. It was also on Gin Branch Road roughly 0.13 miles south of the project area. The site contained brick piers and a dense surface scatter of tin cans, screw top jars, modern beer and soda bottles, and car parts. A total of 12 artifacts were recovered, and included whiteware, container glass, and cloth fragments. The site was recommended not eligible for the NRHP.

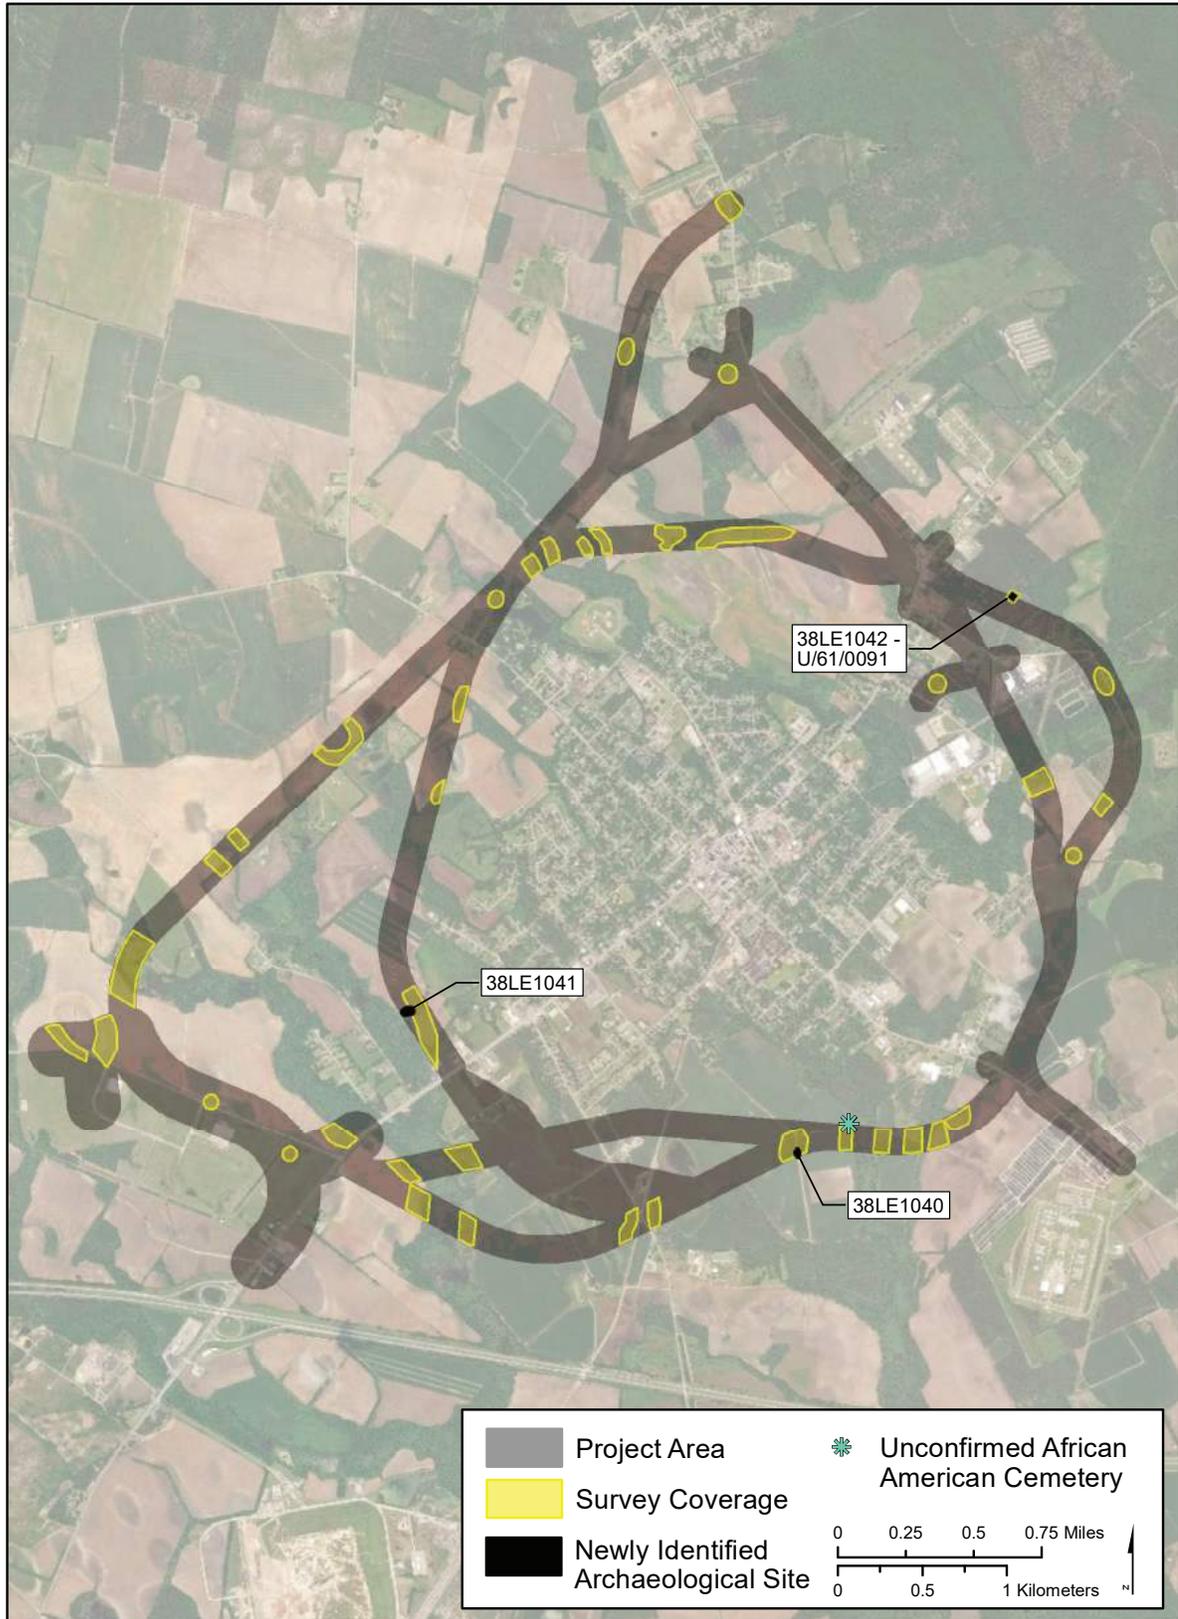
Figure 6.
Reconnaissance Coverage and Newly Identified Sites or Resources

The fieldwork focused on locating areas of high archaeological potential and then examining them through surface survey and judgmental shovel testing. Figure 6 shows the locations of areas examined.

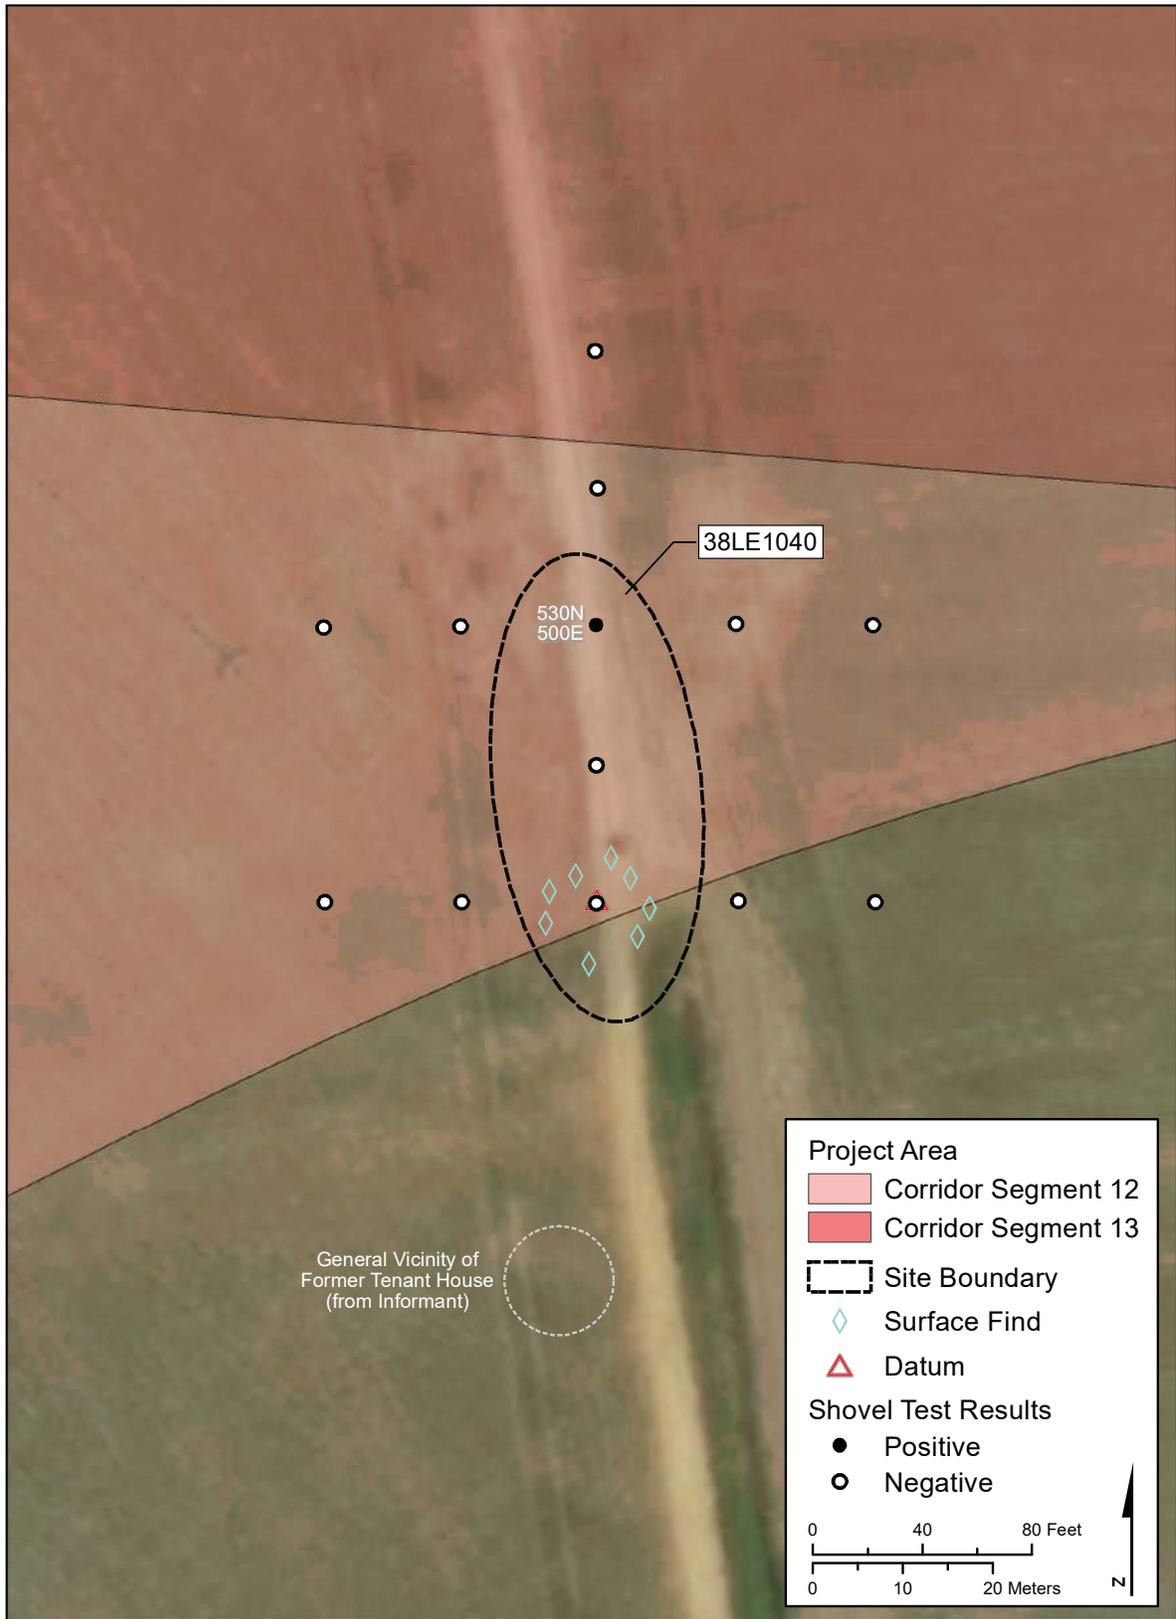
Figure 7.
Map of Site 38LE1040

Site 38LE1040 is a small late nineteenth- to twentieth-century historic artifact scatter identified on a dirt road in an agricultural field in Segment 12 (Figure 7). It is situated approximately 120 meters south of previously identified 38LE1029, which is similar in size, age, and probable function. A local informant stated that this general area once contained tenant houses. No evidence of architectural features associated with tenant houses were observed inside the survey area. It should be noted that early twentieth-century maps do not show houses in this location.

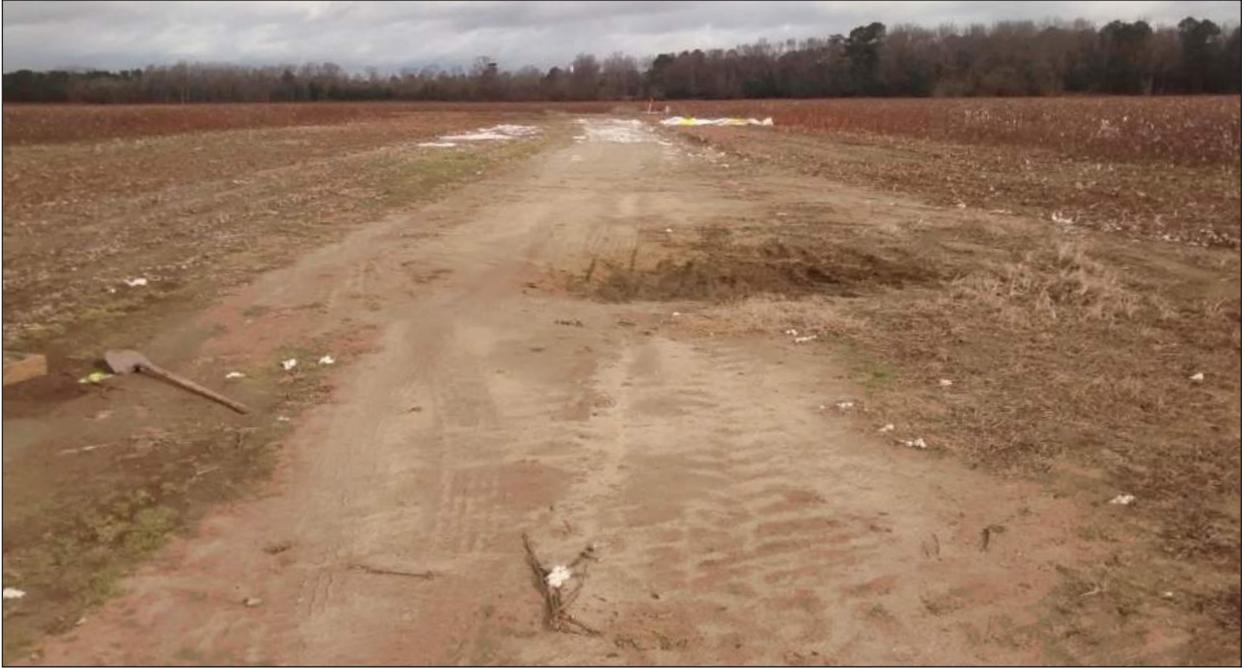
Figure 8.
Conditions at Site 38LE1040, Facing North

direction and so the site is considered completely delineated. Typical shovel test profiles included 20 centimeters of brown (10YR4/3) sandy loam plow zone over dark yellowish brown (10YR4/6) clay loam subsoil.

Based on surface conditions and shovel testing, the site is extremely disturbed from plowing and the dirt road. The thin plow zone suggests the site area is also deflated. Due to these disturbances, the lack of obvious features, and the sparseness of artifacts, 38LE1040 is judged to lack any potential to address significant research questions relating to late nineteenth- to early twentieth-century tenant farming, which would be necessary for NRHP eligibility under Criterion D. With regard to Criteria A, B, and C, available information suggests the site is not directly associated with events that have made a significant contribution to the broad pattern of history, nor does it have any known association with the lives of persons significant in the past. Finally, it does not embody the distinctive characteristics of a type, period, or method of construction or represent the work of a master, possess high artistic values, or represent a significant and distinguishable entity whose components may lack individual distinction. Accordingly, 38LE1040 is recommended not eligible for the NRHP.

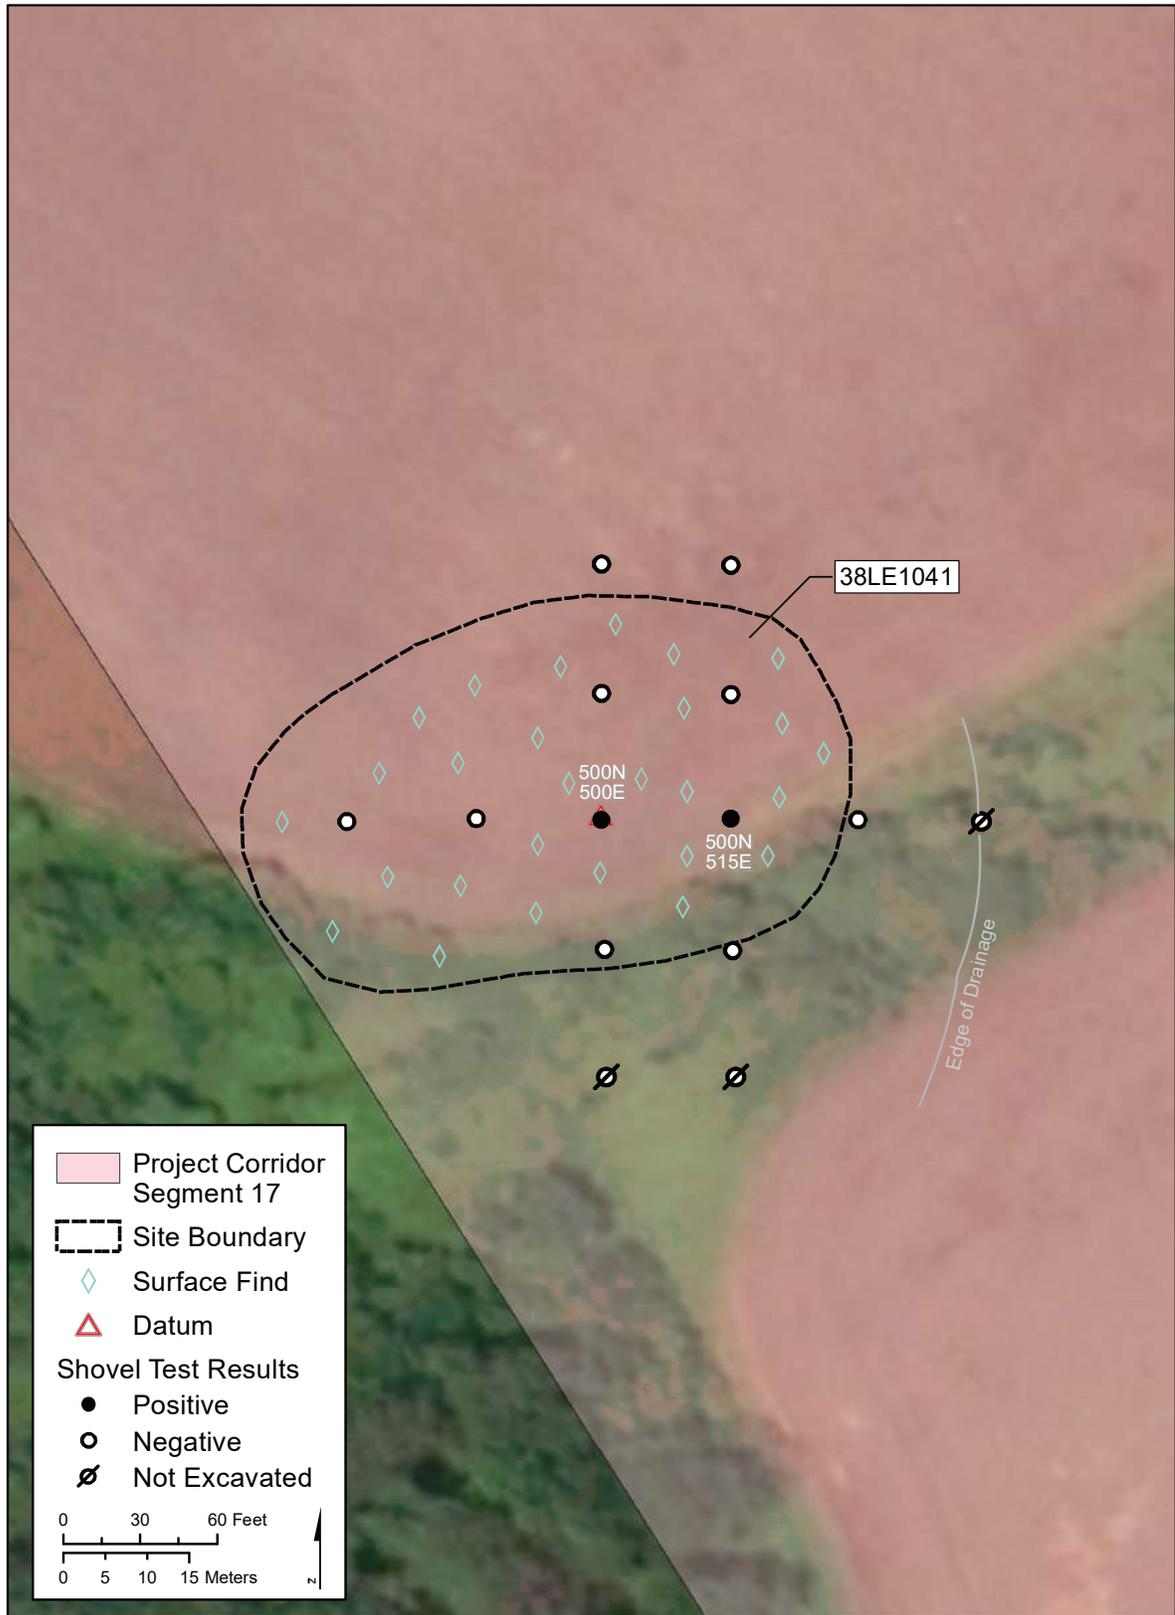
Figure 10.
Map of Site 38LE1041

The site consisted of a widespread surface scatter, measuring approximately 70x45 meters. Three of the 14 projected shovel tests were not excavated because they were within a drainage and two shovel tests (N500E500 and N500E515) were positive for artifacts (Figure 10). Ground surface visibility was between 75 and 100 percent (Figure 11). Typical shovel test profiles included 20 centimeters of dark yellowish brown (10YR3/6) clay loam plow zone over dark yellowish brown (10YR4/6) clay subsoil.

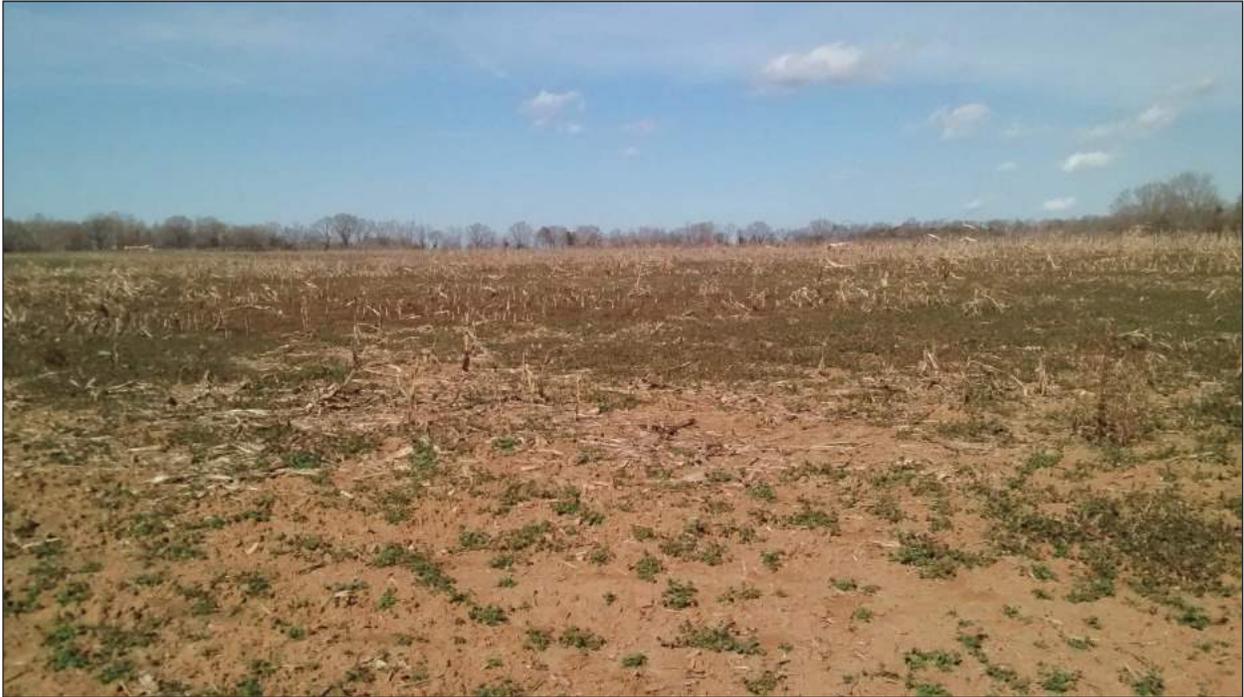
Figure 11.
Conditions at Site 38LE1041, Facing Northwest

Surface collection and shovel testing produced 119 artifacts (Table 3). The majority of the artifacts have lengthy date ranges. For instance, whiteware was introduced by 1830 and remains in production today (Brown 1983). The most temporally sensitive artifact recovered is amethyst-colored glass, which dates between 1880 and 1917 (Baugher-Perlin 1982:261). This artifact suggests that the site’s first occupation could date to the end of the nineteenth century. The absence of any structures on maps prior to 1957 suggests that there could be an early component that pre-dated 1907 and a later post-1941 component.

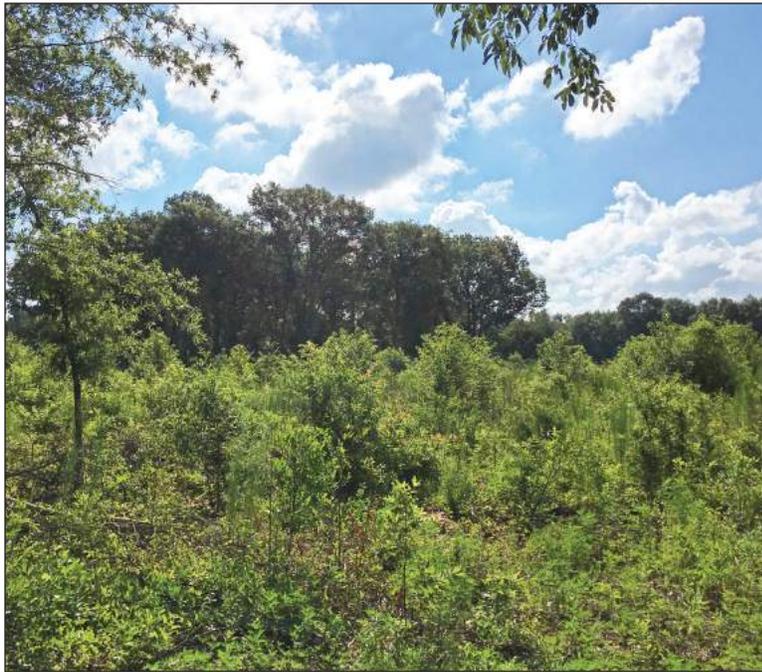
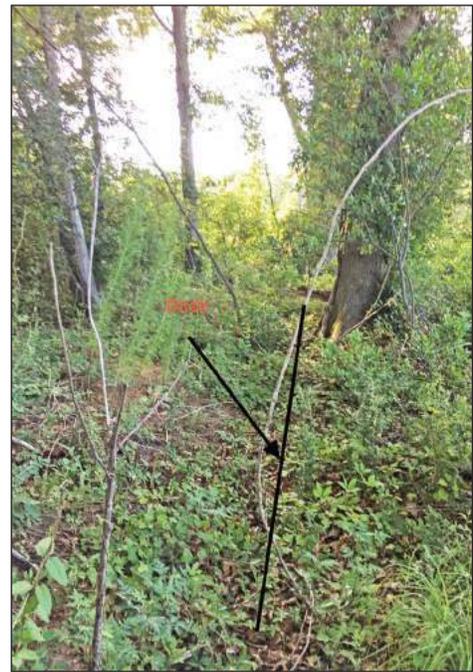
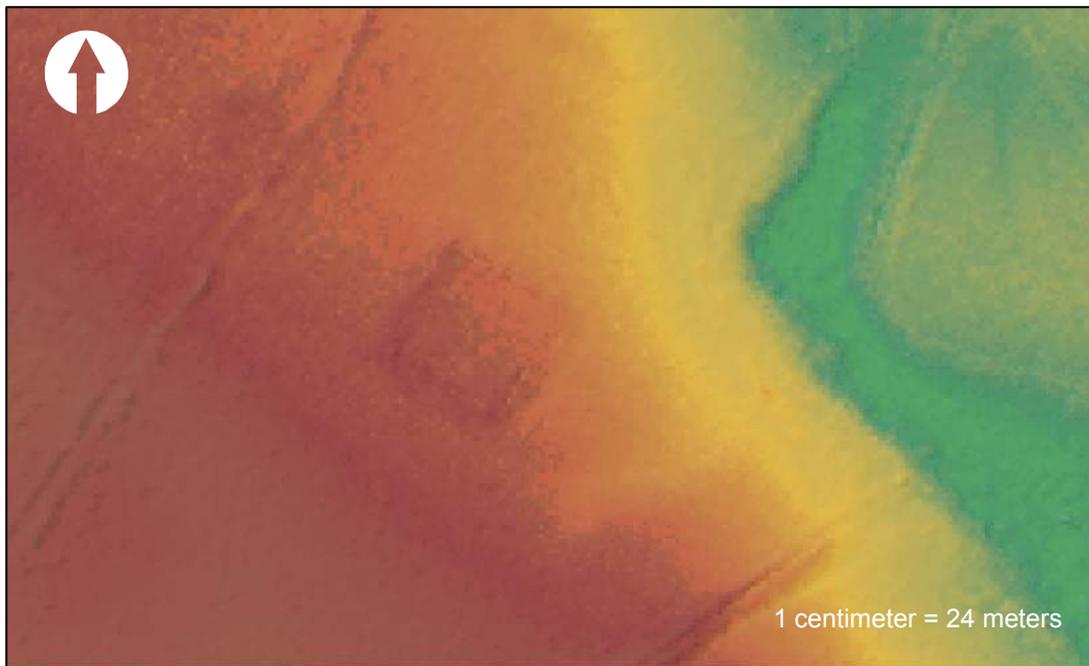
Figure 12.
Views of Site 38LE1042; U/61/0091 (Albert Family Cemetery)

A. Cove of Trees

B. Overgrown Perimeter Ditch

C. LiDAR Imagery Showing Cemetery Boundary

The Albert Family Cemetery (38LE1042 – U/61/0091) is partially located within Segment 6 (Figure 16b). Fieldwork only verified the presence of the cemetery, but due to the thickness of the vegetation, mapping could not be done. If this segment is chosen as part of the preferred alternative, avoidance is recommended. The cemetery is protected under South Carolina state law (e.g., South Carolina Code of Laws 16-17-600).

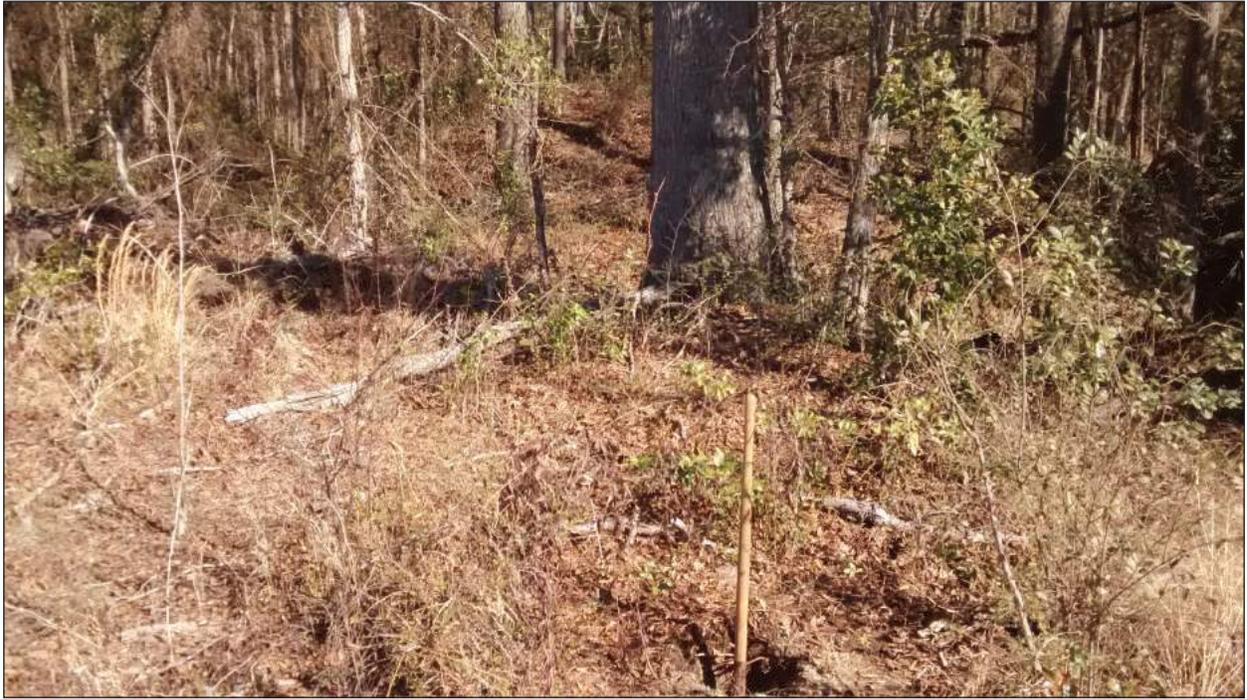
Figure 14.
Photograph of the Reported African American Cemetery

Since the cemetery could not be verified, this location was not recorded as a historic resource. Although New South could not verify the presence of a cemetery, it is very possible that one exists. Therefore, if the segment (Segment 11) containing this possible cemetery is chosen as part of the preferred alignment, additional fieldwork will be necessary. Since the area is heavily vegetated, remote sensing is not an appropriate method. A penetrometer survey would be best suited for the area, given the field conditions.

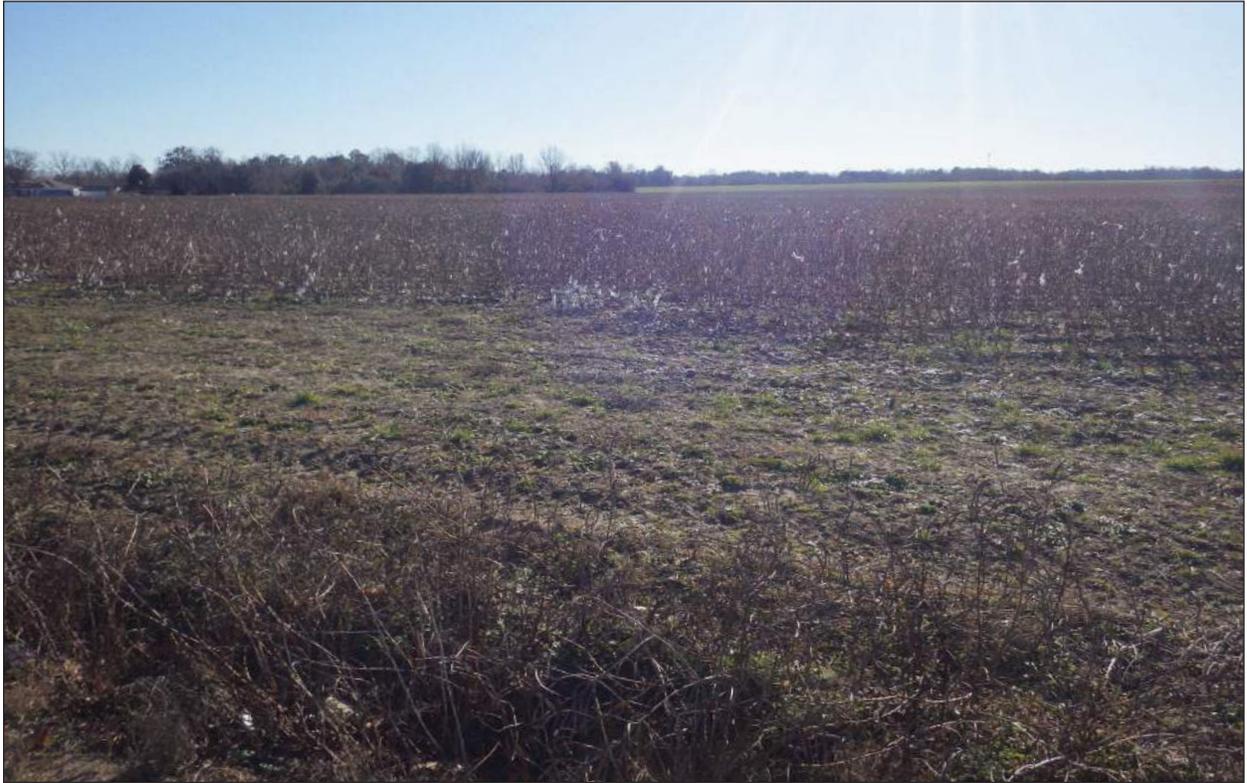
Figure 15.
Agricultural Field Containing Site 38LE1037, Facing West

In addition, there was one previously identified site (38LE1037) in the survey area that has not been fully evaluated for its NRHP eligibility. It was revisited during the current investigation to determine if conditions at this site changed since its initial discovery, but no shovel testing or evaluation was performed. The site was first identified in an agricultural field and this land use continues through the present.

Previously recorded site 38LE1037 is located in overlapping portions of Segments 2, 3, and 20 (Figure 16a). If one of these segments becomes part of the preferred alternative and the site cannot be avoided, Phase II evaluation testing is recommended to definitely determine its NRHP eligibility.
