APPENDIX O. BISHOPVILLE TRUCK ROUTE PROJECT DRAFT CULTURAL RESOURCES ASSESSMENT

RE: Bishopville Truck Routes Alternatives Analysis, Lee County, South Carolina

Reconnaissance-Level Archaeological Survey of Bishopville Truck Route Segments

Phase I Architectural Survey of
**BISHOPVILLE BYPASS
ALTERNATIVES**

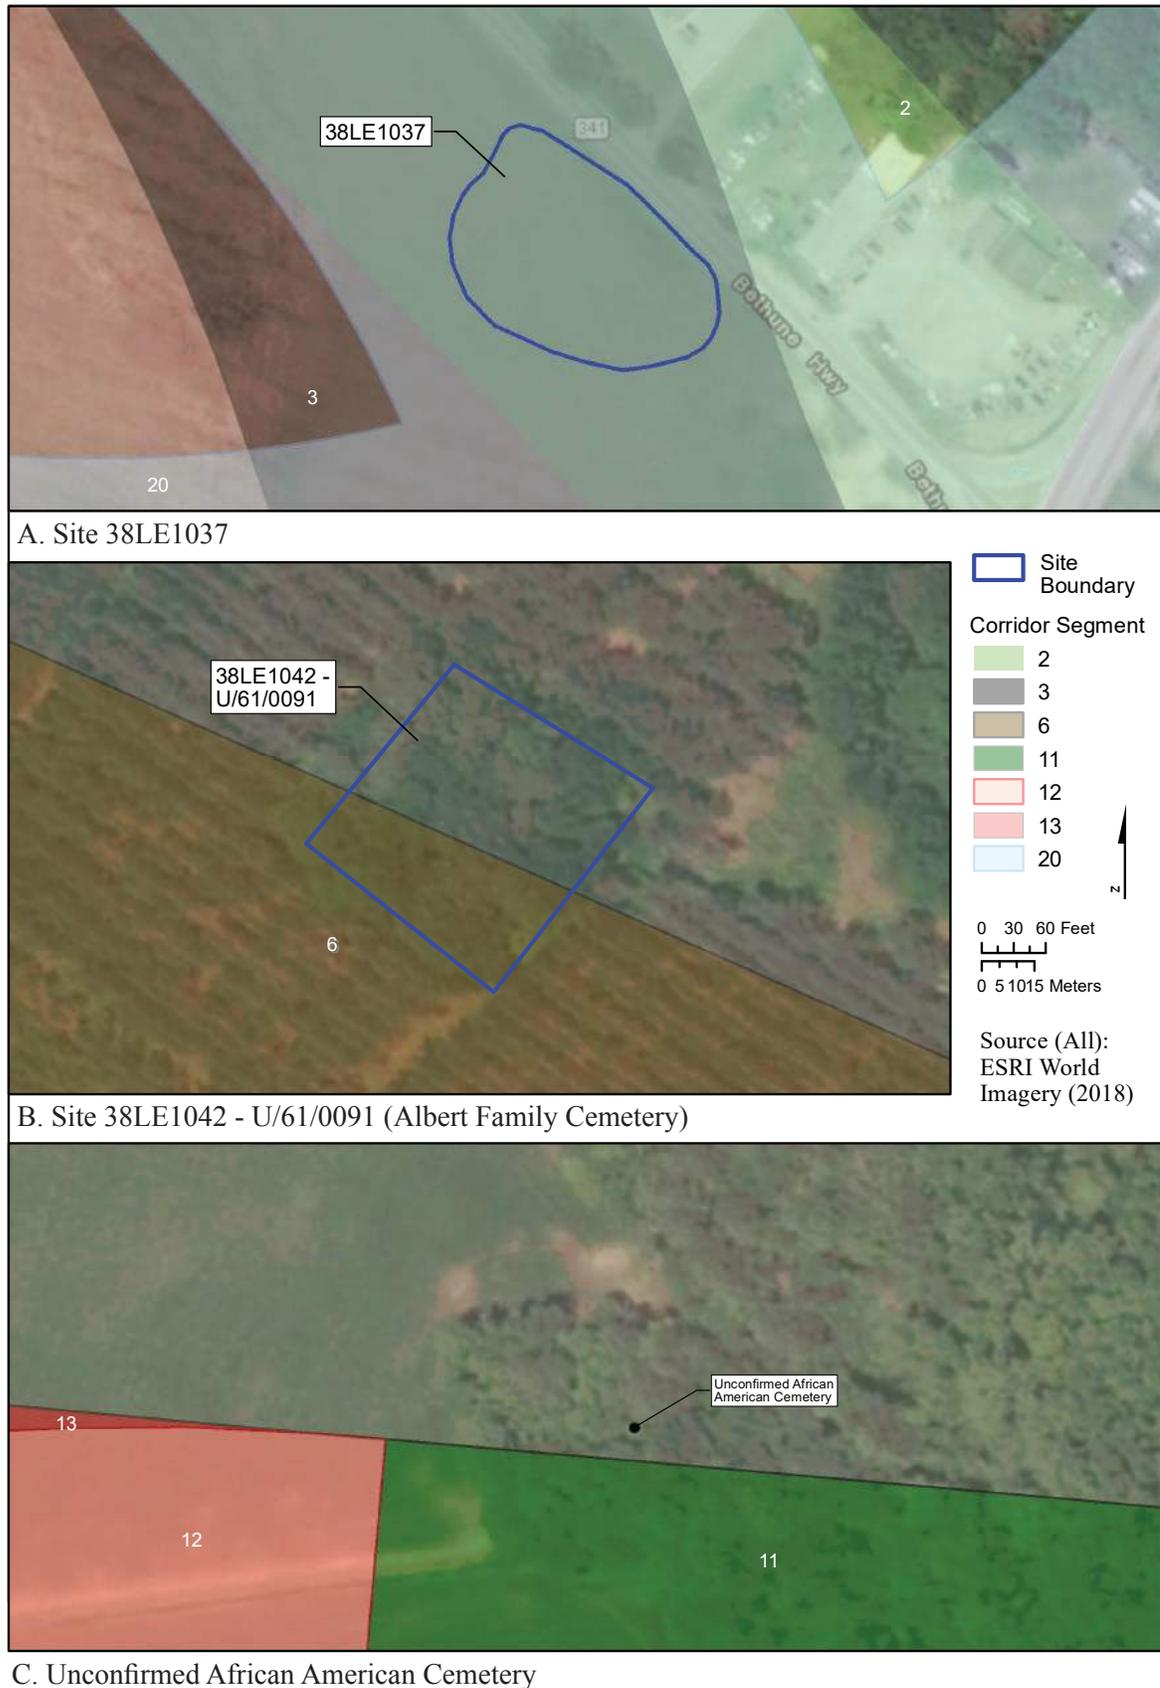
Figure 16.
Location of Potentially Sensitive Resources in Relation to the Survey Segments

Previously recorded site 38LE1037 is located in overlapping portions of Segments 2, 3, and 20 (Figure 16a). If one of these segments becomes part of the preferred alternative and the site cannot be avoided, Phase II evaluation testing is recommended to definitely determine its NRHP eligibility.

The Albert Family Cemetery (38LE1042 – U/61/0091) is partially located within Segment 6 (Figure 16b). Fieldwork only verified the presence of the cemetery, but due to the thickness of the vegetation, mapping could not be done. If this segment is chosen as part of the preferred alternative, avoidance is recommended. The cemetery is protected under South Carolina state law (e.g., South Carolina Code of Laws 16-17-600).

A reported African American cemetery is located near the western terminus of Segment 11 (Figure 16c). If this segment is chosen as part of the preferred alternative, a probe/penetrometer survey is recommended to locate the cemetery, identify possible burials, and delineate the cemetery boundaries (if necessary). Archival research is also recommended to identify plats or other documents that could confirm the presence of a cemetery. Additional interviews with local residents should also be conducted.

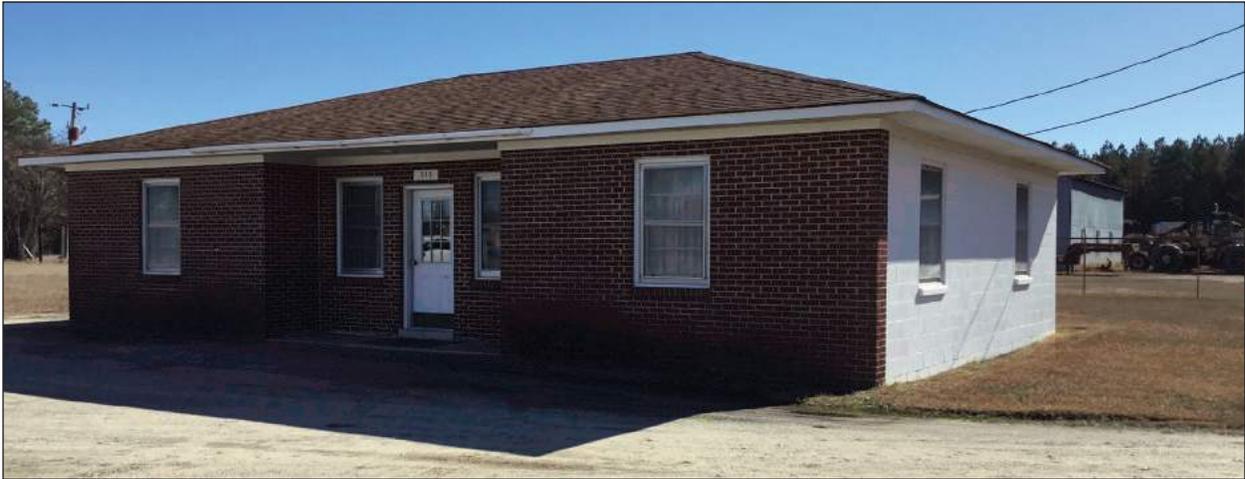
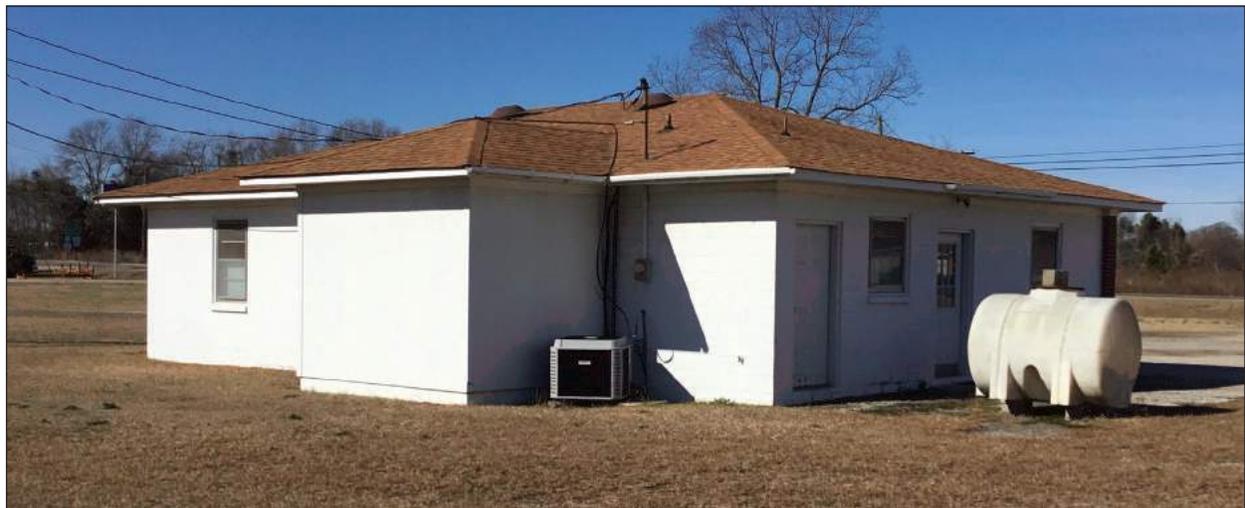
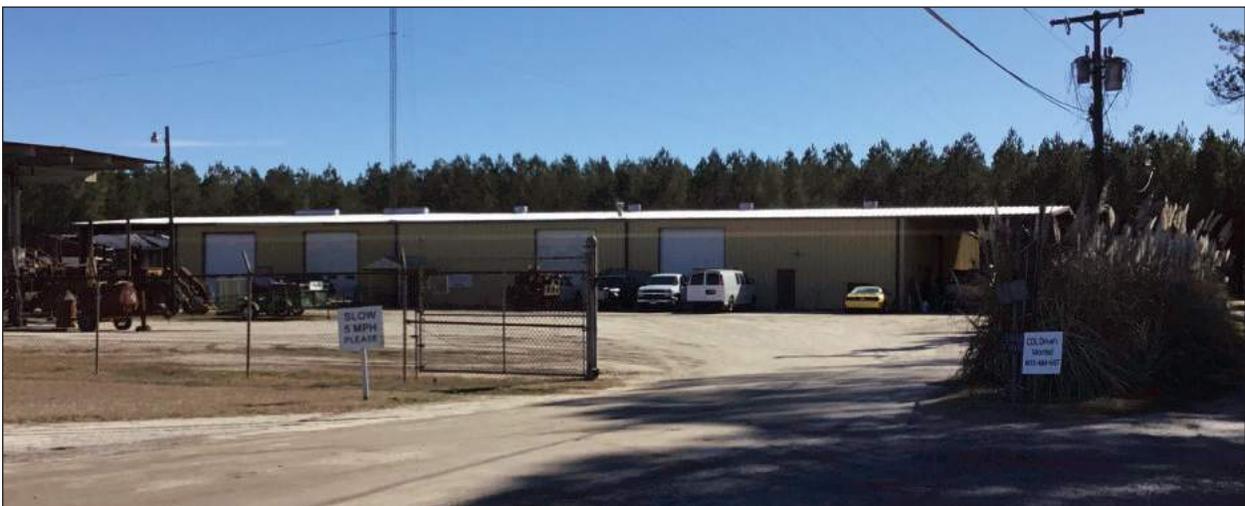
Figure 8.
Resources U/61/0051 and U/61/0051.01 – State Timber (765 U.S. Highway 15)

A. Resource U/61/0051 – Southwest Oblique

B. Resource U/61/0051 – Northeast Oblique

C. Resource U/61/0051.01 – West Elevation

The State Timber complex contains two additional non-historic outbuildings as well as a number of fuel tanks and various heavy machinery. The mowed area of the complex is approximately 5.5 acres in size with timber plantings extending to the northeast of the mowed area. Resource U/61/0051 has a generous setback from U.S. Highway 15, which in this section of the project area is a heavily traveled two-lane highway with a grass shoulder and occasional paved turnouts. The resources are surrounded by grass lawn and dirt parking lots and driveways. Resources U/61/0051

and U/61/0051.01 were not found to embody the distinctive characteristics of a type, period, or method of construction, and do not represent the work of a master or possess high artistic value. Resource U/61/0051.01 has been altered from its original form in ways that are visible from the street. Neither resource is known to be associated with events or persons significant in the past. Therefore, the resources are recommended as not individually or collectively eligible for the NRHP under Criterion A, B, or C.

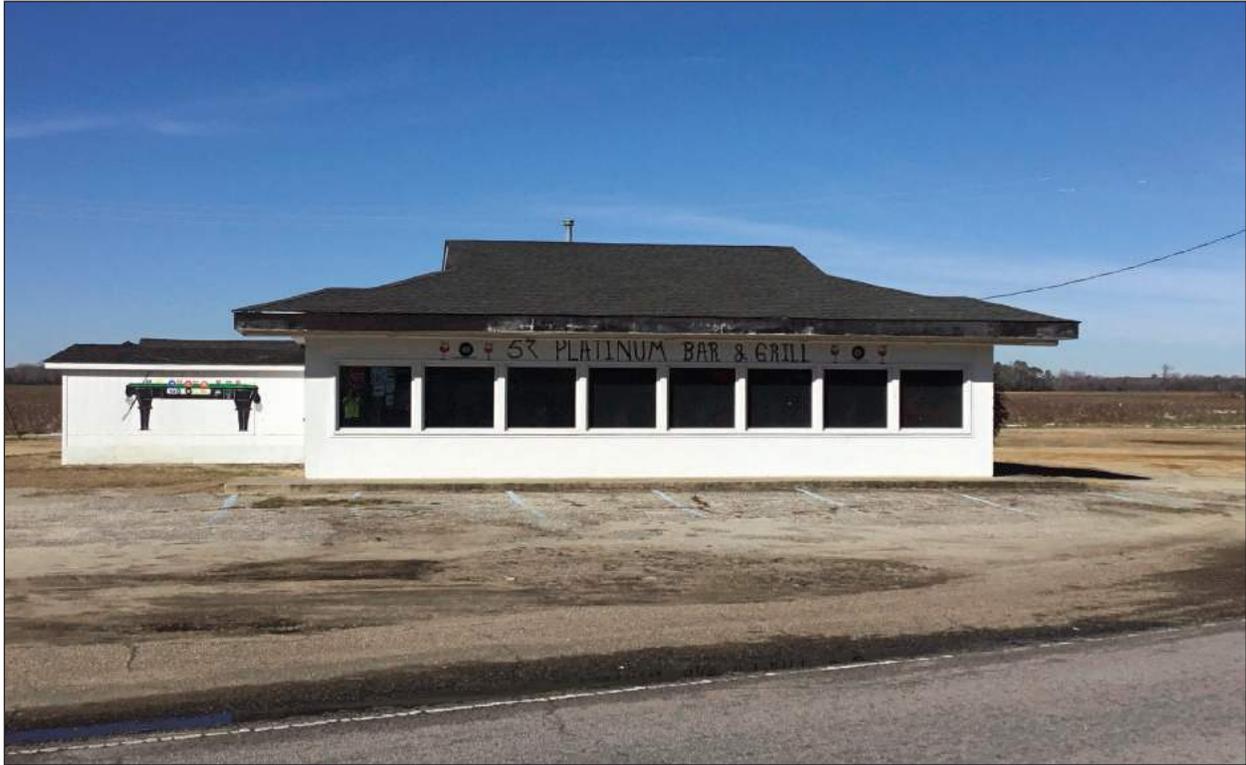
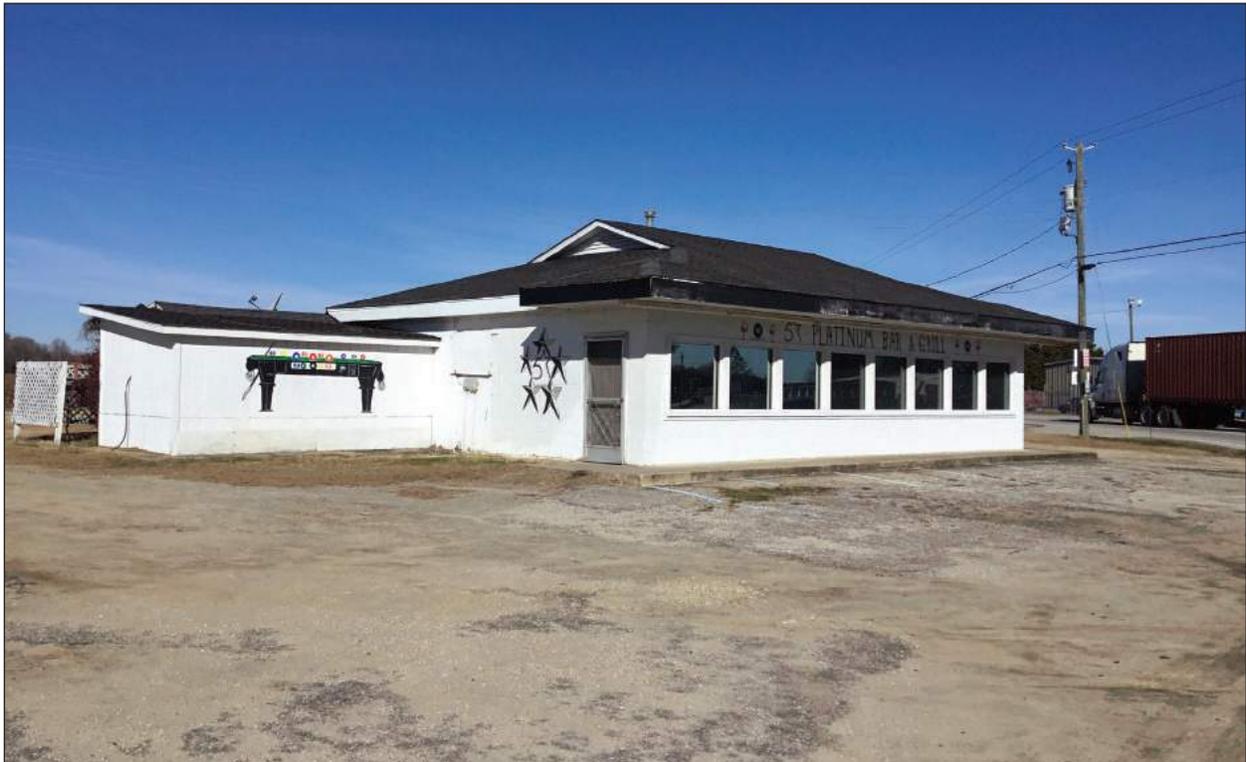
Figure 9.
Resource U/61/0052 – 5-Star Platinum Bar (687 U.S. Highway 15)

A. South Elevation

B. Southwest Oblique

Resource U/61/0052 is located at the corner of U.S. Highway 15 and Bethune Highway, both busy two-lane highways. It is surrounded by paved parking areas and sparse grass lawn. Setback is minimal and is dominated by a parking lot. Resource U/61/0052 was not found to embody the distinctive characteristics of a type, period, or method of construction, and does not represent the work of a master or possess high artistic value. It is not known to be associated with events or persons significant in the past. Therefore, the resource is recommended as not individually eligible for the NRHP under Criterion A, B, or C.

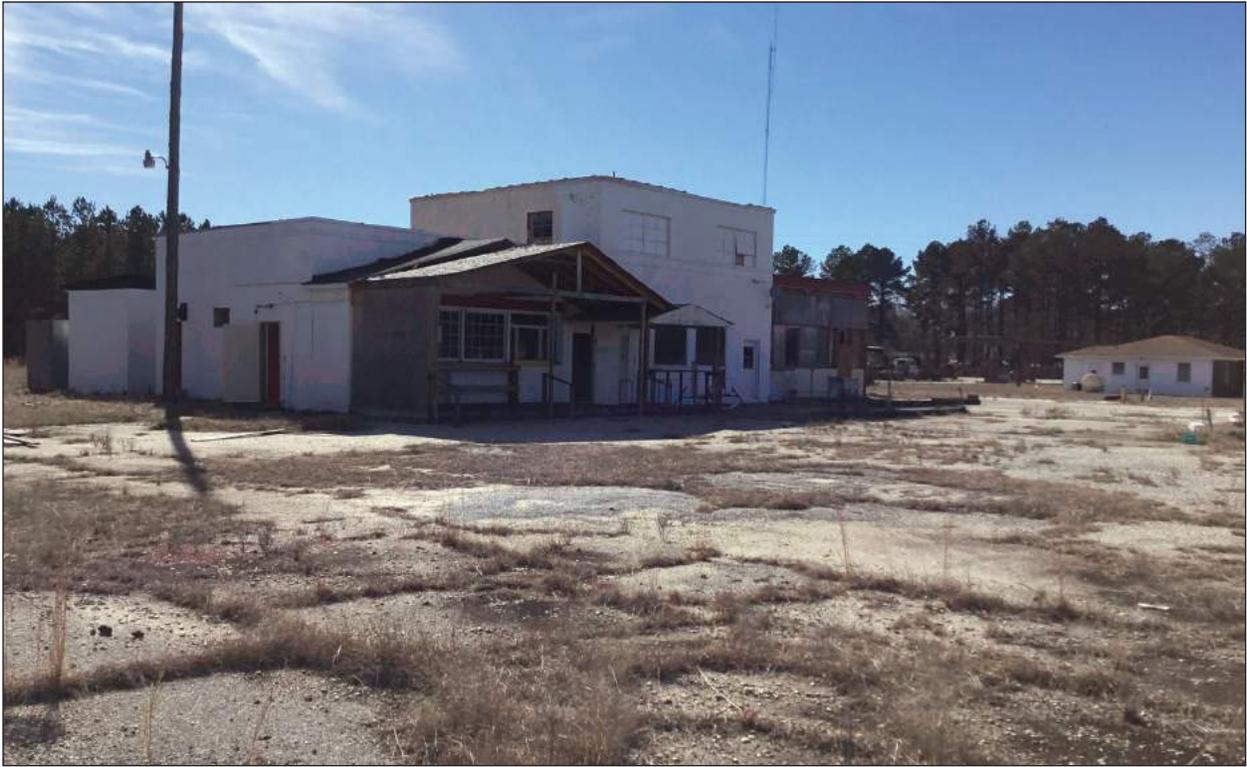
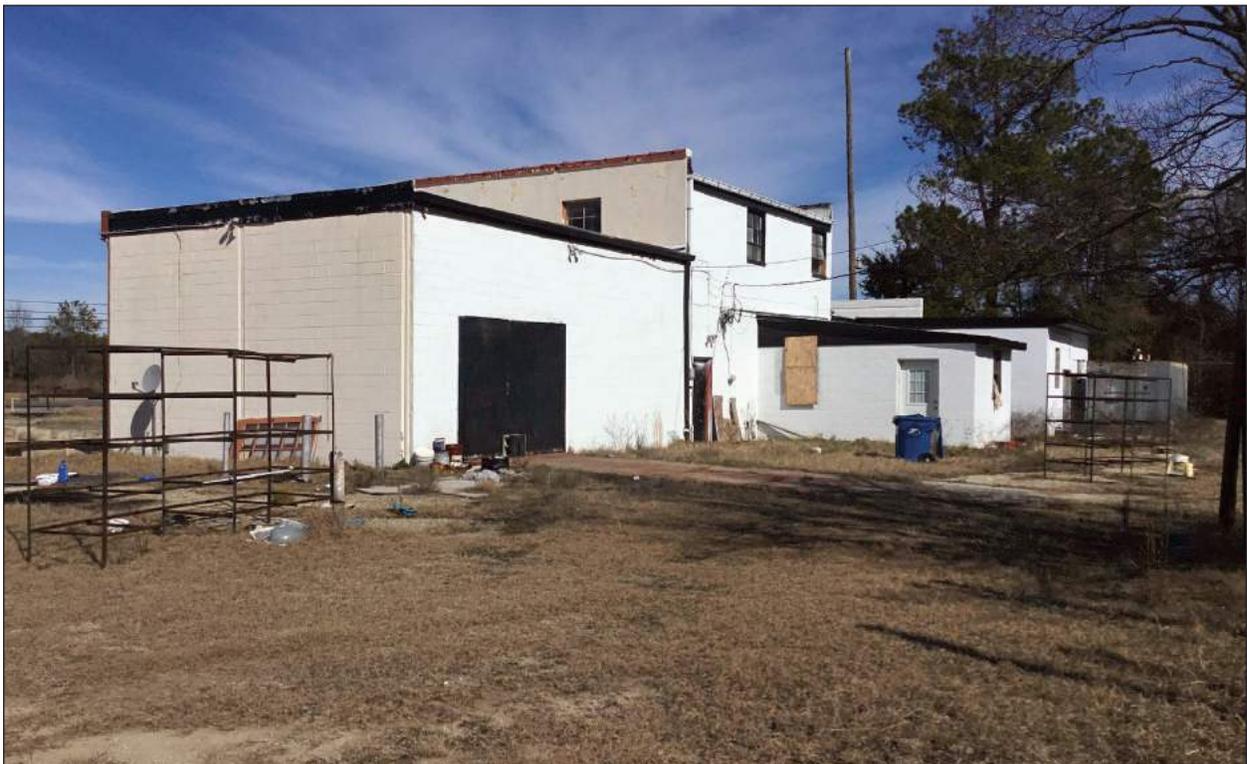
Figure 10.
Resource U/61/0053 – 800 U.S. Highway 15

A. Southeast Oblique

B. Northwest Oblique

Resource U/61/0053 is a circa 1950 commercial building located at 800 U.S. Highway 15. It faces east towards U.S. Highway 15 and is vacant. The building is comprised of an original two-part commercial block building and an original one-part commercial block building, which is located on the two-part commercial block's southwest elevation (Figure 10). It is of stuccoed concrete block construction with brick and metal coping at the roofline. A simple parapet wraps around the roofline and conceals a flat built-up roof. The two-part commercial block building is largely symmetrical with two fixed picture windows flanked by two slightly inset wood panel doors on the ground floor. The northern door is a two-pane half-light door. The picture windows are not original to the building. The second story has two pairs of four-over-two metal frame windows. The original façade of the one-part commercial block is concealed by a concrete block addition.

A band of non-historic windows fenestrates the addition, including two sliding windows of the type seen in drive-through or walk-up restaurant windows. This portion of the building is sheltered by an added front-gabled wood frame porch. A one-story concrete block addition has been made to the northeast side of the two-part commercial block building as well. This portion of the building contains a wood panel half-light door and two modern vinyl windows. A large portion of the front elevation of this addition is clad in plywood, indicating that it was once contained multiple fixed picture windows. The foundation is not visible.

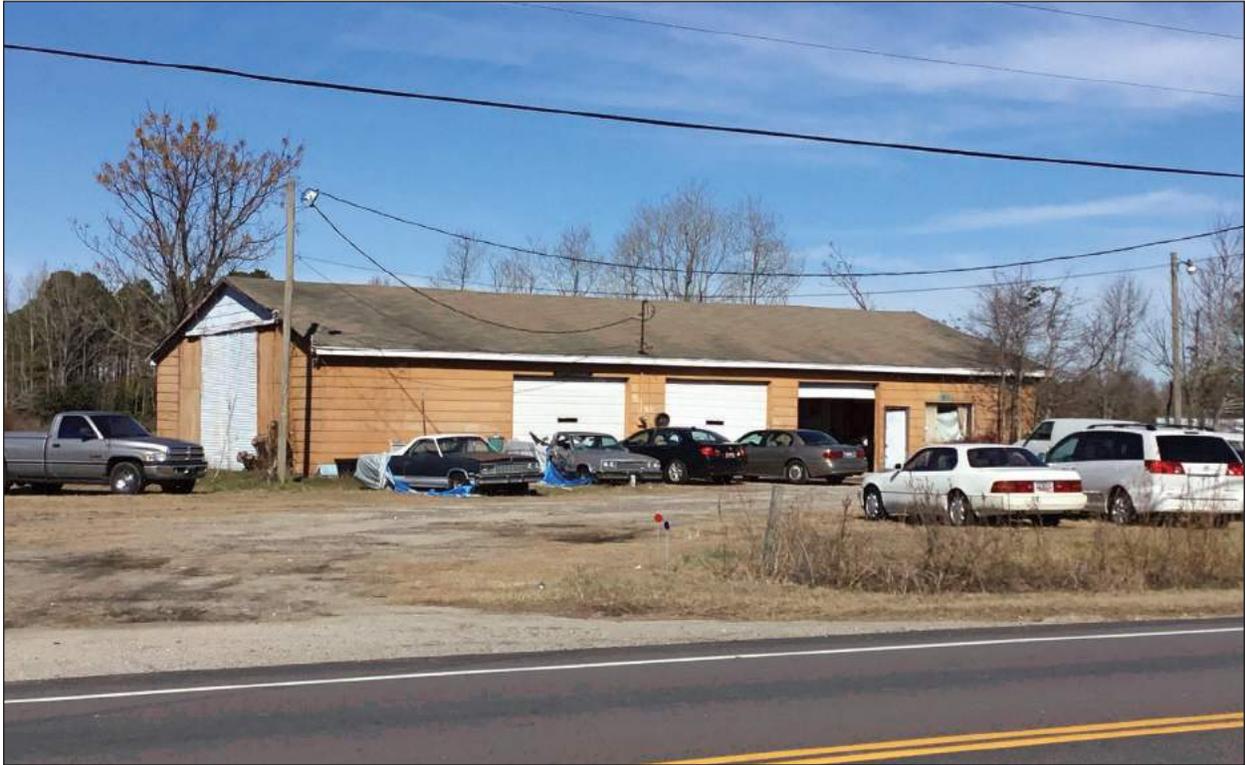
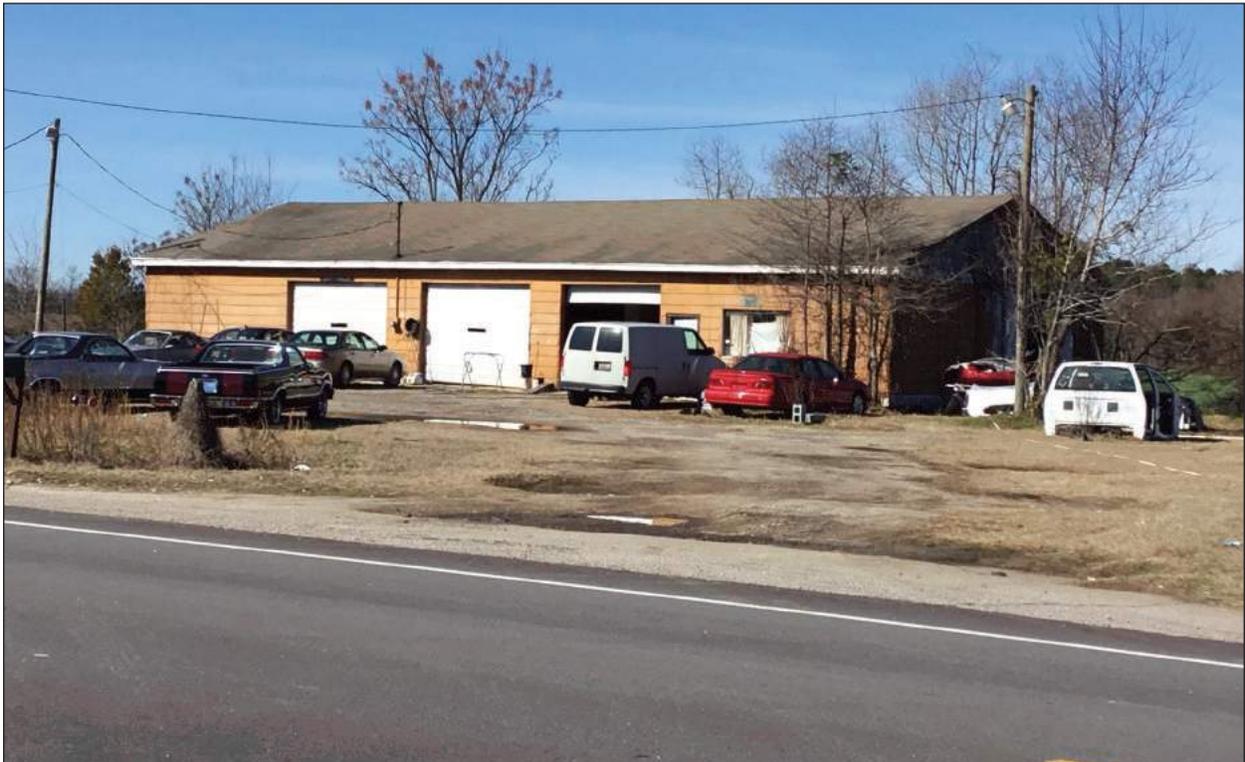
Figure 11.
Resource U/61/0054 – 803 U.S. Highway 15

A. Northwest Oblique

B. Southwest Oblique

Resource U/61/0054 is a circa 1960 commercial garage building of no distinct style or type located at 803 U.S. Highway 15. It is visible on a 1964 aerial photograph and faces west towards U.S. Highway 15. The resource is one story tall and has a rectangular plan with a laterally gabled composition shingle roof and is clad in aluminum siding (Figure 11). Fenestration on the front (west) elevation is irregularly spaced and includes three modern rolling metal garage doors, a modern wood panel personnel door, and a fixed picture replacement window. Rolling metal garage doors are located on the north and south elevations of the building and appear to have replaced earlier sets of barn doors.

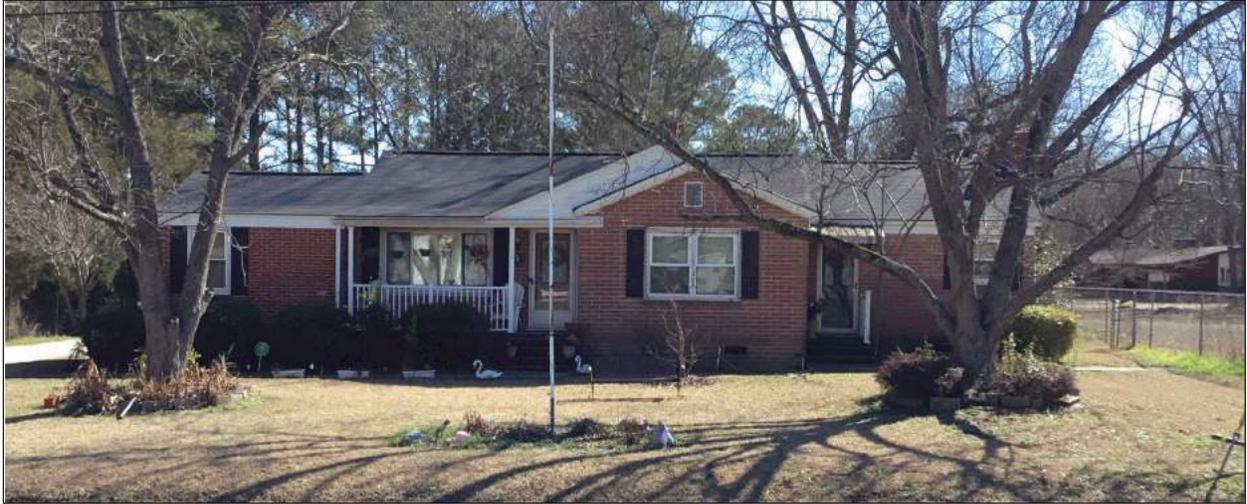
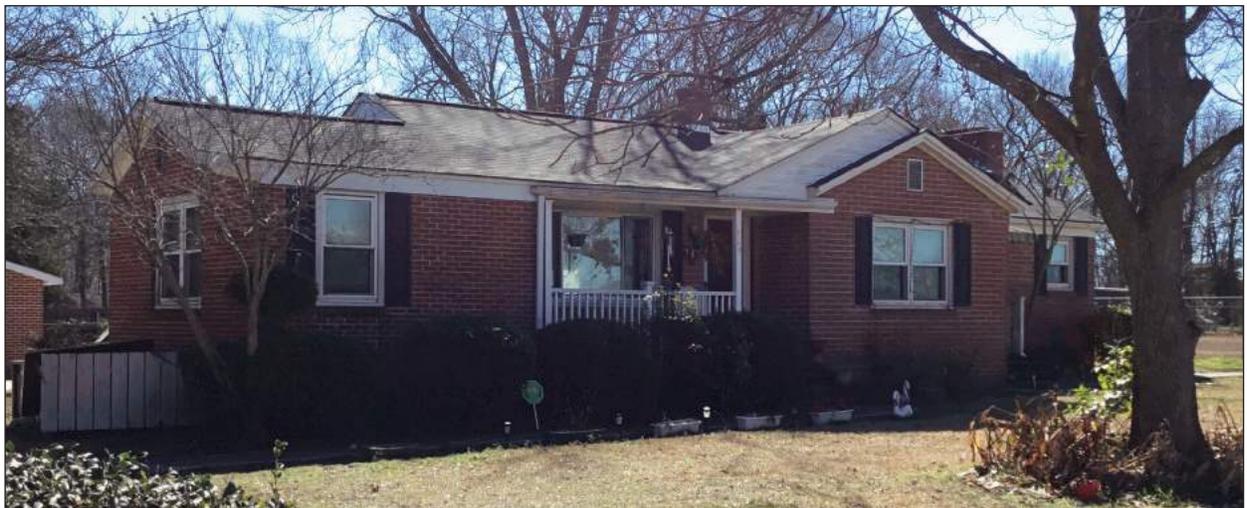
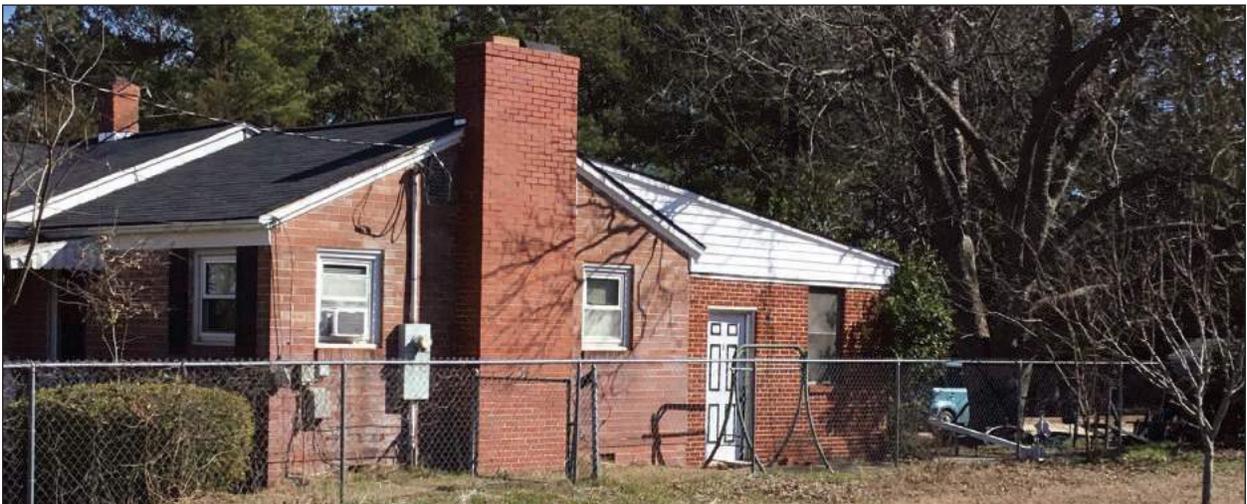
Figure 12.
Resource U/61/0055 – 720 U.S. Highway 15

A. East Elevation

B. Southeast Oblique

C. Southwest Oblique Detail

Resource U/61/0055 is a circa 1950 American Small House located at 720 U.S. Highway 15. It faces east towards U.S. Highway 15. It is one story in height with a rectangular historic core and a laterally gable composition shingle roof. It is clad in brick veneer (Figure 12). The east elevation contains a tripartite replacement window and a modern wood panel door under a partially engaged shed roofed porch. The porch is supported by round wood posts with a wood railing and turned balusters. Immediately southwest of the front doorway is a double front gable end containing a set of paired replacement one-over-one double-hung sash windows. Historic additions have been made to both the north and south side elevations. The addition to the north includes a small one-over-one double-hung sash window and an exterior brick chimney. The addition to the south contains a one-over-one double-hung sash window. A shed-roofed addition has been made to the rear of the house. All additions are one story tall and are clad in brick veneer. The foundation is concealed by brick veneer. The property also contains two brick veneer outbuildings, a garage, and a shed. They are not visible on a 1966 aerial photograph.

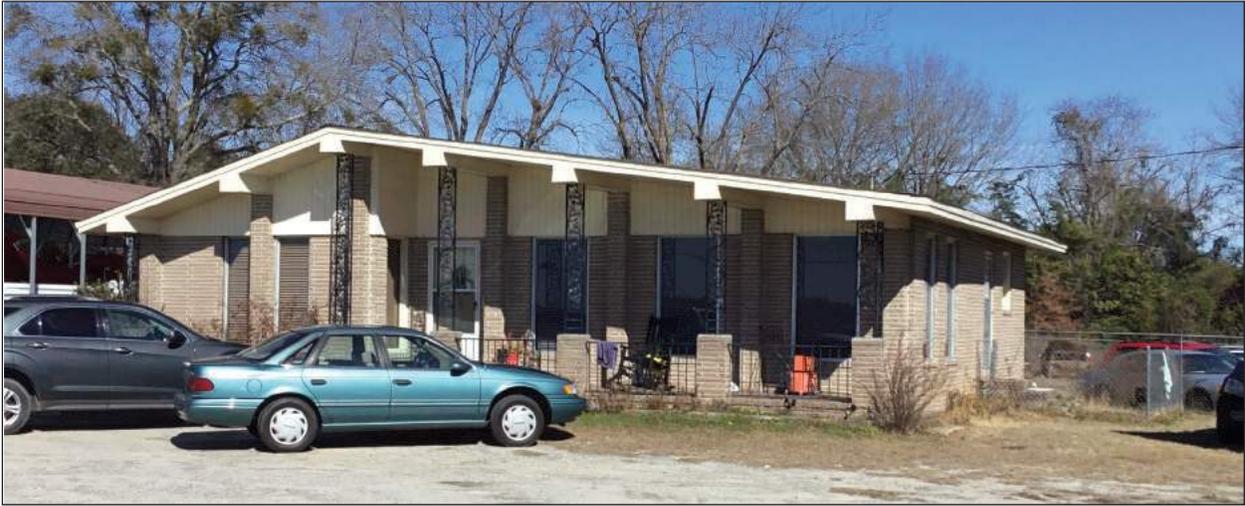
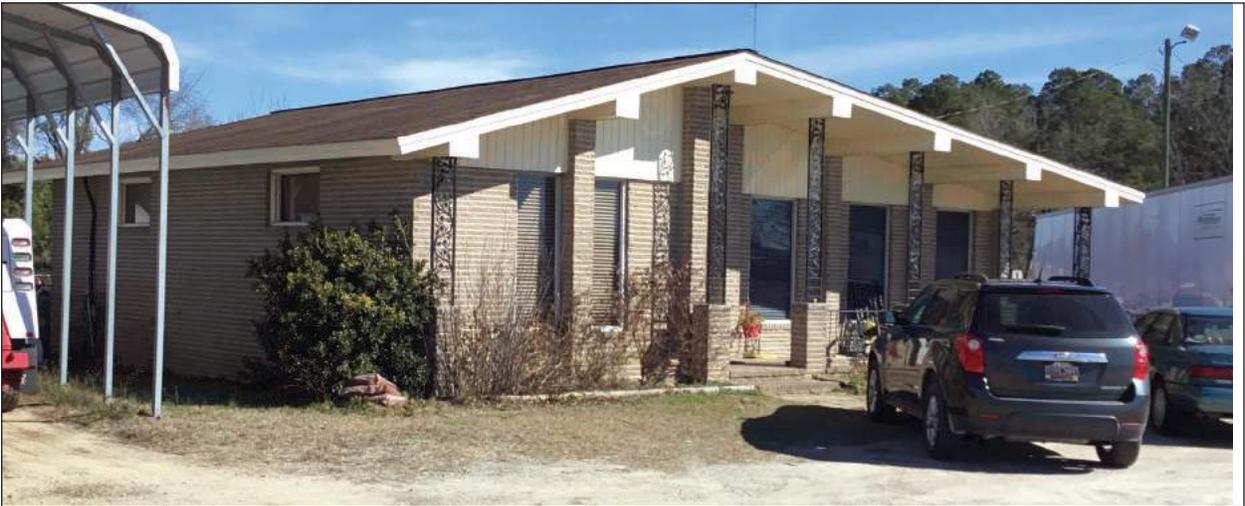
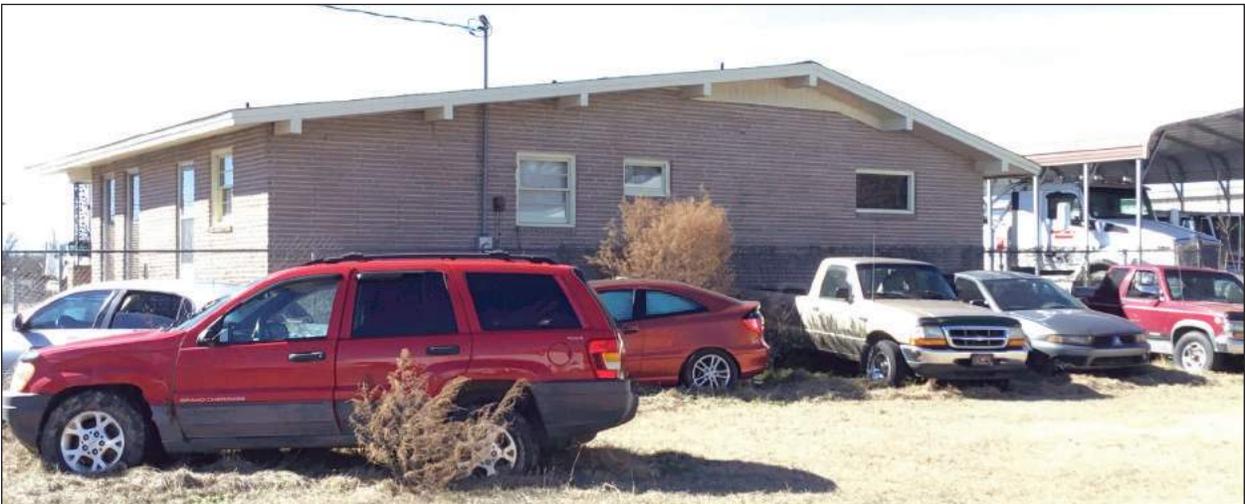
Figure 13.
Resource U/61/0056 – Buster’s Garage (707 U.S. Highway 15)

A. Northeast Oblique

B. Northwest Oblique

C. Southwest Oblique

Resource U/61/0056 is a circa 1960 building exhibiting elements of the Eichleresque style located at 707 U.S. Highway 15. While it is unclear as to whether or not the resource was originally a residence, the building is currently used as the office for an automobile repair shop, Buster's Garage. The building faces north towards Bethune Highway and is visible on a 1964 aerial photograph. It has a rectangular plan with an asymmetrical front gabled composition shingle roof and is clad in Roman brick veneer (Figure 13). There is vertical siding in the gable ends. The projection on the northwest end of the front (southwest) elevation contains two narrow, fixed pane windows. The wood panel door is roughly in the center of the elevation and is a modern replacement. To the

southeast of the door lie three fixed aluminum frame windows. The windows appear to be modern replacements. The full front façade is separated into six evenly spaced bays by a series of square brick veneer pilasters. The pilasters extend through the vertical wood siding of the gable end to the roofline. The building has deep overhanging boxed eaves supported by simple wood brackets which are aligned with the pilasters. A recessed porch spans a portion of the front elevation. It is supported by decorative aluminum supports on square brick piers. Additional modern replacement windows are set irregularly along the side elevations. A side entrance is located on the northwest elevation, as well as a small, original horizontal two-over-two wood frame double-hung sash window. An additional original window is located on the rear of the building. The foundation is concealed. A metal shed is located on the property but is not visible on a 1966 aerial photograph.

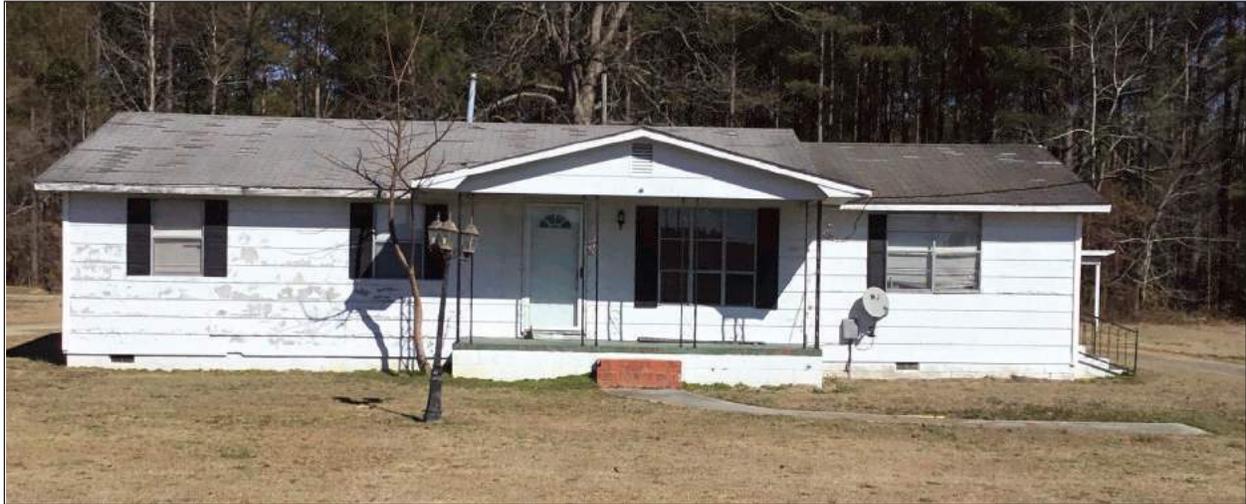
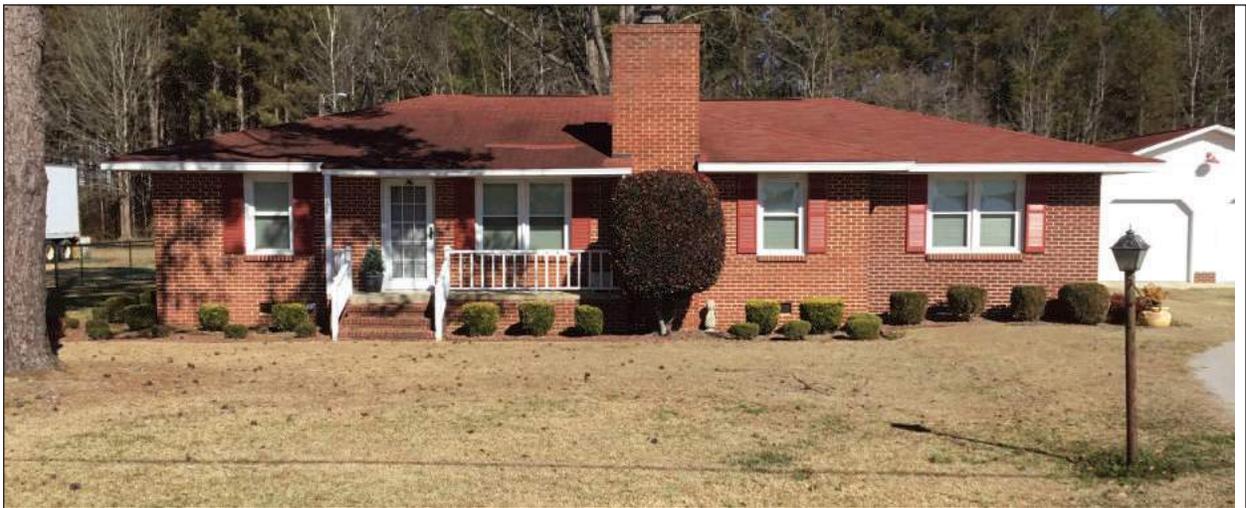
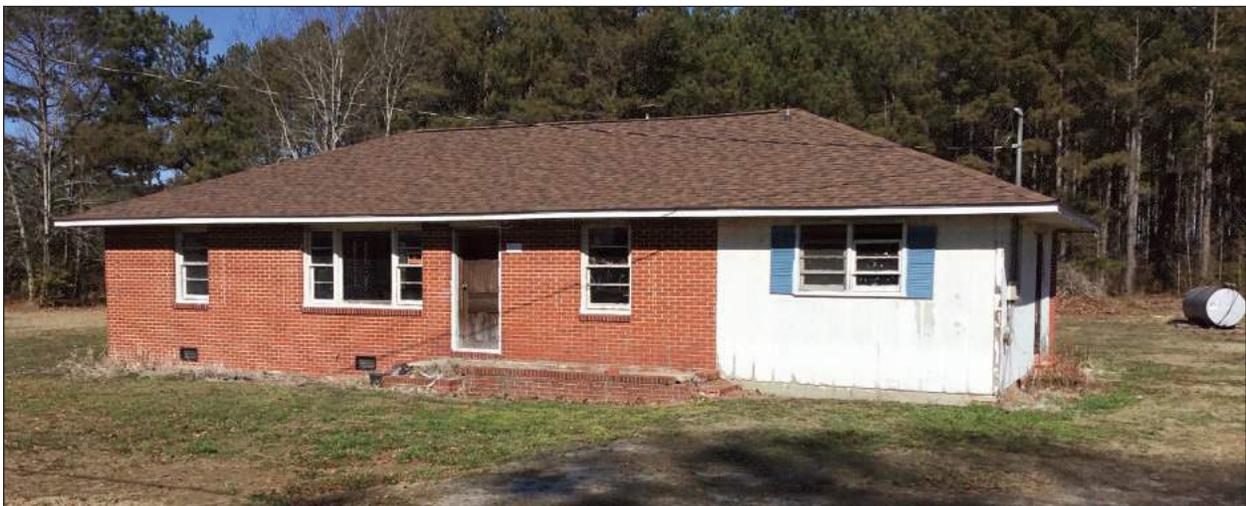
Figure 15.
Bethune Highway and Airport Road Historic District

A. Resource U/61/0057 – West Elevation

B. Resource U/61/0058 – West Elevation

C. Resource U/61/0059 – West Elevation

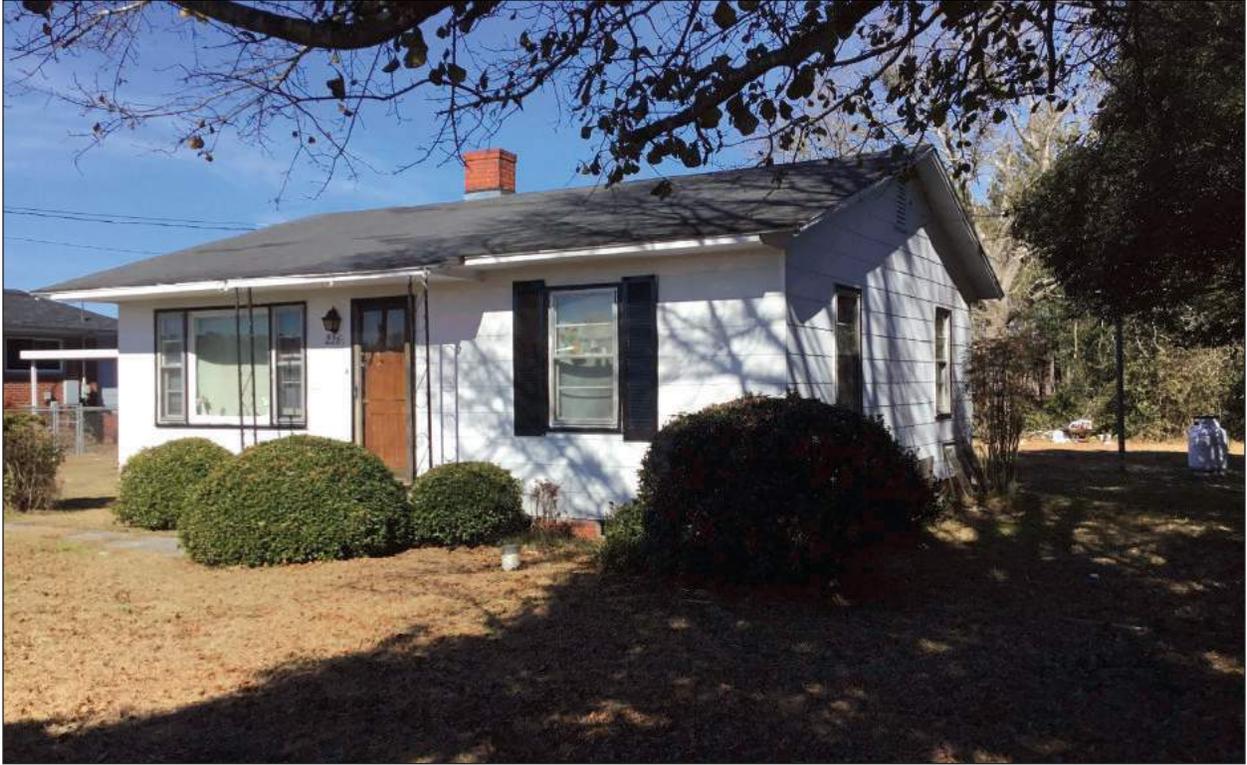
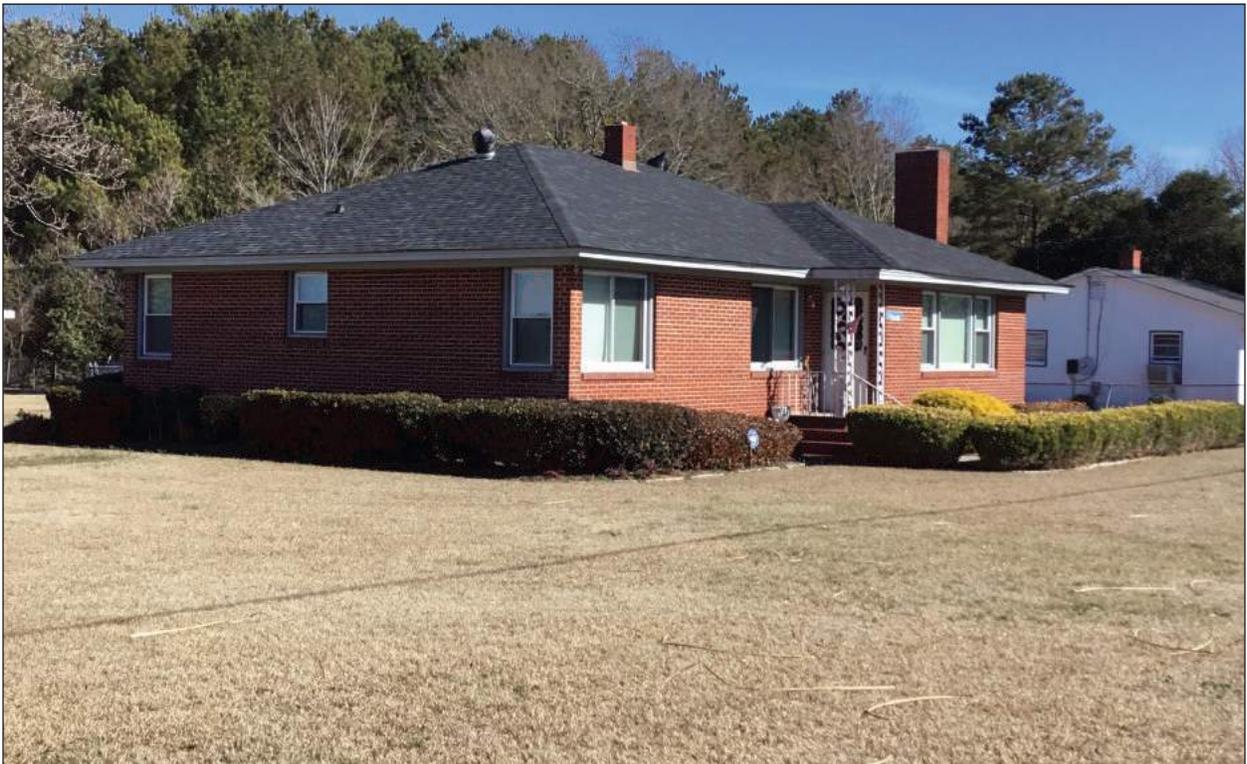
Figure 16.
Bethune Highway and Airport Road Historic District

A. Resource U/61/0060 – Southwest Oblique

B. Resource U/61/0061 – Northeast Oblique

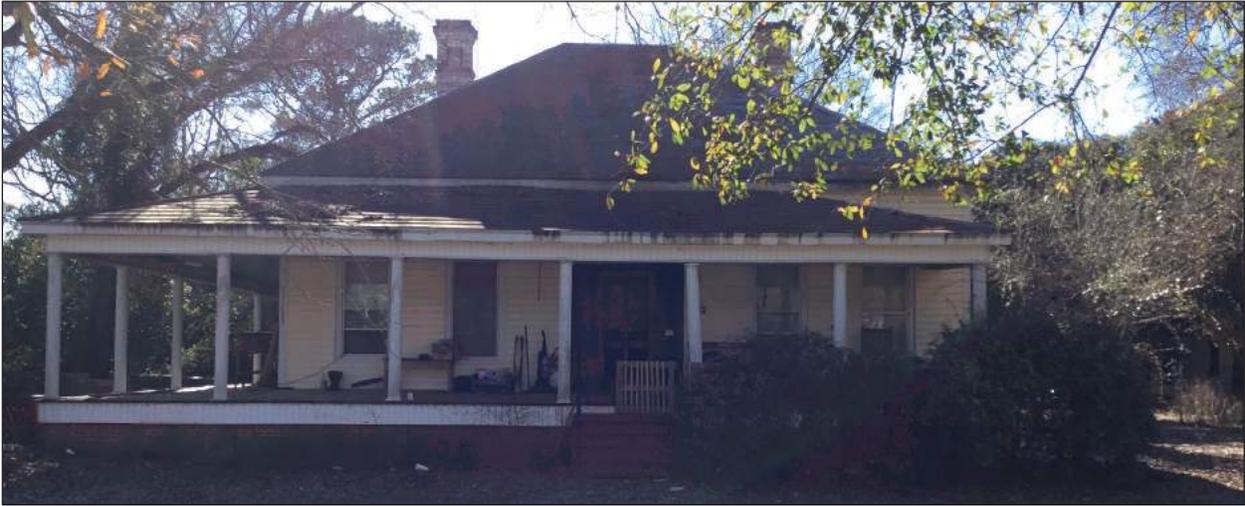
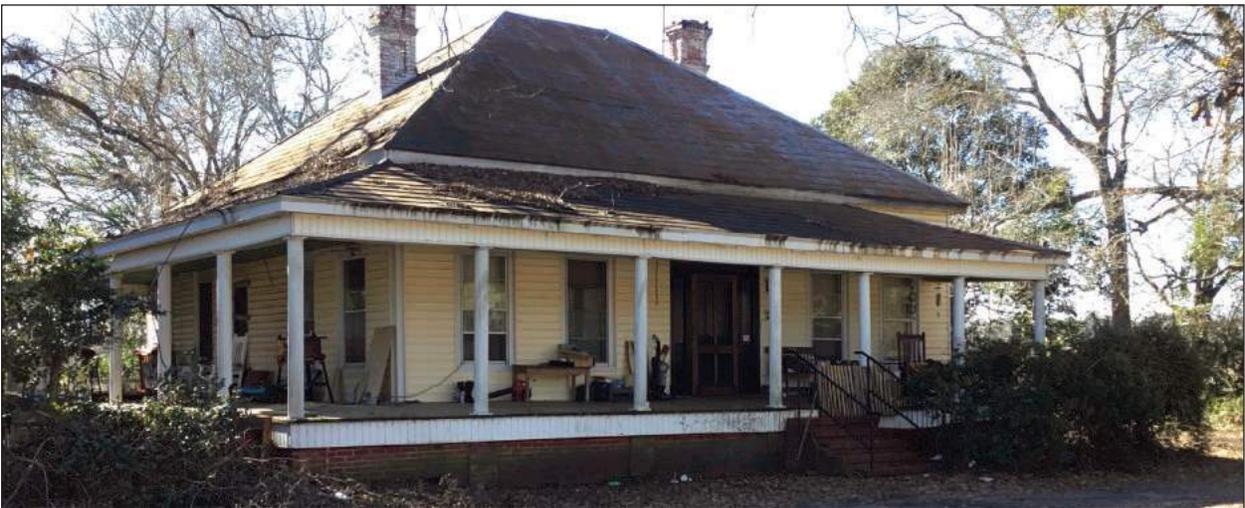
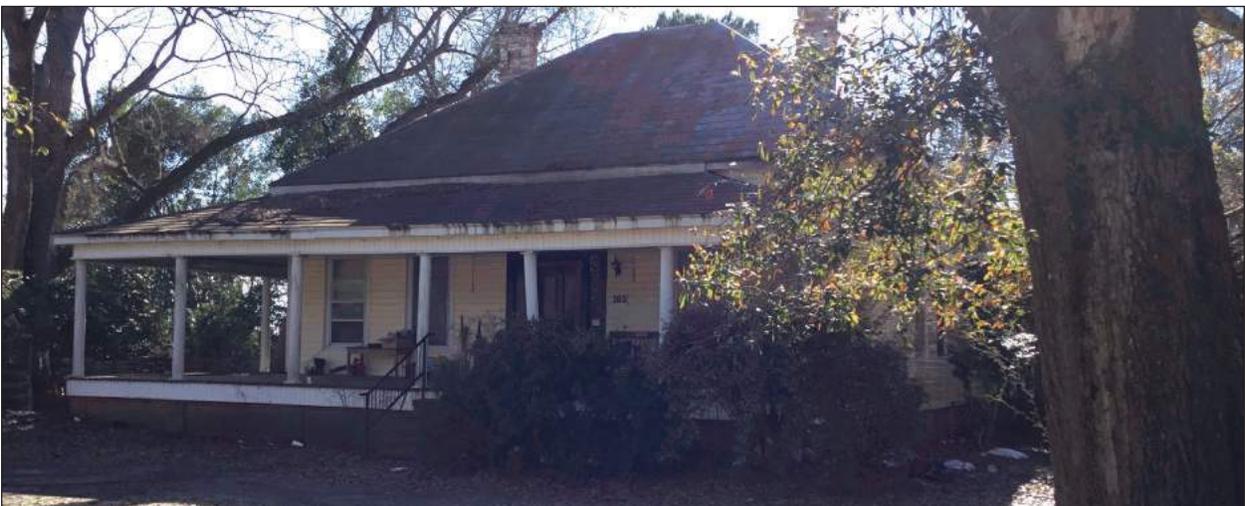
Figure 17.
Resource U/61/0062 – 203 Bethune Highway

A. East Elevation

B. Southeast Oblique

C. Northeast Oblique

Resource U/61/0062 is a circa-1910 Georgian Cottage located at 203 Bethune Highway. The historic core is square and one story tall with a steeply pitched hipped metal shingle roof (Figure 17). The building is clad in synthetic siding and faces east towards Bethune Highway. The front façade is symmetrical and centered on an original half-light wood panel door with sidelights and transom. Two horizontal two-over-two aluminum frame replacement windows are located to either side of the door. A large hipped front porch with non-historic aluminum columns wraps around part of the front and south elevations. A bay window is located on the north elevation and two corbeled brick chimneys rise symmetrically from the roofline.
