APPENDIX O. BISHOPVILLE TRUCK ROUTE PROJECT DRAFT CULTURAL RESOURCES ASSESSMENT

RE: Bishopville Truck Routes Alternatives Analysis, Lee County, South Carolina

Reconnaissance-Level Archaeological Survey of Bishopville Truck Route Segments

Phase I Architectural Survey of
**BISHOPVILLE BYPASS
ALTERNATIVES**

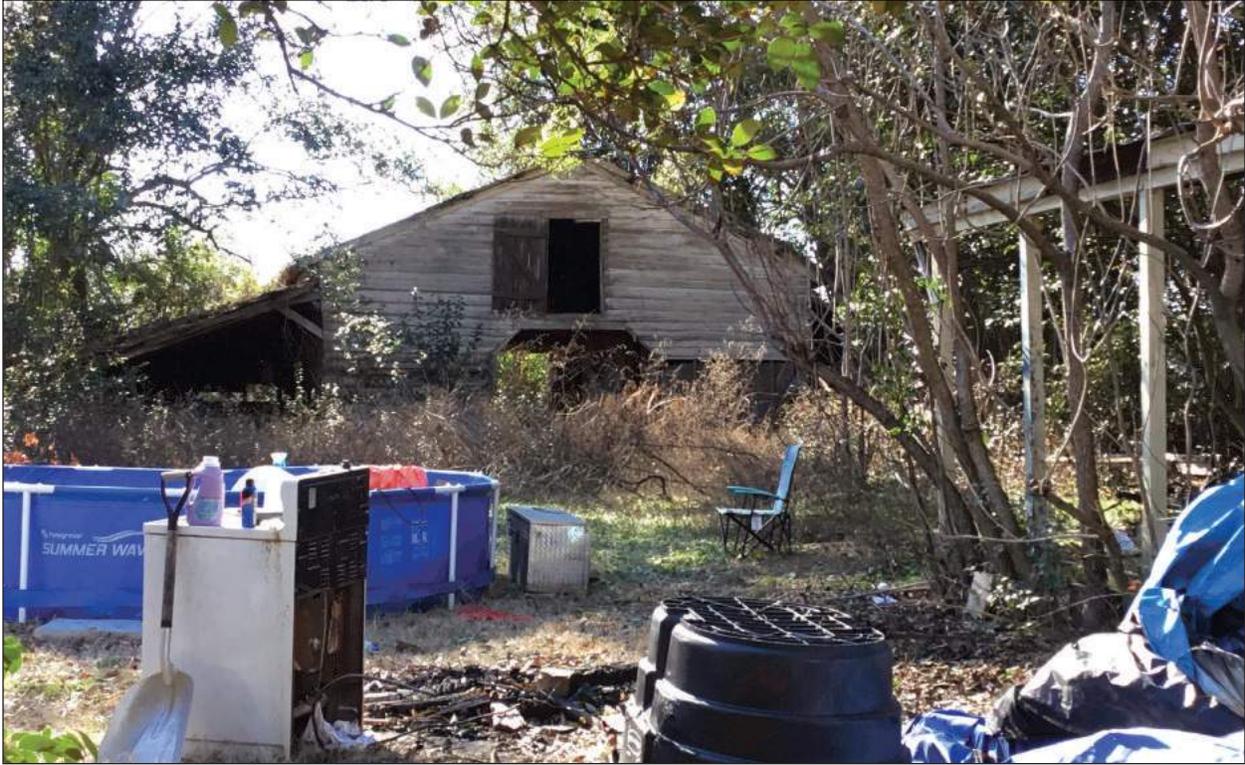
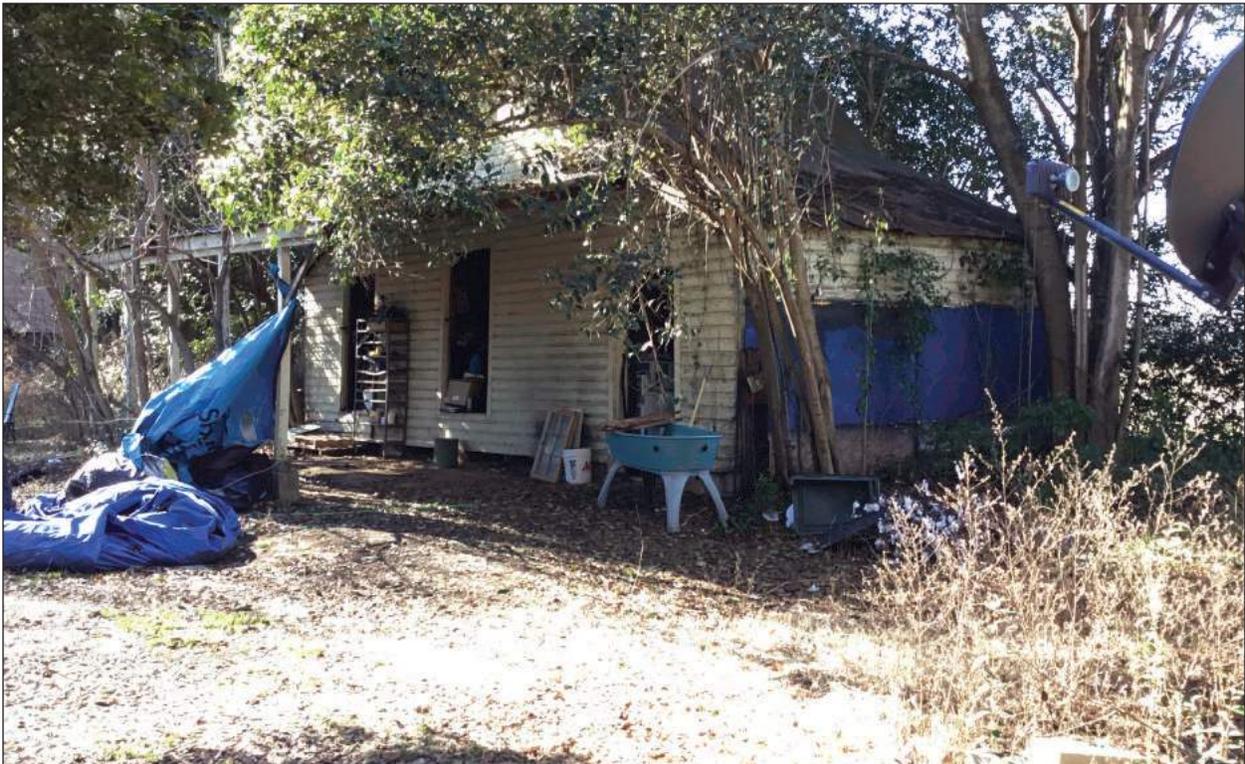
Figure 18.
Resources U/61/0062.01 and U/61/0062.02 – 203 Bethune Highway Barn and Shed

A. Resource U/61/0062.01 – South Elevation

B. Resource U/61/0062.02 – Southeast Oblique

The property contains two historic outbuildings. Resource U/61/0062.01 is a circa 1930 double crib barn located about 100 feet southwest of U/61/0062 (Figure 18). The two-story barn is rectangular with a front-gabled V-crimp metal roof and weatherboard cladding. An open canted walkway runs through the building and there is a hay loft with a wood siding door above it. Shed roofed open porches run along both side elevations. Resource U/61/0062.02 is a circa 1910 shed located roughly 50 feet southwest of U/61/0062 (see Figure 18). It is one story tall and rectangular with a steeply pitched composition shingle gable roof and shiplap siding. There is fenestration for a door and two windows on the front elevation. A porch with square wood supports extends across the left half of the front elevation. Shed roofed additions are located on both side elevations.

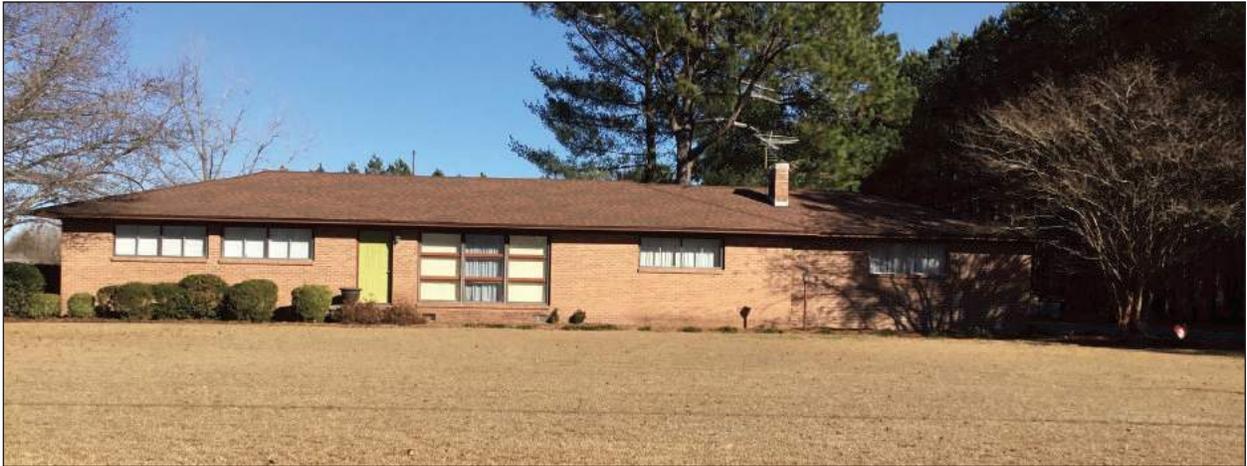
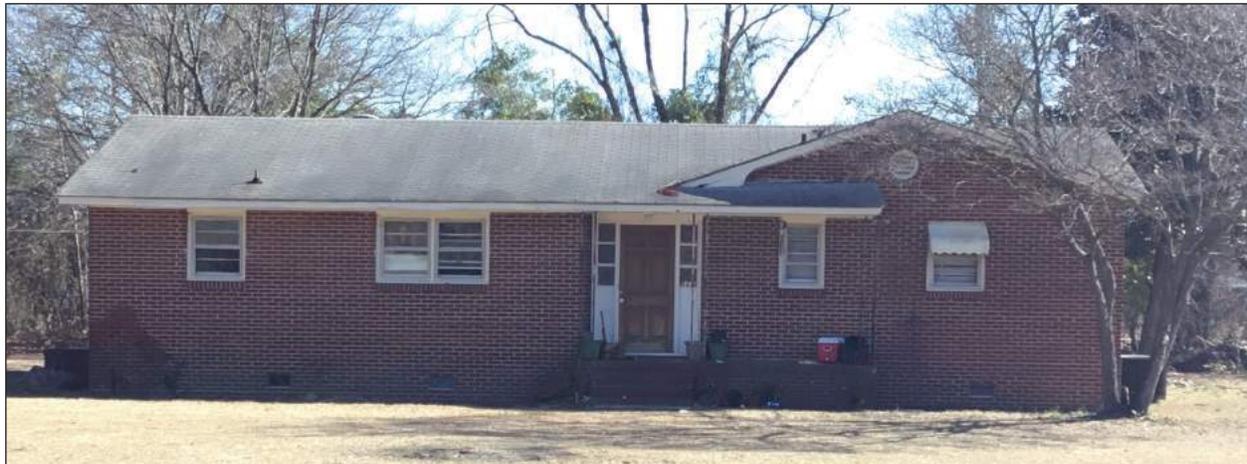
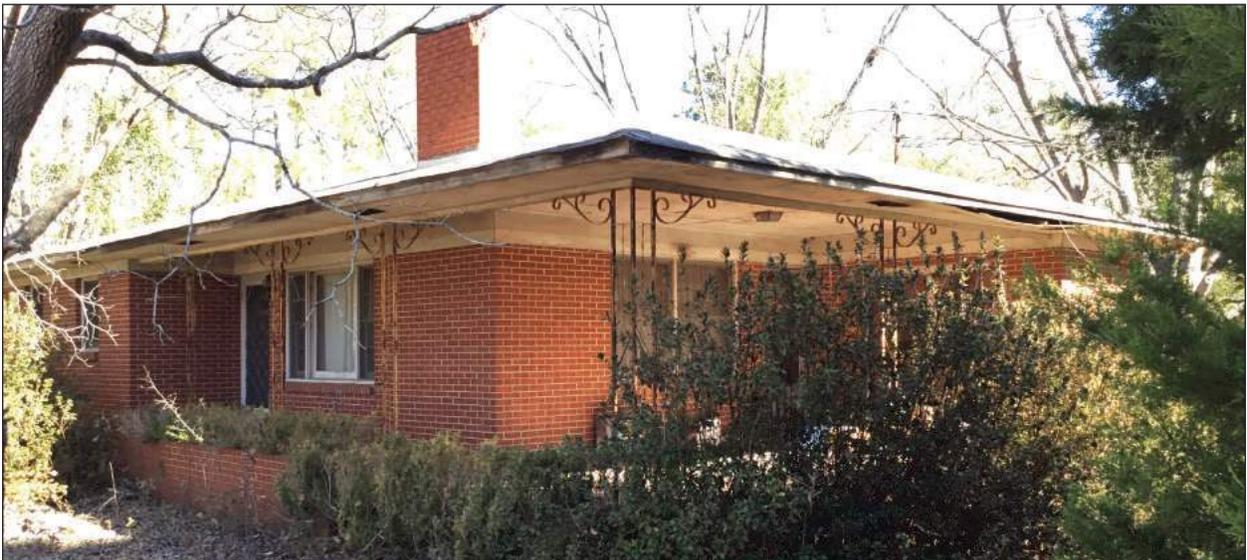
Figure 22.
Bethune Highway Historic District

A. Resource U/61/0063 – North Elevation

B. Resource U/61/0064 – North Elevation

C. Resource U/61/0065 – Northeast Oblique

Historic resources within the district date from circa 1955 through circa 1965 and are primarily Linear, Linear-with-Clusters, Bungalow, and Compact Ranch Houses (Figures 22 and 23). The non-historic resources are Ranch Houses as well with construction dates ranging from circa 1975 through circa 1985. While the majority of the Ranch Houses are of no particular style, some have Contemporary Style detailing including the use of a perforated brick curtain wall and low-slung, geometric design with a large nine-pane picture window. All resources are either rectangular or L-shaped, one story tall, and clad in brick veneer. Roofs are either laterally gabled or hipped composition shingle and typical fenestration consists of wood frame horizontal two-over-two double-hung sash, either individually or in a tripartite picture window. One resource has vertical two-pane sliding windows, while another has vinyl replacement windows. Decorative details include partially engaged porches with aluminum supports, overhanging boxed eaves, and interior brick chimneys. There are frequently non-historic garages and occasionally sheds which have been added to the rear of the lots.

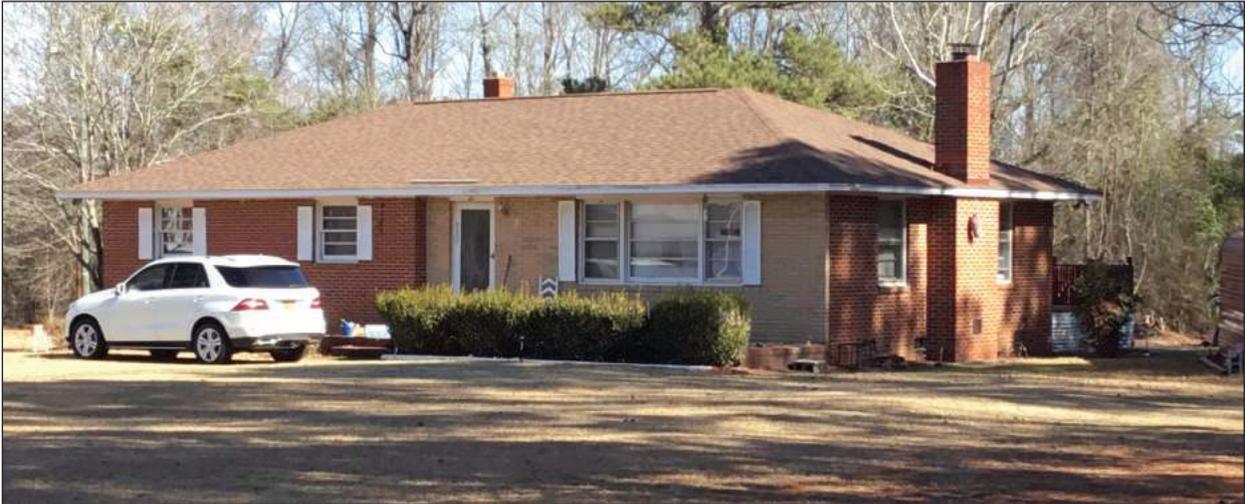
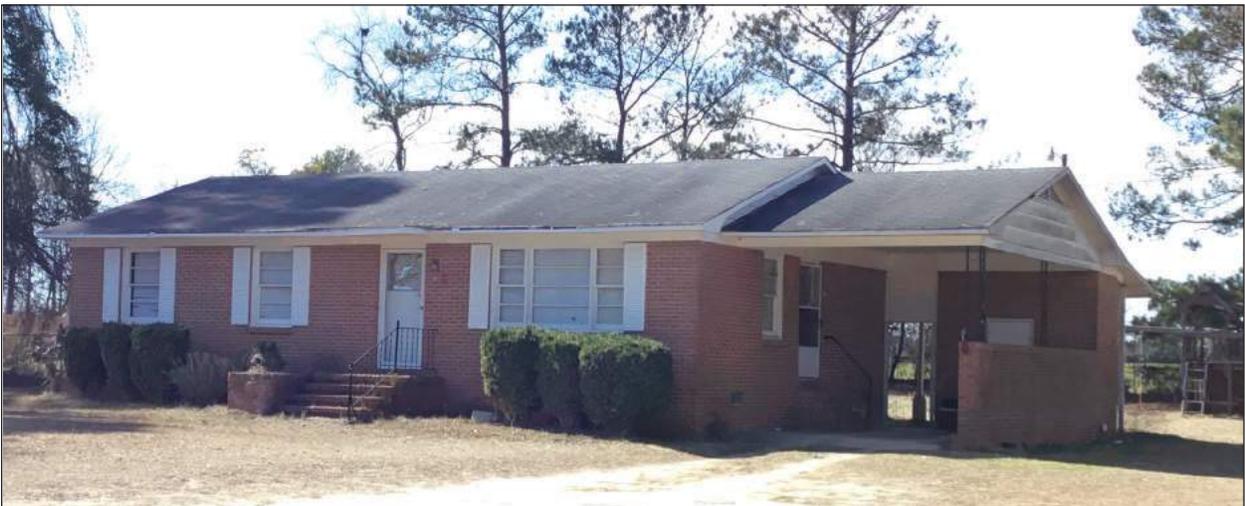
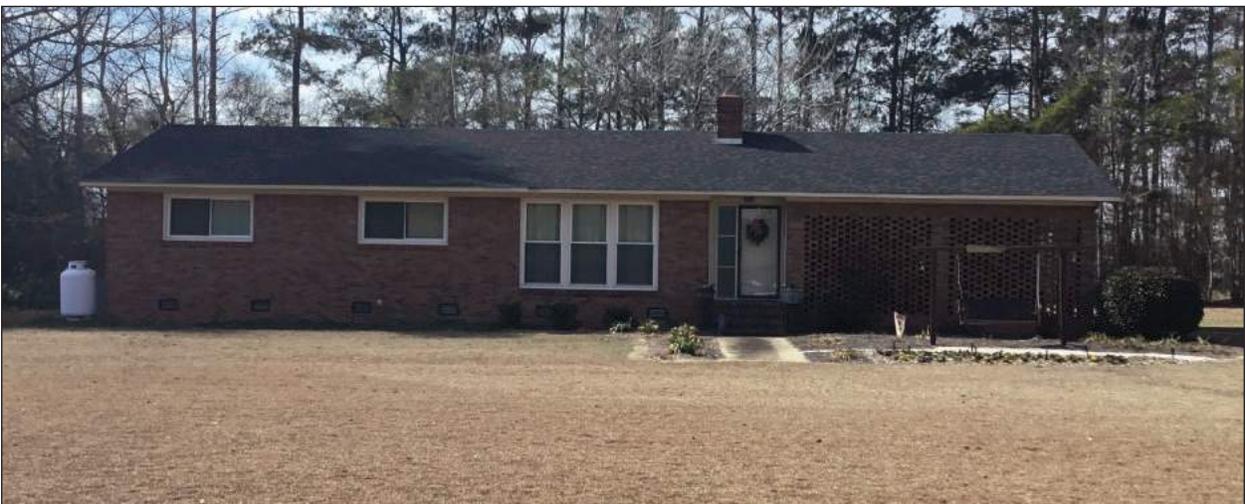
Figure 23.
Bethune Highway Historic District

A. Resource U/61/0066 – Northwest Oblique

B. Resource U/61/0067 – Southeast Oblique

C. Resource U/61/0068 – South Elevation

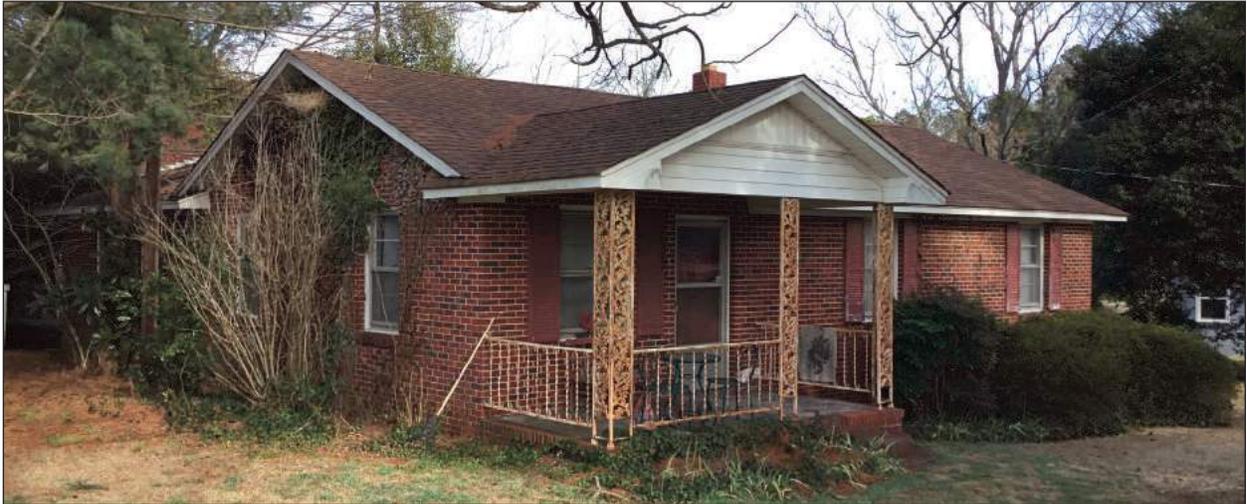
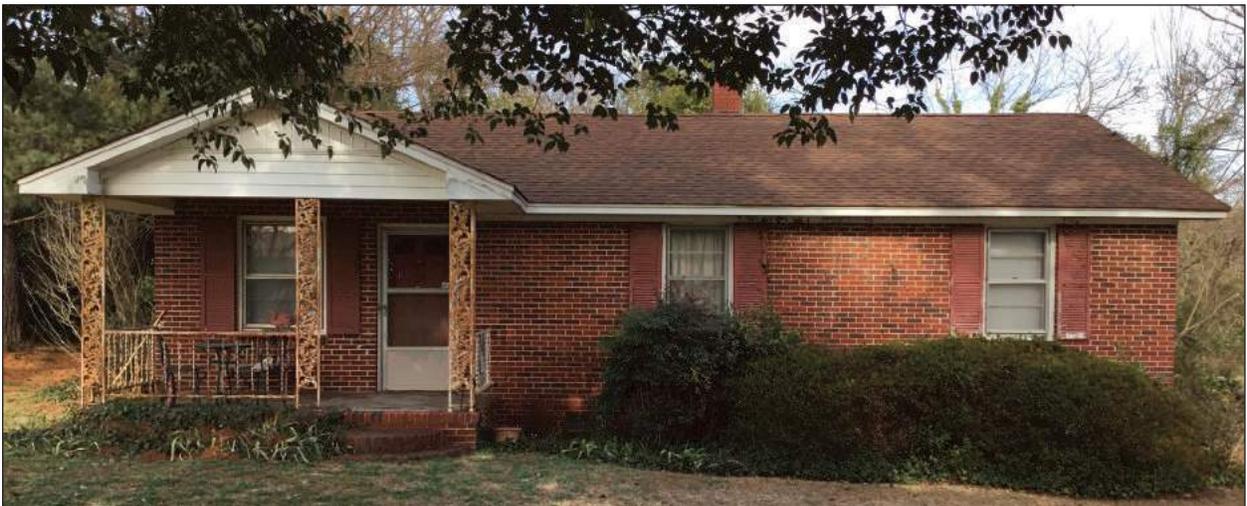
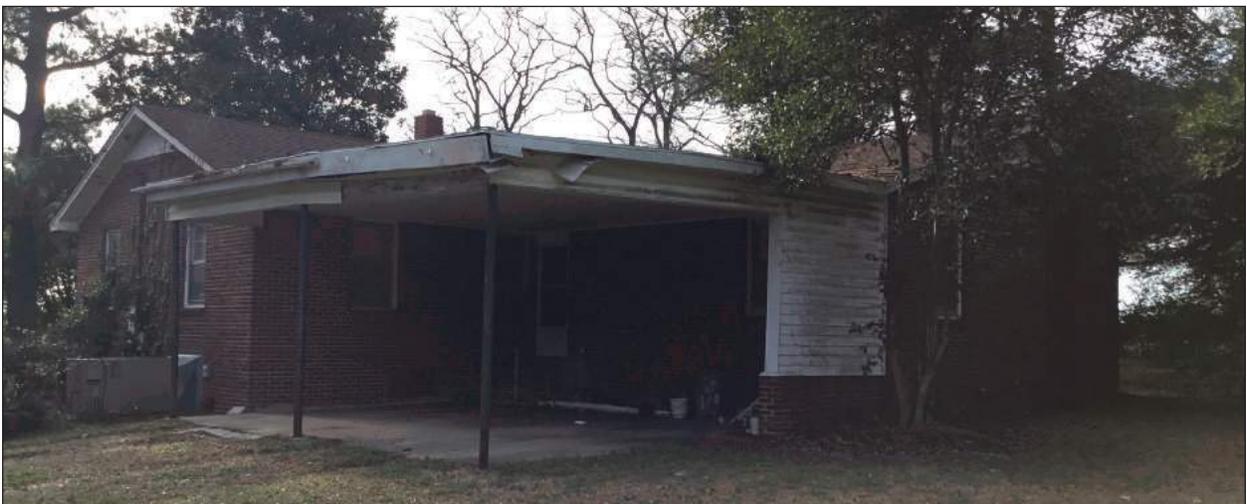
Figure 24.
Resource U/61/0069 – 622 West Church Street

A. Southwest Oblique

B. South Elevation

C. Northeast Oblique

Resource U/61/0069 is a circa 1950 Compact Ranch House located at 622 West Church Street. It is located near the intersection of Denny Pond Road and West Church Street and faces south towards West Church Street. It is one story tall and is rectangular with a laterally gabled composition shingle roof and brick veneer cladding (Figure 24). The wood panel door and a replacement aluminum frame double-hung sash window are sheltered by a front-gabled porch with decorative aluminum supports and vinyl siding in the pediment. To the east of the door lies two wood frame horizontal two-over-two double-hung sash windows. All windows have louvered shutters. An interior brick chimney rises from the roofline and the foundation is concealed. Two additions have been made to the rear of the building including a front-gabled room and a flat-roofed carport.

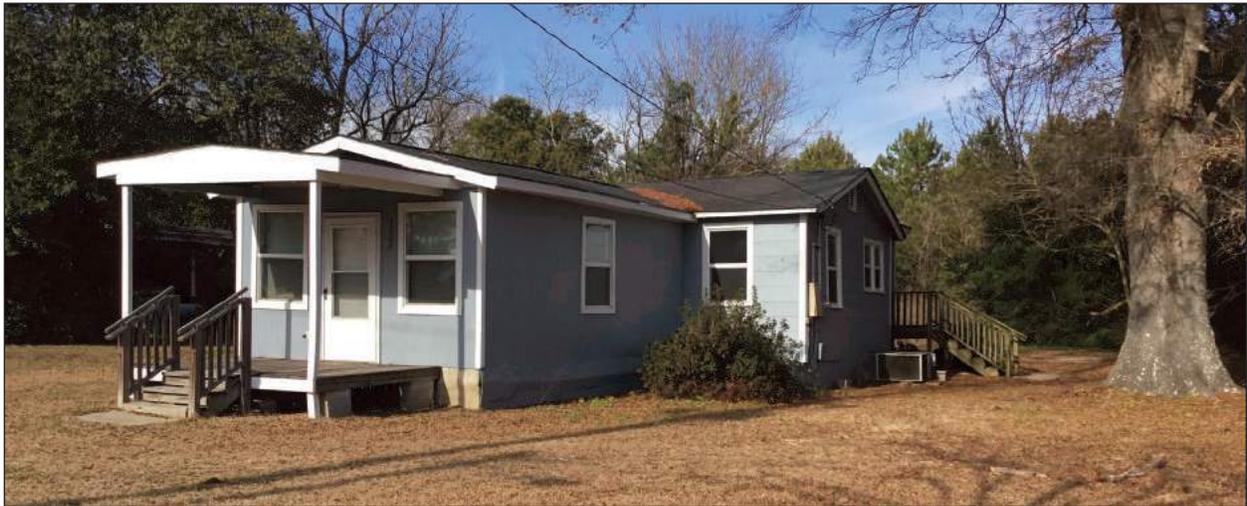
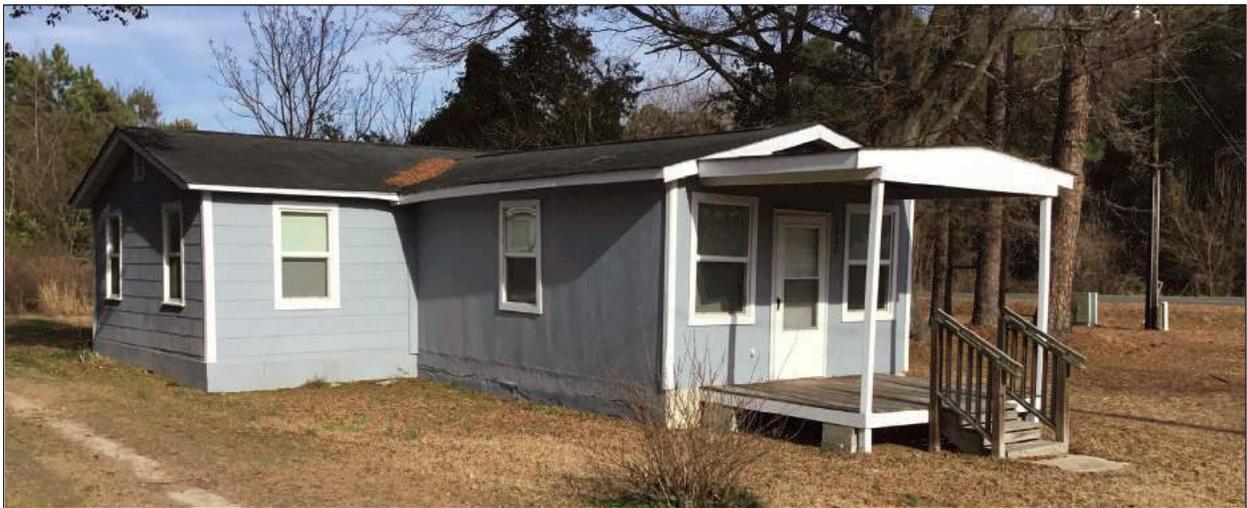
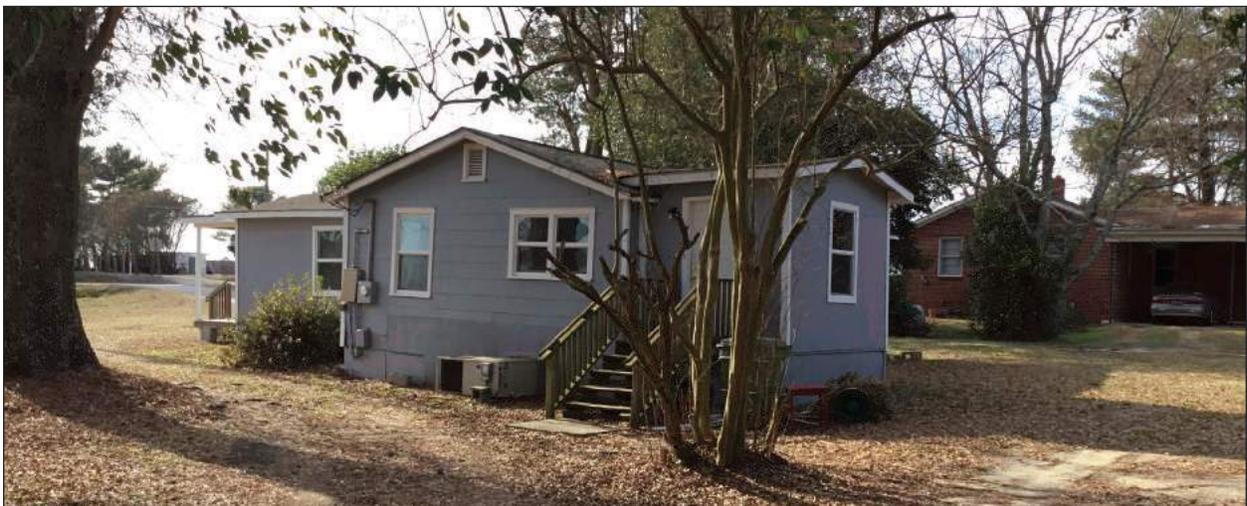
Figure 25.
Resource U/61/0070 – 1002 West Church Street

Resource U/61/0070 is a circa 1960 American Small House located at 1002 West Church Street. It is located on the corner of West Church Street and Denny Pond Road and faces south towards West Church Street. The historic core is rectangular and one story tall (Figure 25). A lateral-gabled composition shingle roof shelters the historic core and a large front-gabled entry vestibule addition on the front elevation. The resource is clad in asbestos shingle siding and all windows on the resource are modern replacements. Much of the original front elevation is obscured by the addition, which is clad in pressboard and is symmetrical with a modern wood panel door flanked by one-over-one double-hung sash windows. A shallow pitched front gabled porch has been added to the entry vestibule and has square wood supports. A window is located to either side of the entry vestibule. A front-gabled addition has been made to the rear of the house and the foundation is concealed by plywood.

Resource U/61/0070 is located at the corner of West Church Street, a busy two-lane highway, and Denny Pond Road, a rural two-lane road. The resource is sited on a generously sized lot with a sparse grass lawn and mature trees. It has a setback of roughly 100 feet from West Church Street. Although Resource U/61/0070 is an American Small House, it is not a distinctive or noteworthy example of this house type, which is common in South Carolina. Its integrity is greatly impacted by a large addition to the front of the house which significantly alters the character of the house. It was not found to embody the distinctive characteristics of a style, period, or method of construction, and does not possess significance for its engineering or materials. It is not known to be associated with events or persons significant in the past. Therefore, the resource is recommended as not individually eligible for the NRHP under Criterion A, B, or C.

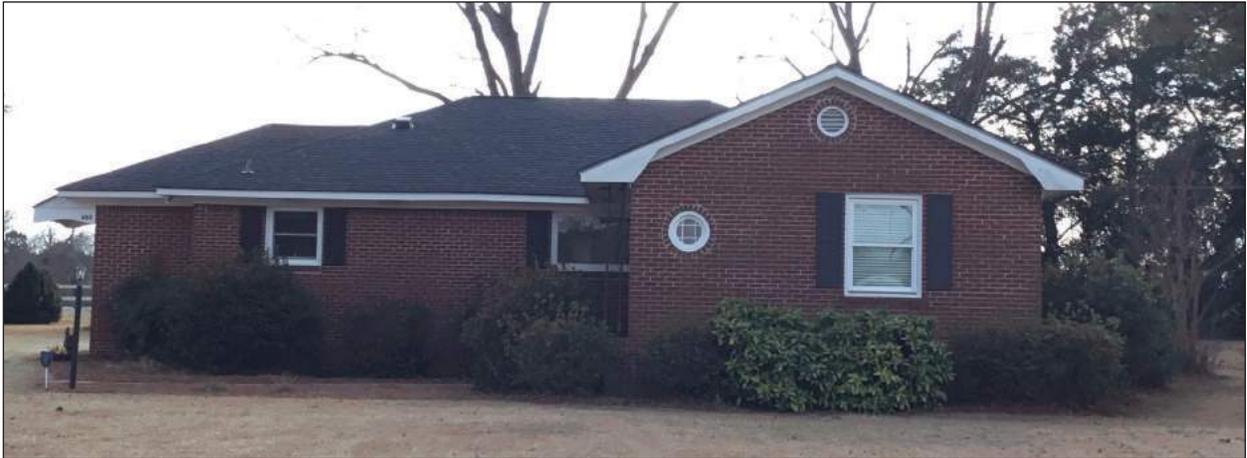
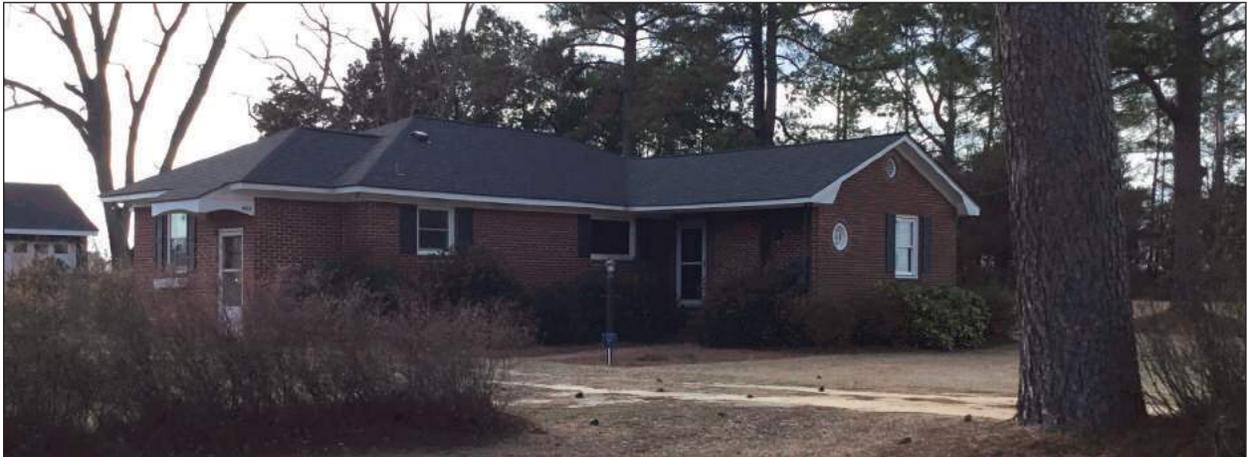
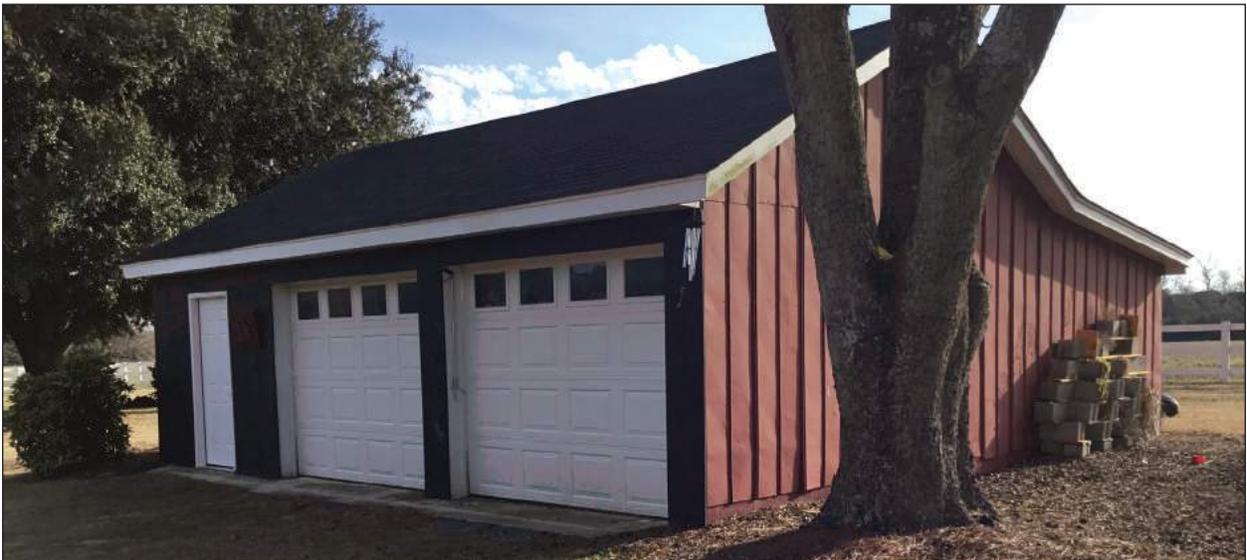
Figure 26.
Resources U/61/0071 and U/61/0071.01 – 603 West Church Street and Garage

Resource U/61/0071 is a circa 1945 house Linear Ranch House located at 603 West Church Street. It is located near the intersection of West Church Street and Denny Pond Road and faces north towards West Church Street. It is one story tall with a largely rectangular historic core and is clad in brick veneer (Figure 26). The historic core has a hipped composition shingle roof and the front elevation is dominated by a circa 1970 front-gabled addition to the west half of the elevation. The house is accessed via a wood panel door on the east side of the addition which is sheltered by an extended overhanging eave with an aluminum support. Replacement vinyl frame one-over-one double-hung sash windows are found throughout the house, in addition to a fixed vinyl frame picture window on the historic core and multiple round porthole windows on the addition. A side entrance with unsupported hood is located on the east elevation. All sash and picture windows have louvered shutters and the foundation is concealed.

A circa 1945 garage, Resource U/61/0071.01, is located approximately 35 feet south of Resource U/61/0071. It is rectangular with a laterally gabled composition shingle roof and is clad in V-crimp metal siding (see Figure 26). It has two modern rolling wood panel garage doors and a single modern wood panel personnel door. A shed roofed addition has been added to the rear and the building is supported by a concrete block foundation.

Resources U/61/0071 and U/61/0071.01 are located on West Church Street, a busy two-lane highway. They are sited on a generously sized lot and Resource U/61/0071 has a 150-foot setback from West Church Street. The lot is landscaped with grass lawn, ornamental shrubs, mature trees, and a wooded buffer to the rear. The surrounding land is partially developed with single family homes on similarly sized lots and partially dedicated to agriculture. Resources U/61/0071 and U/61/0071.01 were not found to embody the distinctive characteristics of a style, period, or method of construction, and do not represent the work of a master or possess high artistic value. They are not known to be associated with events or persons significant in the past. Therefore, the resources are recommended as not individually or collectively eligible for the NRHP under Criterion A, B, or C.

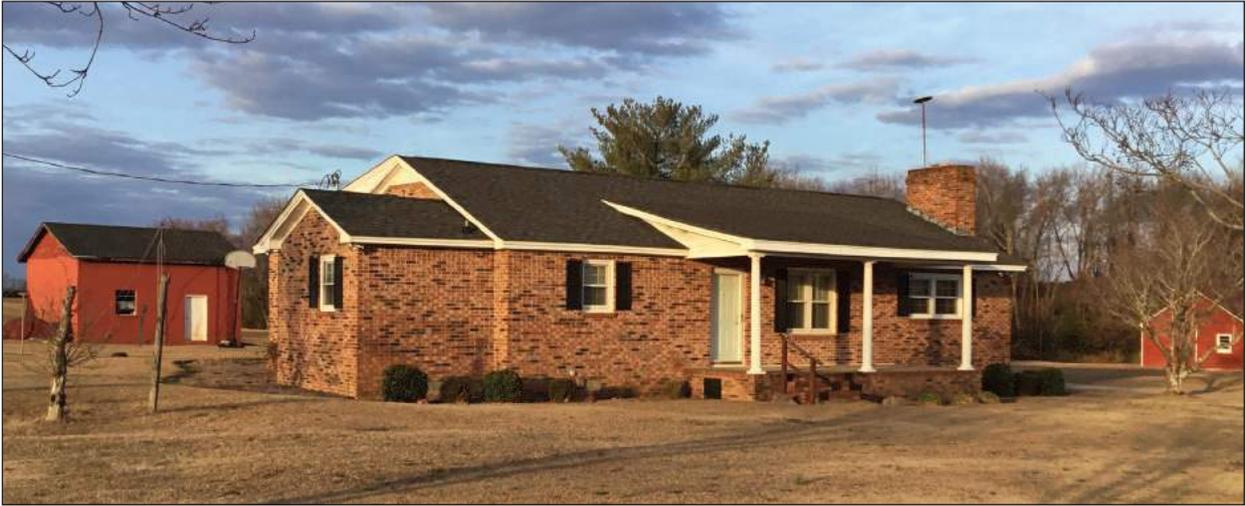
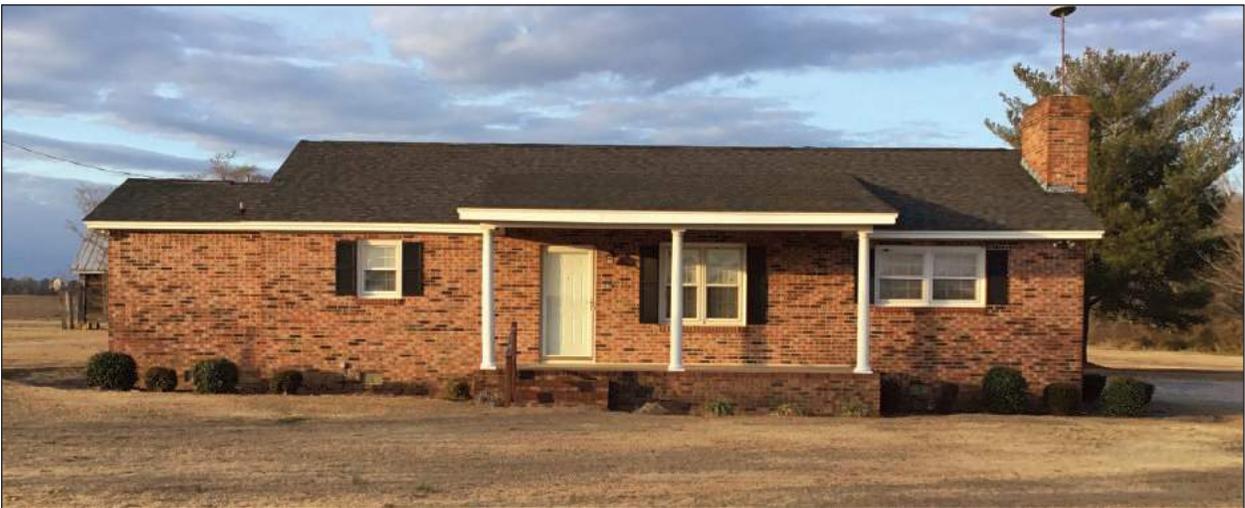
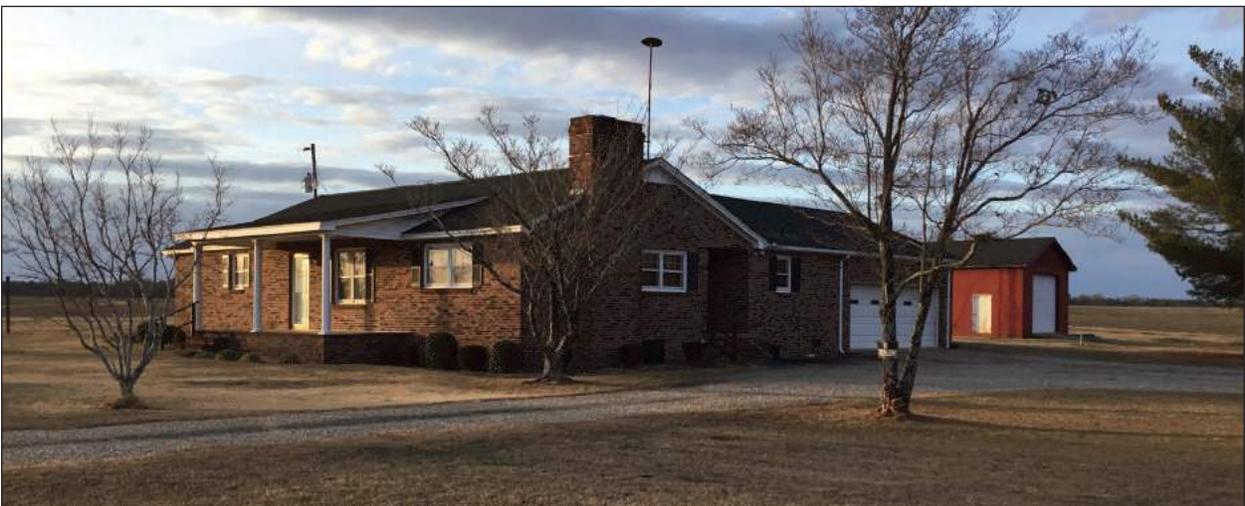
Figure 27.
Resource U/61/0072 – 680 Browntown Road

Resource U/61/0072 is a circa 1965 Linear Ranch House located at 680 Browntown Road. It is visible on a 1966 aerial photograph of the area but is not visible on a 1958 topographic map and faces south towards Browntown Road. The resource is one story tall with a rectangular historic core, a laterally gabled composition shingle roof, and brick veneer cladding (Figure 27). All windows are vinyl frame one-over-one replacement double-hung sash. The front (south) elevation contains a wood panel door and paired double-hung sash window under a shed-roofed porch with

column supports. To the east of the porch lies another set of paired windows and a large external brick chimney is located on the east elevation. To the west of the porch lies a single window and a small, slightly inset portion under a lower laterally gabled roofline. The foundation is concealed and there are multiple additions to the rear of the house including a front-gabled two-car garage. Three circa 1970-1980 outbuildings are located on the property, including a concrete block garage and two weatherboard-clad sheds. None of the outbuildings are visible on the 1966 aerial photograph.

Although Resource U/61/0072 is a Linear Ranch House, it is not a distinctive or noteworthy example of this house type, which is common in South Carolina. Its integrity is further impacted by the replacement of its original windows and multiple additions which nearly double the size of the house. It was not found to embody the distinctive characteristics of a style, period, or method of construction, and does not possess significance for its engineering or materials. It is not known to be associated with events or persons significant in the past. Therefore, the resource is recommended as not individually eligible for the NRHP under Criterion A, B, or C.

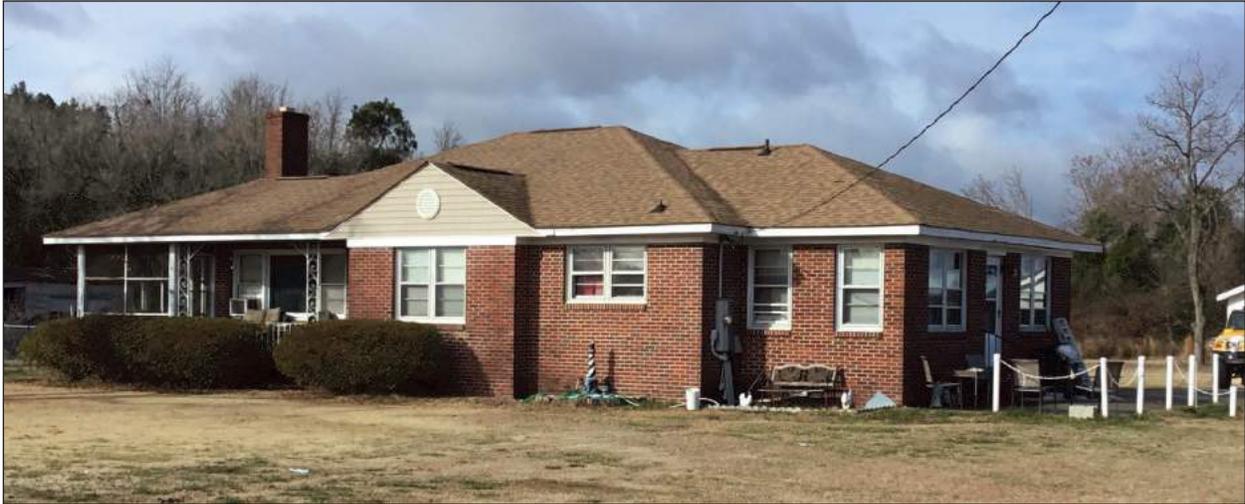
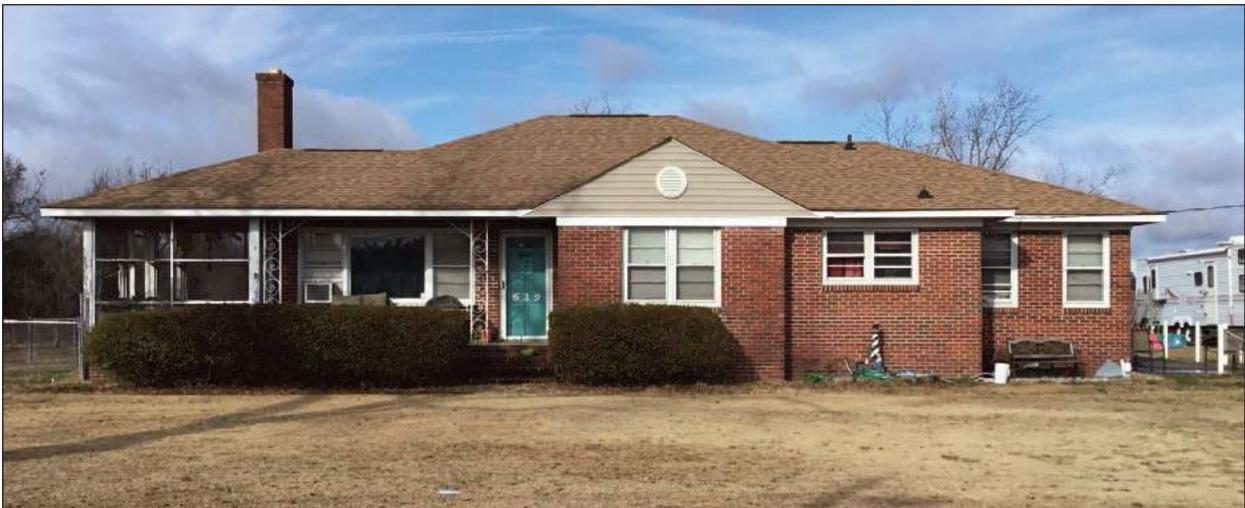
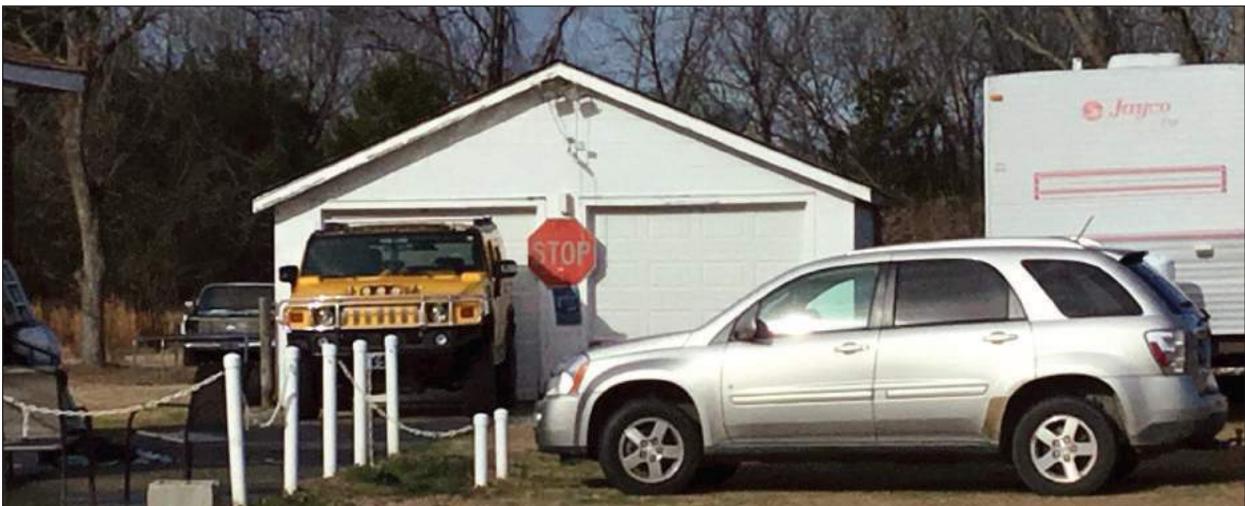
Figure 28.
Resources U/61/0073 and U/61/0073.01 – 629 North Main Street and Garage

Resource U/61/0073 is a circa 1960 Linear-with-Clusters Ranch House located at 629 North Main Street. It faces east towards North Main Street. It has a rectangular plan with a cascading hipped composition shingle roof (Figure 28). It is one story tall and is clad in brick veneer. Windows are wood frame horizontal two-over-two double-hung sash. The front elevation features a central front gable with a pair of windows and vinyl siding in the gable end. The partially engaged front porch has decorative aluminum supports. A wood panel front door and a tripartite picture window are within the porch. A screened porch lies under the main roofline on the south elevation. Additional architectural features include an interior brick chimney and two-over-two double hung sash windows throughout. The foundation is concealed.

A two-story concrete block garage is located approximately 40 feet to the west of Resource U/61/0073 and is visible on a 1964 aerial photograph. Resource U/61/0073.01 is a circa 1960 garage with a front-gabled composition shingle roof (Figure 28). It has two garage bays with modern synthetic panel doors. It has a concrete block foundation.

Resources U/61/0073 and U/61/0073.01 are located on North Main Street which is also U.S. Highway 15 and is a busy two-lane highway. Development in this area is generously spaced and consists primarily of single family homes and agricultural land. Resources U/61/0073 and U/61/0073.01 are sited on a large lot with a setback of approximately 85 feet. The resources are surrounded by grass lawn, shrubs and a wooded buffer on the rear and south sides of the lot. Although Resource U/61/0073 is a Linear-with-Clusters Ranch House, it is not a distinctive or

noteworthy example of this house type, which is common in South Carolina. It was not found to embody the distinctive characteristics of a style, period, or method of construction, and does not possess significance for its engineering or materials. It is not known to be associated with events or persons significant in the past. Resource U/61/0073.01 was not found to embody the distinctive characteristics of a type, period, or method of construction, and does not represent the work of a master or possess high artistic value. It is not known to be associated with events or persons significant in the past. Therefore, neither resource is recommended as individually or collectively eligible for the NRHP under Criterion A, B, or C.

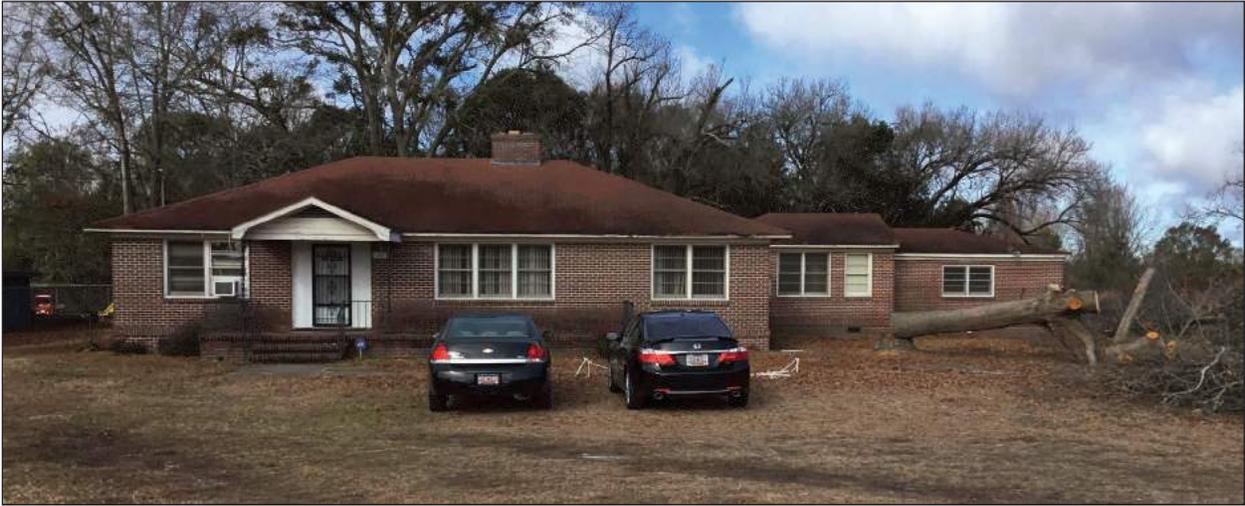
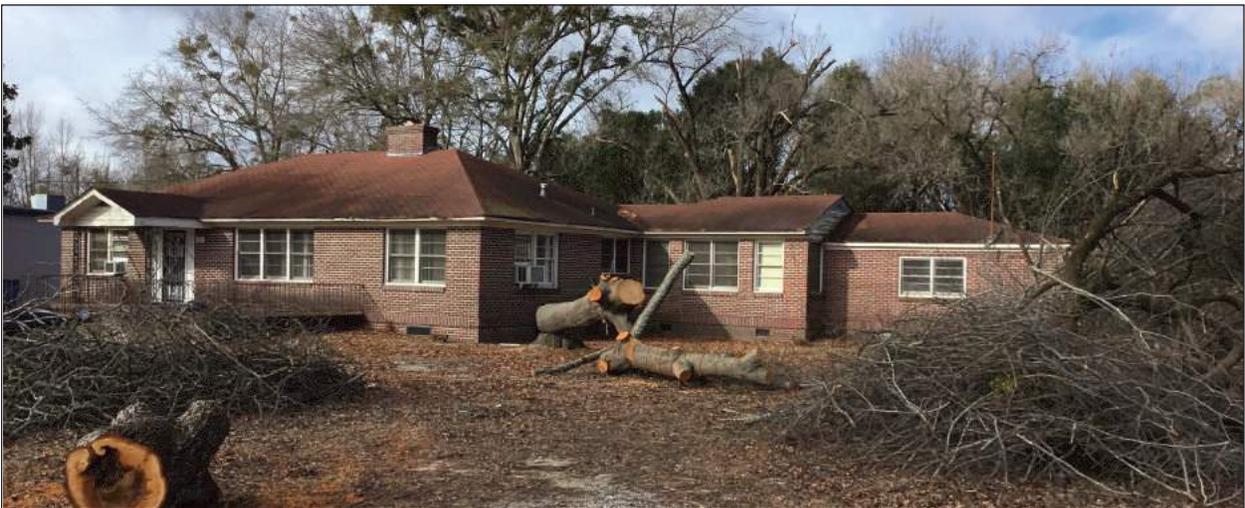
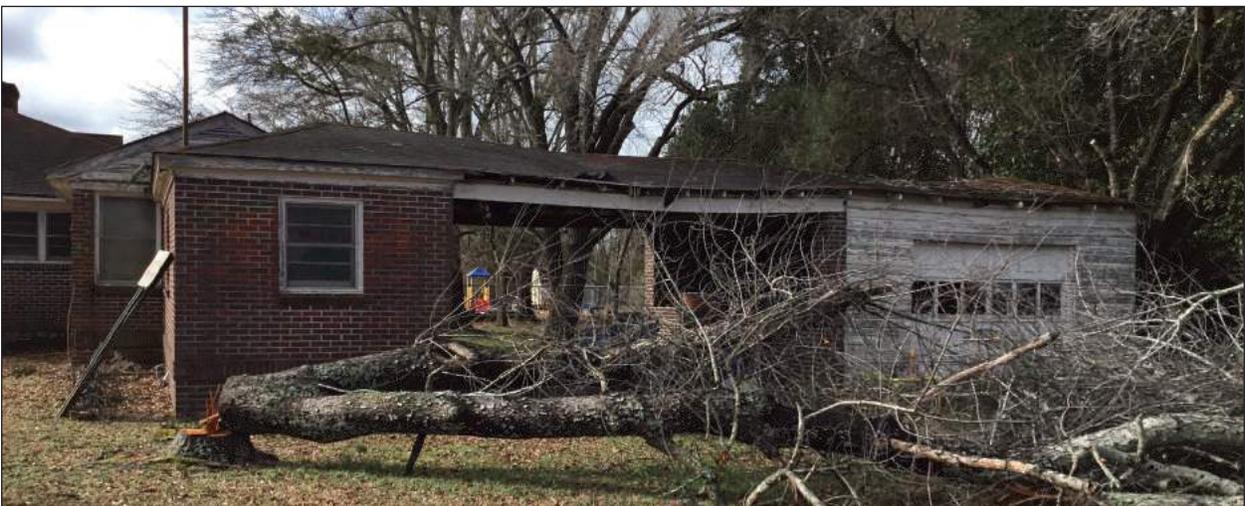
Figure 29.
Resource U/61/0074 – Wateree Community Center (1001 North Main Street)

Resource U/61/0074 is a circa 1960 Linear Ranch House located at 1001 North Main Street. It currently houses the Wateree Community Center and faces east towards North Main Street. It is visible on a 1964 aerial photograph of the area. Resource U/61/0074 is one story tall with a rectangular historic core and a hipped composition shingle roof (Figure 29). Windows are wood frame horizontal two-over-two double-hung sash. The front entrance is a modern wood panel door with fanlight under an entry porch comprised of front-gabled roof with weatherboard in the gable end and decorative aluminum supports. To the south of the door lies a set of paired windows and to the north of the door lies a set of tripled and a set of paired windows. Two additions have been made to the north elevation of the building, both one story tall and clad in brick veneer. One is laterally gabled while the other has a hipped roof. The building's foundation is concealed.

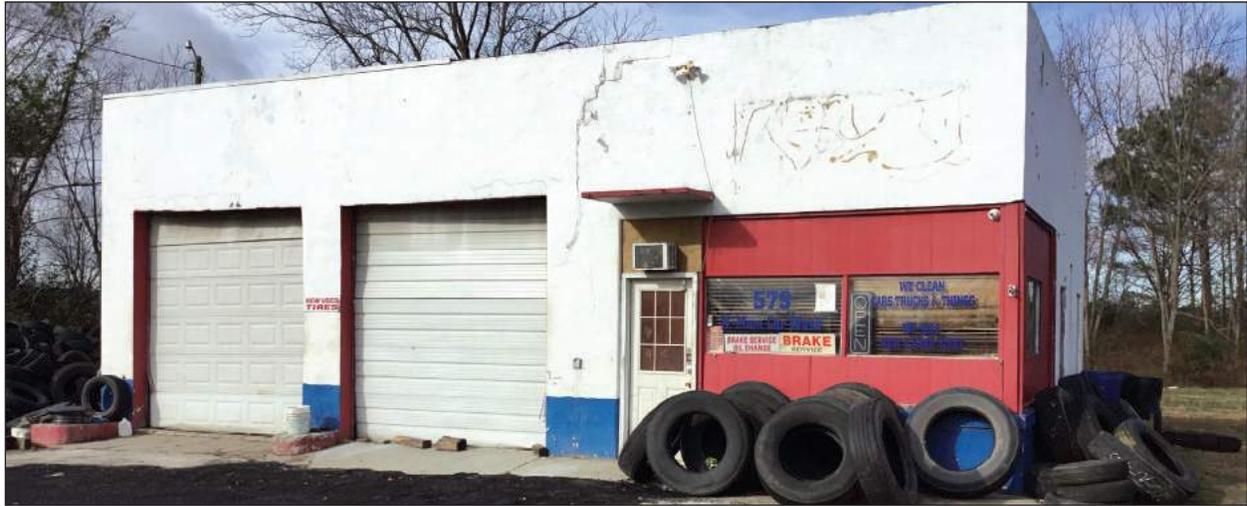
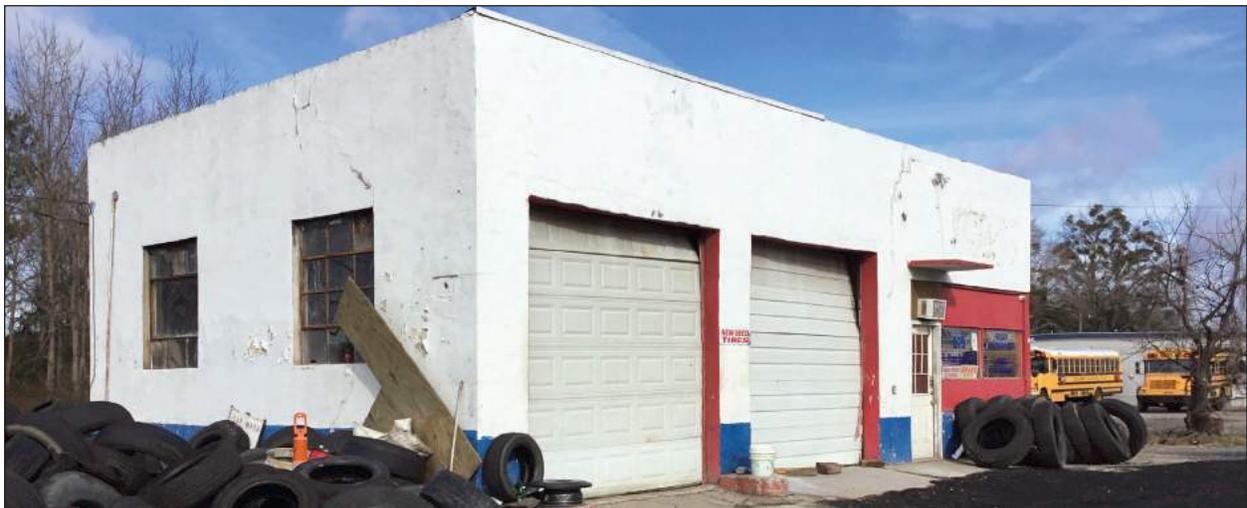
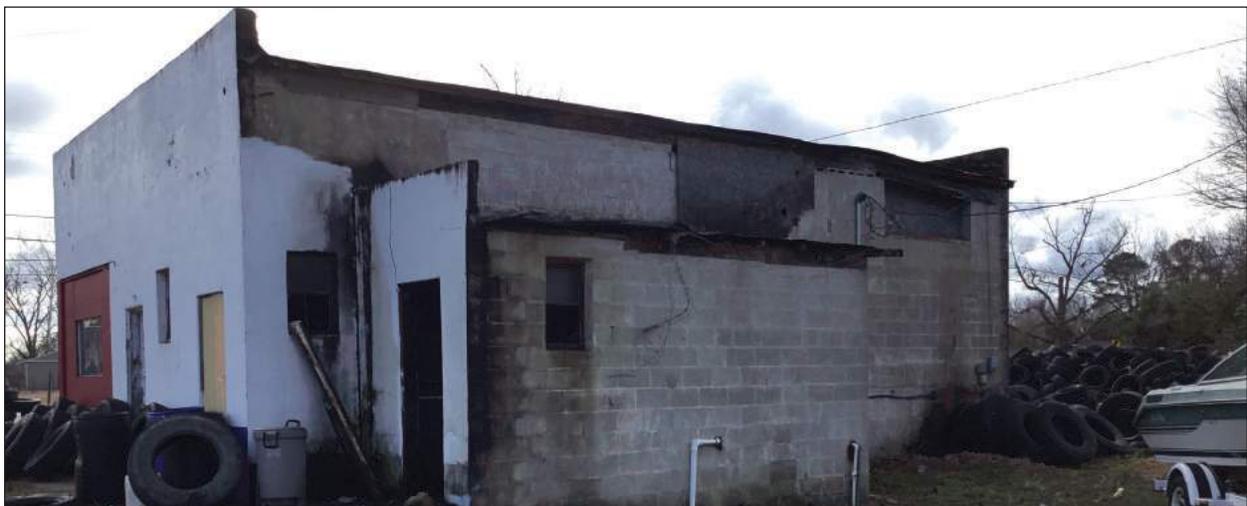
Figure 30.
Resource U/61/0075 – Scott Tire (579 North Main Street)

Resource U/61/0075 is a circa 1950 former automobile service station located at 579 North Main Street. It faces east towards North Main Street and houses Scott Tire. It is rectangular with a built-up roof that is concealed by a simple parapet and stucco cladding (Figure 30). Two garage bays

with modern rolling metal doors are located on the south end of the front (east) elevation. An office area is located on the north end and is demarcated on the exterior by the use of vertical wood siding which has likely been used to replace a band of large windows. A modern wood panel door is sheltered by a flat cantilevered concrete awning. There is fenestration for a transom window which has been boarded over and two modern fixed picture windows are located to the north of the door. The foundation is not visible but is likely concrete block.
