APPENDIX O. BISHOPVILLE TRUCK ROUTE PROJECT DRAFT CULTURAL RESOURCES ASSESSMENT

RE: Bishopville Truck Routes Alternatives Analysis, Lee County, South Carolina

Reconnaissance-Level Archaeological Survey of Bishopville Truck Route Segments

Phase I Architectural Survey of
**BISHOPVILLE BYPASS
ALTERNATIVES**

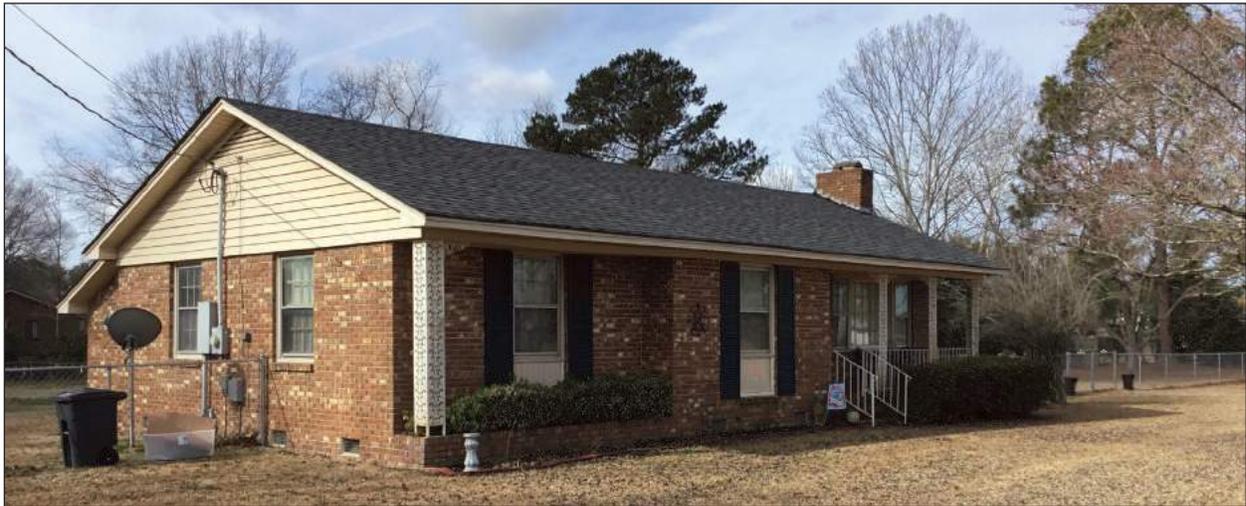
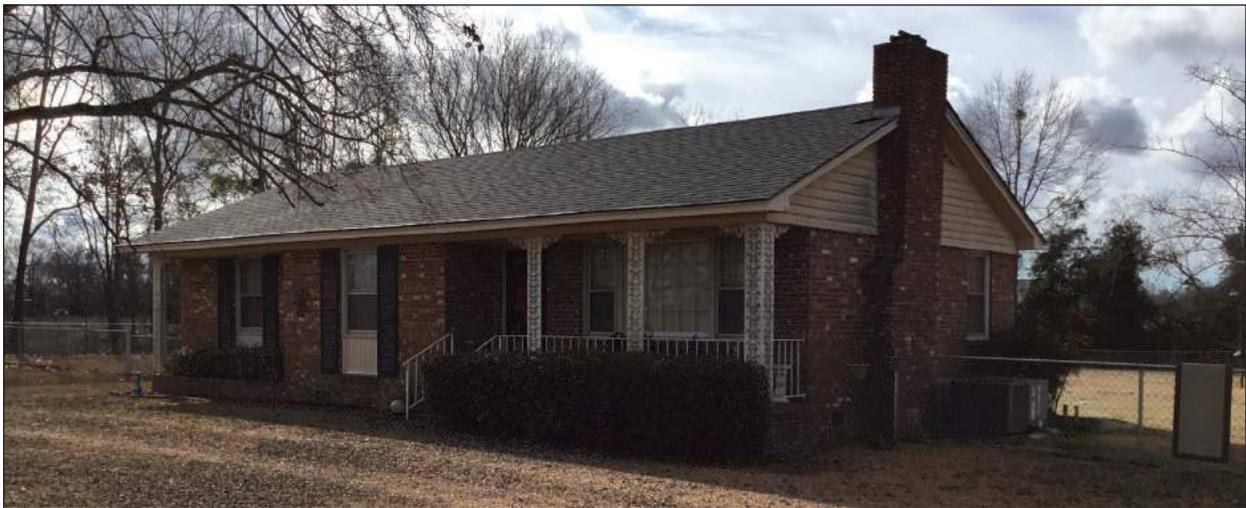
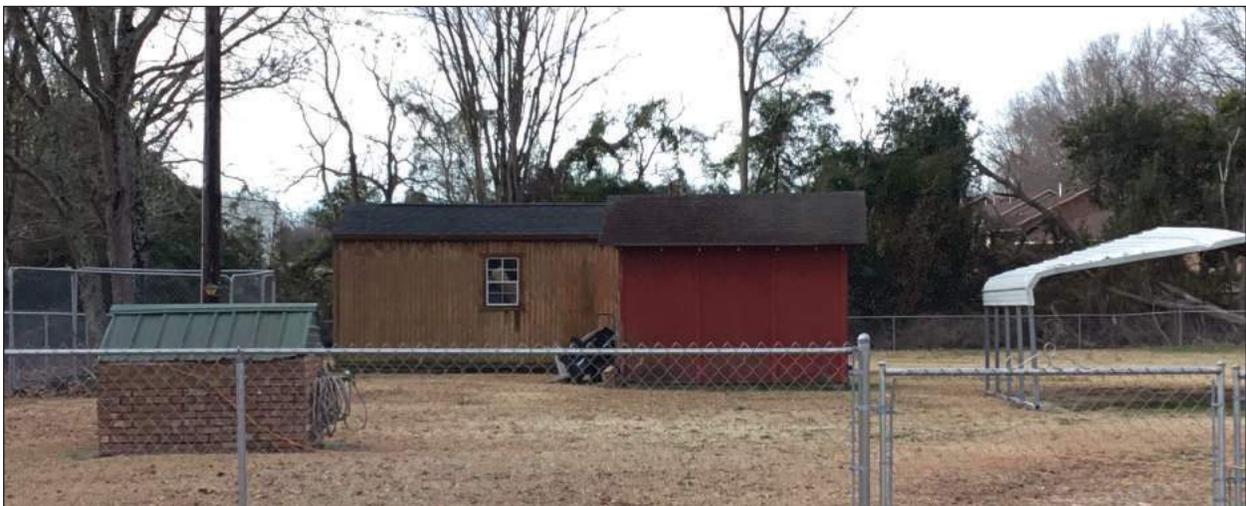
Figure 31.
Resources U/61/0076 and U/61/0076.01 – 88 Mendy Lane and Pump House

Resource U/61/0076.01 is a circa 1955 pump house located approximately 35 feet southwest of Resource U/61/0076. This small brick structure is rectangular and has a gabled V-crimp metal roof (Figure 31). Three additional non-historic outbuildings are located on the property, including two sheds and a carport. None are visible on the 1966 aerial photograph.

Resources U/61/0076 and U/61/0076.01 are located on Mendy Lane which is a paved one-lane residential drive. Development in this area is generously spaced and consists primarily of single family homes and agricultural land. Resources U/61/0076 and U/61/0076.01 are sited on a large lot with a setback of approximately 50 feet. The resources are surrounded by grass lawn, shrubs and a wooded buffer on the rear and south sides of the lot. Although Resource U/61/0076 is a Linear Ranch House, it is not a distinctive or noteworthy example of this house type, which is common in South Carolina. It was not found to embody the distinctive characteristics of a style, period, or method of construction, and does not possess significance for its engineering or materials. It is not known to be associated with events or persons significant in the past. Resource U/61/0076.01 was not found to embody the distinctive characteristics of a type, period, or method of construction, and does not represent the work of a master or possess high artistic value. It is not known to be associated with events or persons significant in the past. Therefore, neither resource is recommended as individually or collectively eligible for the NRHP under Criterion A, B, or C.

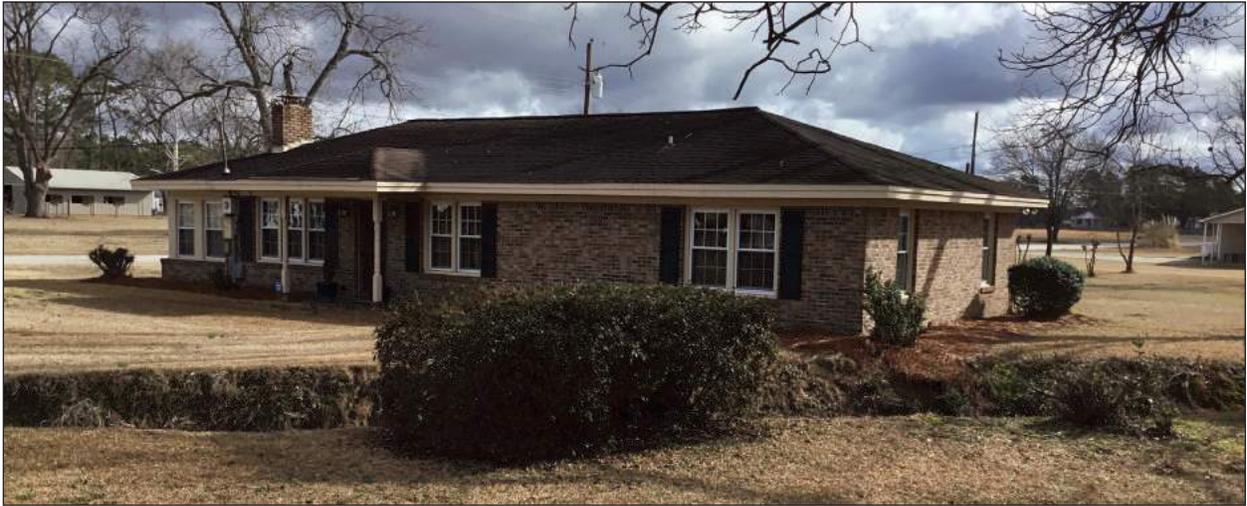
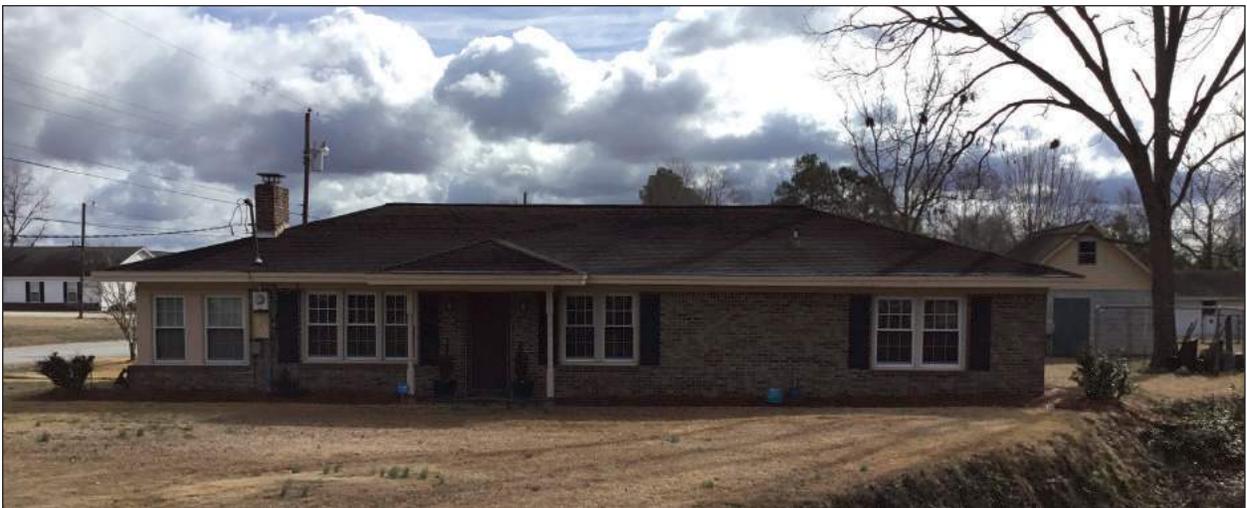
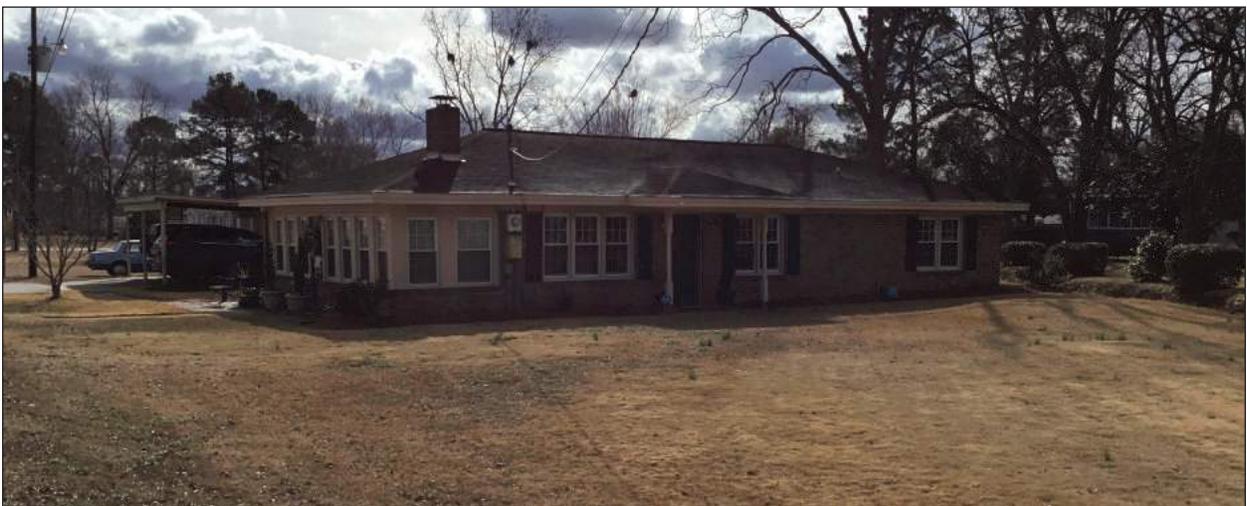
Figure 32.
Resource U/61/0077 – 12 Mendy Lane

Resource U/61/0077 is located on the corner of Mendy Lane, a one-lane residential drive, and North Main Street, a busy two-lane highway. The surrounding development is primarily residential and agricultural with generous lot sizes. Resource U/61/0077 is sited on a large lot and has a shallow setback of approximately 20 feet from Mendy Lane, while retaining a deeper setback from North Main Street. Landscaping includes a grass lawn, ornamental shrubs, and a wooded buffer to the rear of the lot as well as to the northwest. Although Resource U/61/0077 is a Linear Ranch House, it is not a distinctive or noteworthy example of this house type, which is common in South Carolina. Its integrity is further impacted by the alteration of its side porch. It was not found to embody the distinctive characteristics of a style, period, or method of construction, and does not possess significance for its engineering or materials. It is not known to be associated with events or persons significant in the past. Therefore, the resource is recommended as not individually eligible for the NRHP under Criterion A, B, or C.

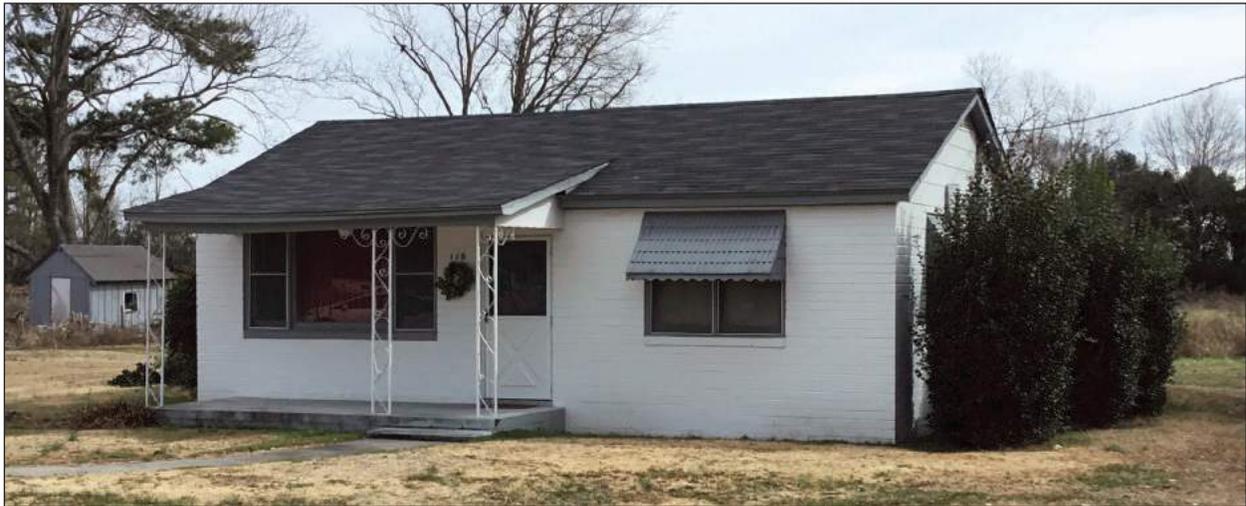
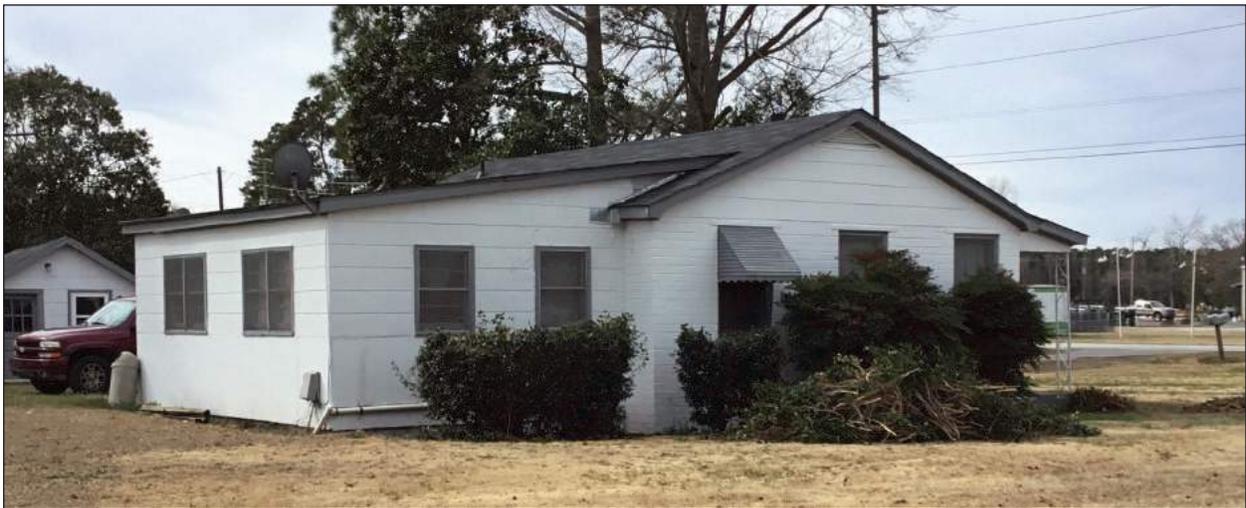
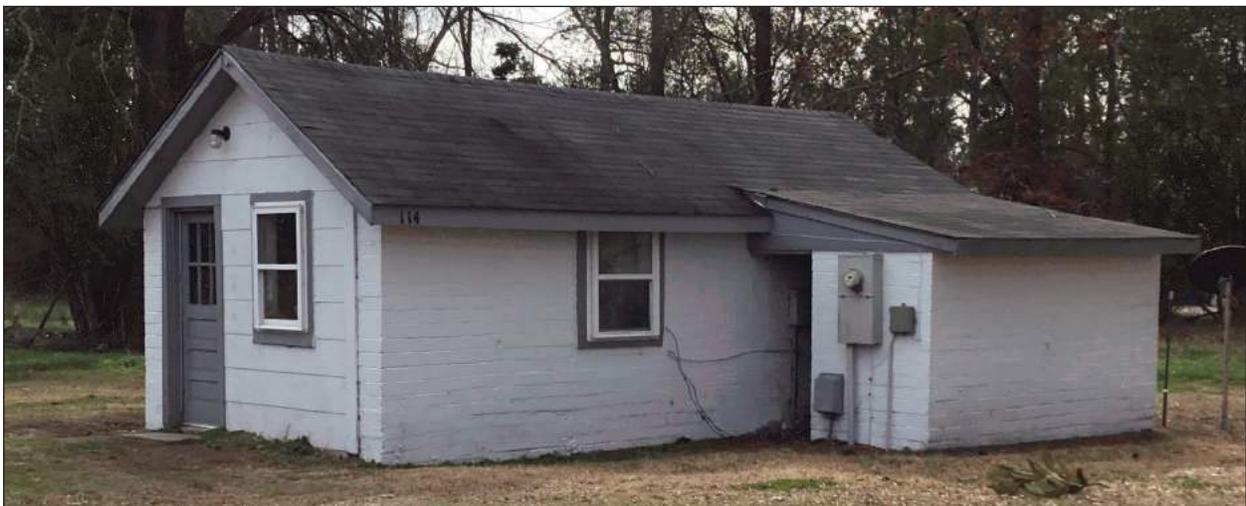
Figure 33.
Resources U/61/0078 and U/61/0078.01 – 116 Wags Drive and Shed

Resource U/61/0078 is a circa 1955 American Small House located at 116 Wags Drive. It faces west towards Wags Drive and is one story tall and rectangular in plan with a laterally gabled composition shingle roof (Figure 33). It is clad in brick veneer which has been painted. Windows are replacement aluminum frame one-over-one double-hung sash. The wood panel door and a tripartite picture window are sheltered by a shed roofed porch with aluminum supports. To the south of the porch a set of paired windows are sheltered by a vinyl awning. The house has weatherboard in the gable ends. A shed roof addition has been made to the rear of the house and the foundation is concealed.

Resource U/61/0078.01 is a circa 1955 shed located approximately 40 feet to the west of Resource U/61/0078. It is a one-story front-gabled brick building with a smaller shed roofed portion on the west elevation (see Figure 33). It has vinyl one-over-one replacement windows and a half-light wood frame door. The front elevation of the front-gabled portion is clad in asbestos shingle siding. The building has been altered for use as both a residence and formerly as a barber shop.

Resources U/61/0078 and U/61/0078.01 are located on Wags Drive, a paved two-lane road with commercial and residential development. It is sited on a fairly large lot and has a setback of approximately 80 feet. It is surrounded by a lawn and has an agricultural field to the rear with a wooded buffer to the south and east of the field. Although Resource U/61/0078 is an American Small House, it is not a distinctive or noteworthy example of this type, which is common in South Carolina. It was not found to embody the distinctive characteristics of a style, period, or method of construction, and does not possess significance for its engineering or materials. Its integrity is negatively impacted by the use of modern replacement windows and by painting its brick veneer cladding. It is not known to be associated with events or persons significant in the past. Resource U/61/0078.01 was not found to embody the distinctive characteristics of a type, period, or method of construction, and does not represent the work of a master or possess high artistic value. It is not known to be associated with events or persons significant in the past. Therefore, neither resource is recommended as individually or collectively eligible for the NRHP under Criterion A, B, or C.

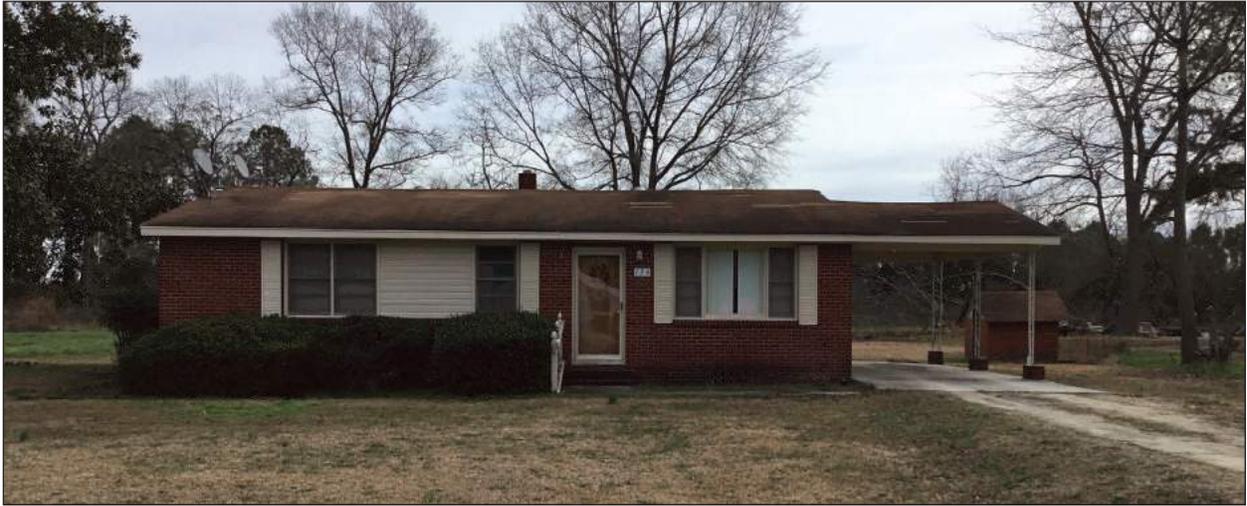
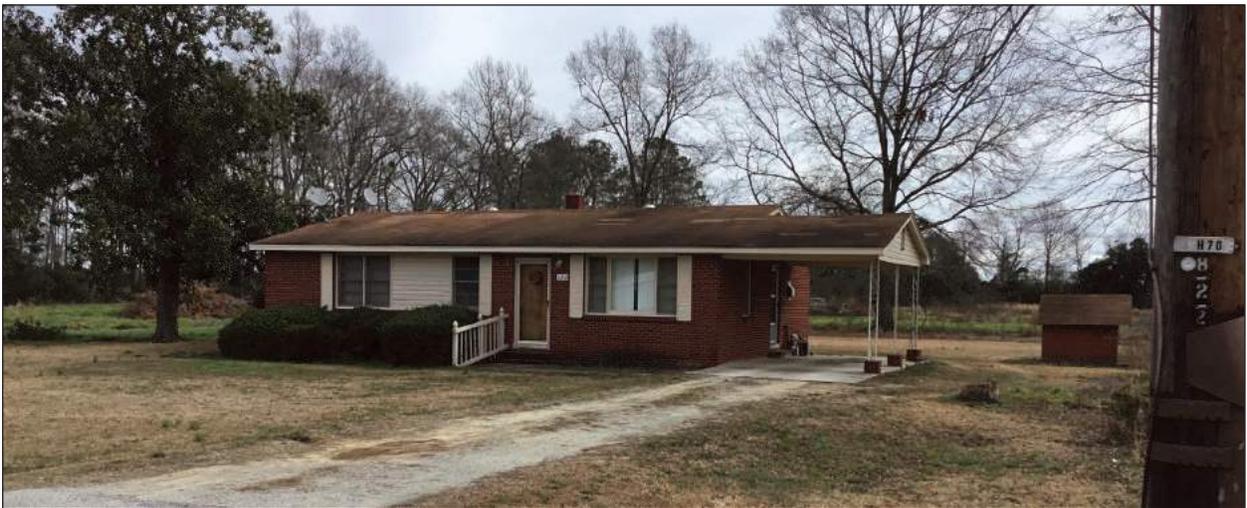
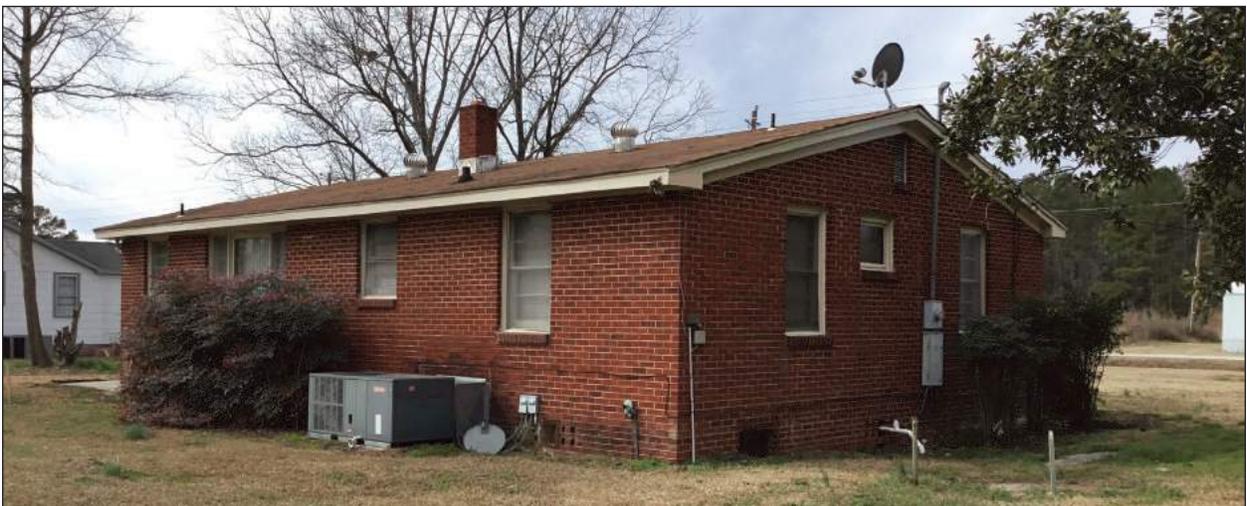
Figure 34.
Resource U/61/0079 – 126 Wags Drive

Resource U/61/0079 is a circa 1960 Plain Linear Ranch House locate at 126 Wags Drive. It faces west towards Wags Drive. The house is one story tall and rectangular with a laterally gabled composition shingle roof and wood frame horizontal two-over-two double-hung sash windows (Figure 34). It is entered via a modern wood panel door in the rough center of the west elevation. To the north of the entrance lies a section of synthetic siding with a set of paired windows and a single window, while to the south lies a tripartite picture window within a similar but smaller section of synthetic siding. An open carport with aluminum supports is located on the south elevation of the building. The foundation is concealed.

Resource U/61/0079 is located on Wags Drive, a paved two-lane road with both commercial and residential development. It is sited on a fairly large lot and has a setback of approximately 80 feet. It is surrounded by a grass lawn and has an agricultural field to the rear with a wooded buffer to the north and east of the field. Although Resource U/61/0079 is a Plain Linear Ranch House, it is not a distinctive or noteworthy example of this house type, which is common in South Carolina. It was not found to embody the distinctive characteristics of a style, period, or method of construction, and does not possess significance for its engineering or materials. It is not known to be associated with events or persons significant in the past. Therefore, the resource is recommended as not individually eligible for the NRHP under Criterion A, B, or C.

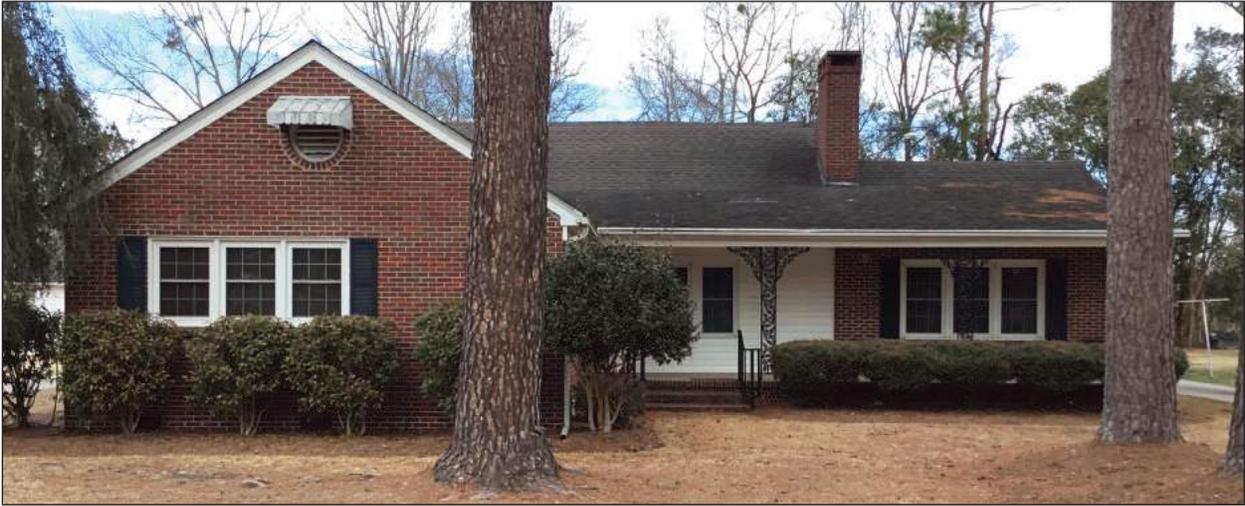
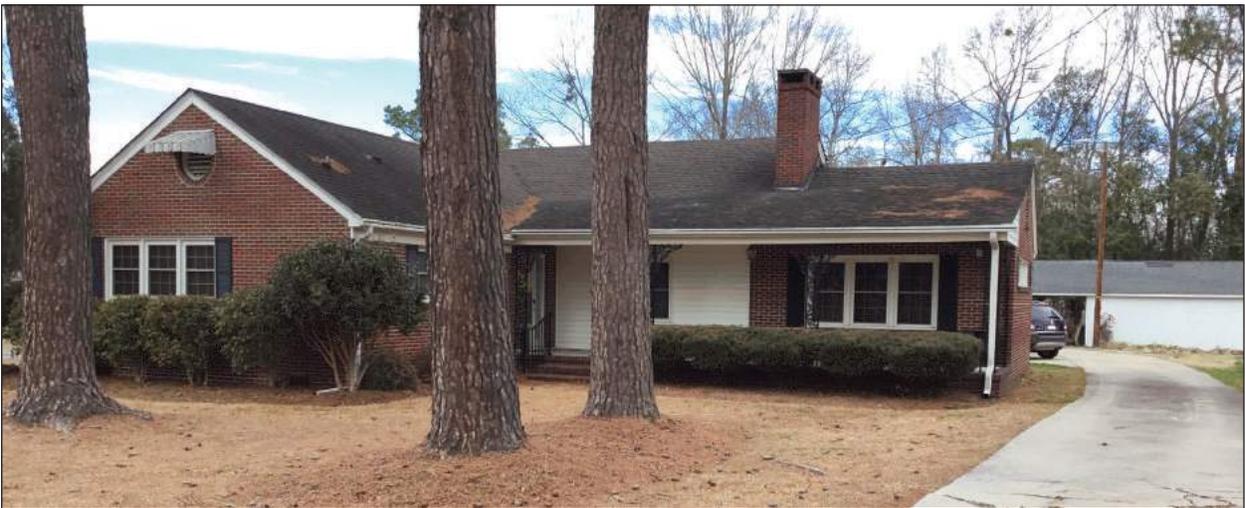
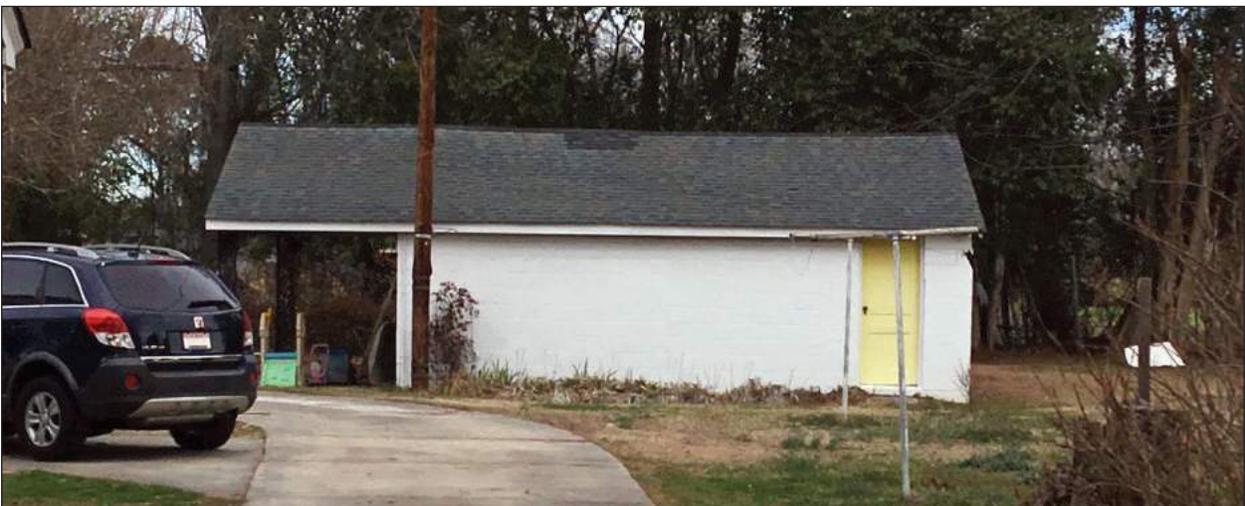
Figure 35.
Resources U/61/0080 and U/61/0080.01 – 613 Wisacky Highway and Shed

Resource U/61/0080 is a circa 1955 house of no distinct style or type located at 613 Wisacky Highway. Facing south towards the road, it is L-shaped and one story tall with a cross-gabled composition shingle roof and brick veneer cladding (Figure 35). Windows are six-over-six double-hung sash replacements. A large projecting front-gable with tripled windows and a round louvered window in the gable end dominates the front elevation. A porch spans the front elevation parallel to the road and has decorative wrought iron supports with a vine motif. Located within the porch are a front door and bay clad in vinyl siding. A brick veneer addition with triple windows is on the east end of the front elevation. A brick chimney is enclosed between the original exterior of the house and the addition.

Resource U/61/0080.01 is a circa 1955 concrete block shed located approximately 50 feet northeast of U/61/0080. It is rectangular with a laterally gabled composition shingle roof and is one story tall (see Figure 35). It is accessed via a wood panel door on the south elevation. A large porch with aluminum supports is located on the west elevation under the main roofline and a shed roofed addition has been made to the north elevation. An additional non-historic frame multipurpose building is located on the property.

Resources U/61/0080 and U/61/0080.01 are located on Wisacky Highway (S.C. Route 341), which in this section of the project area is a relatively busy two-lane road. Land use includes mid-twentieth-century single family homes and modern commercial properties on generously sized lots as well as agricultural fields. The resources are on a large lot with an oblong paved driveway running around and to the rear of the house. Resource U/61/0080 has a setback of about 75 feet. Landscaping includes a lawn and mature trees. Neither Resource U/61/0080 nor U/61/0080.01 was found to embody the distinctive characteristics of a type, period, or method of construction, and neither represents the work of a master or possesses high artistic value. An addition to Resource U/61/0080 is visible from the street and negatively impacts its integrity. Neither resource is known to be associated with events or persons significant in the past. Therefore, neither resource is recommended as individually or collectively eligible for the NRHP under Criterion A, B, or C.

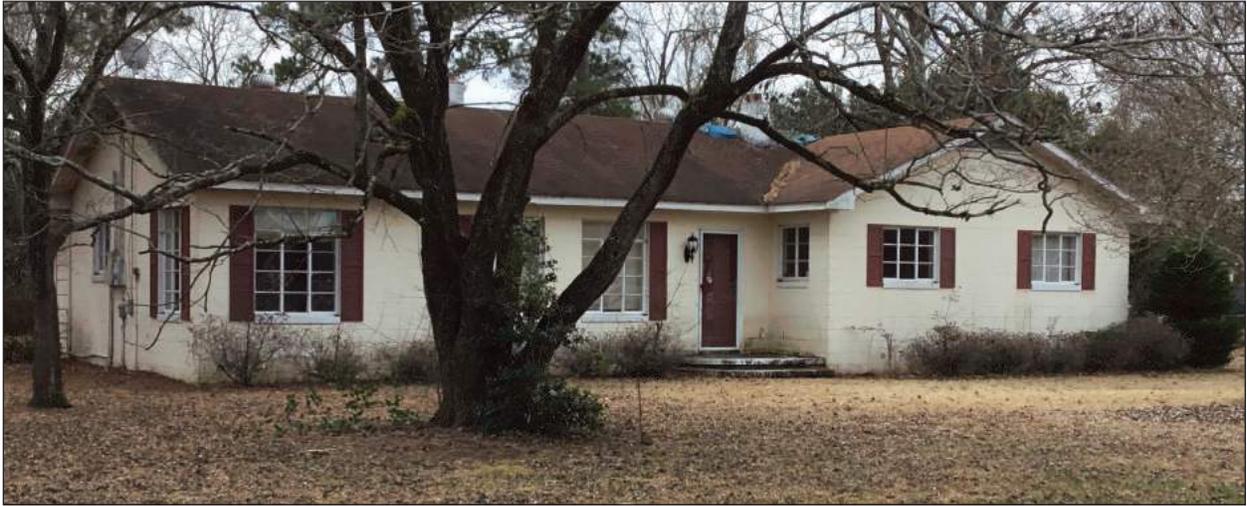
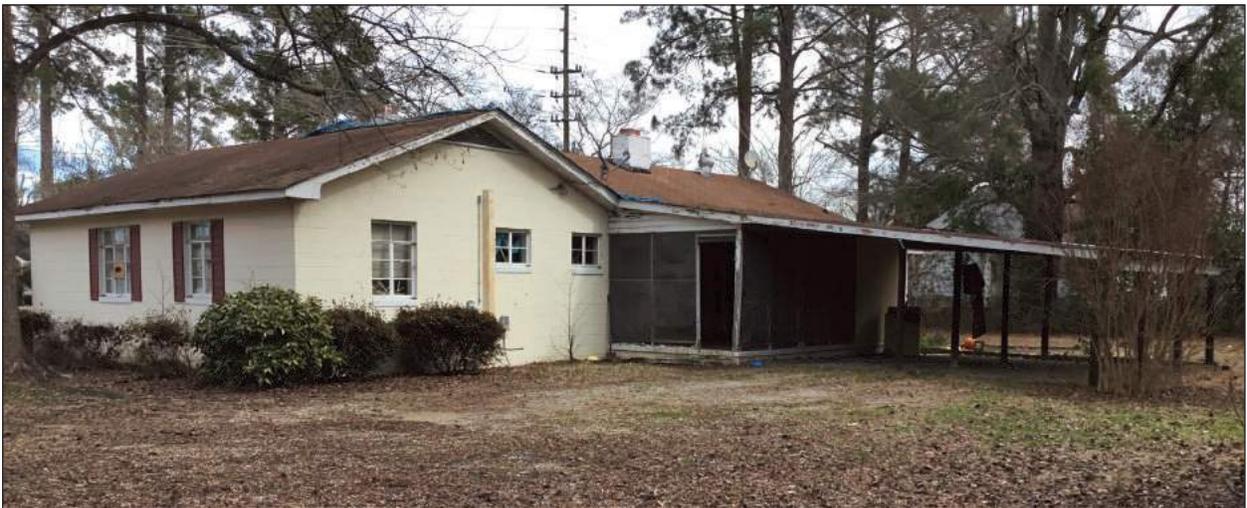
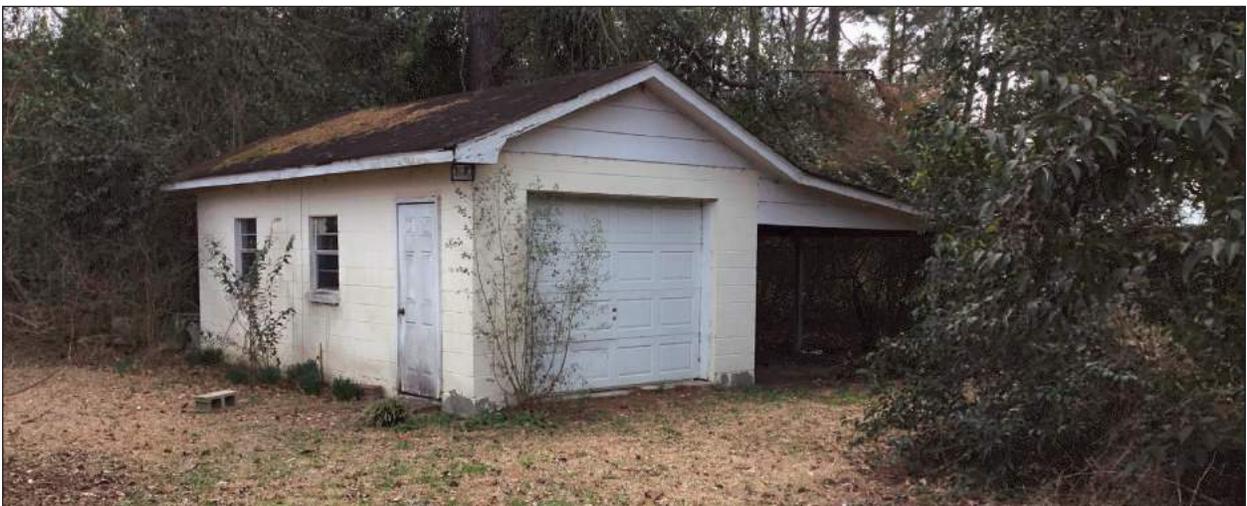
Figure 36.
Resources U/61/0081 and U/61/0081.01 – 612 Wisacky Highway and Garage

Resource U/61/0081 is a circa 1965 Linear-with-Clusters Ranch House located at 612 Wisacky Highway. It is visible on a 1966 aerial photograph of the area and faces east towards Wisacky Highway. It is one story tall and rectangular in plan with a cross-gabled composition shingle roof (Figure 36). It is of concrete block construction with 15- and nine-pane aluminum frame casement windows with louvered shutters. The projecting front gable has two nine-pane windows and is located on the north side of the front elevation. The wood panel front door is located in the rough center of the east elevation on a laterally gabled portion of the house. To the south of the door are three 15-pane windows. Two interior brick chimneys rise from the roofline. A large gable roof addition has been constructed onto the rear of the house. An additional shed-roof screened porch and open carport has been added to the rear of the house. The house has a concrete block foundation.

Resource U/61/0081.01 is a circa 1965 garage located approximately 40 feet to the west of U/61/0081. It is visible on a 1966 aerial photograph of the area and is one story tall and rectangular in plan with a front-gabled composition shingle roof (see Figure 36). It is of concrete block construction with weatherboard siding in the gable end. It has a wood panel rolling garage door, a wood panel personnel door, and two aluminum frame horizontal two-over-two double-hung sash windows. A shed roofed carport has been added to the right side of the building.

Resources U/61/0081 and U/61/0081.01 are located on Wisacky Highway, which is also S.C. Route 341. In this section of the project area, it is a relatively busy two-lane road. Development includes mid-twentieth-century single family homes and modern commercial properties on generously sized lots as well as agricultural fields. The lot is fairly large and Resource U/61/0081 has a setback of approximately 145 feet. Landscaping includes a grass lawn, deciduous trees, and a wooded buffer to the rear of the lot. Although Resource U/61/0081 is a Linear-with-Clusters Ranch House, it is not a distinctive or noteworthy example of this house type, which is common in South Carolina. It was not found to embody the distinctive characteristics of a style, period, or method of construction, and does not possess significance for its engineering or materials. Its integrity is negatively impacted by a series of large additions. It is not known to be associated with events or persons significant in the past. Resource U/61/0081.01 was not found to embody the distinctive characteristics of a type, period, or method of construction, and does not represent the work of a master or possess high artistic value. It is not known to be associated with events or persons significant in the past. Therefore, neither resource is recommended as individually or collectively eligible for the NRHP under Criterion A, B, or C.

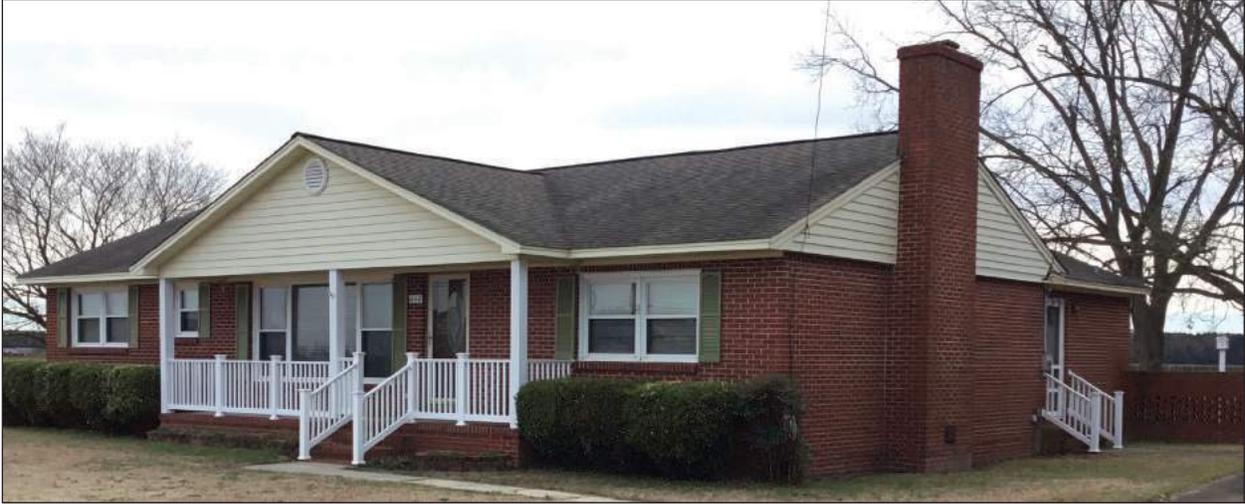
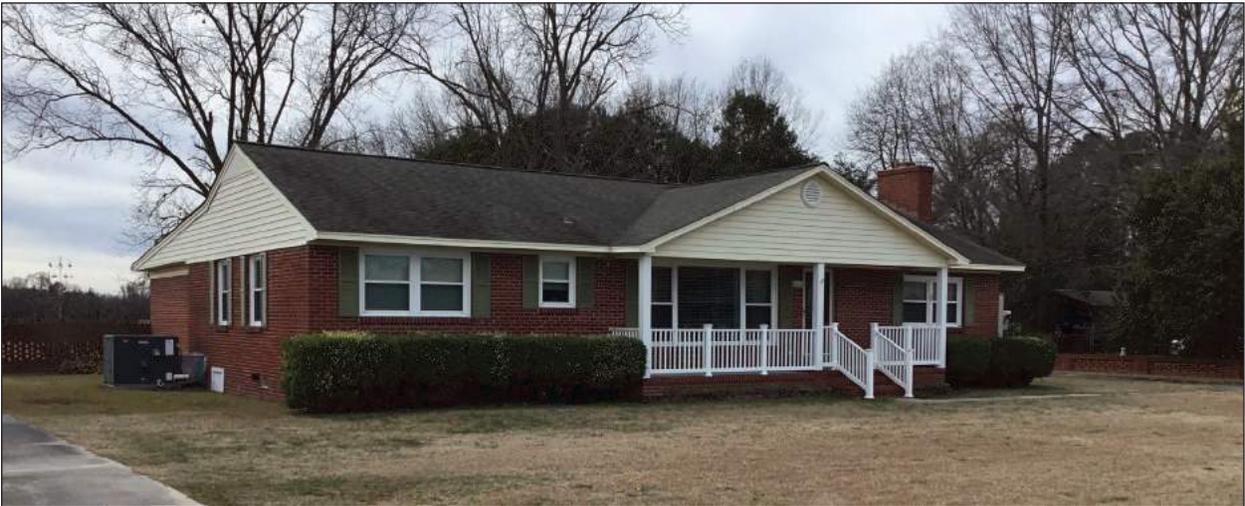
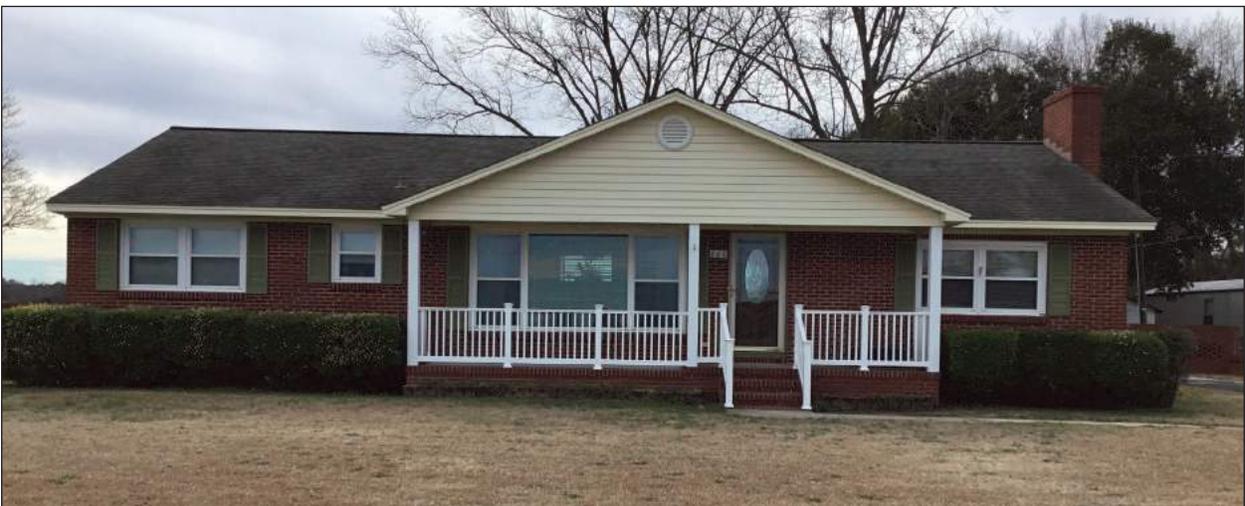
Figure 37.
Resource U/61/0082 – 660 Wisacky Highway

Resource U/61/0082 is a circa 1965 Linear Ranch House located at 660 Wisacky Highway. It is visible on a 1966 aerial photograph and faces east towards Wisacky Highway. It is one story tall and rectangular with a laterally gabled composition shingle roof and brick veneer cladding (Figure 37). Windows are vinyl frame one-over-one double-hung sash modern replacements with louvered shutters. The front (northeast) elevation is dominated by a large front-gabled porch with square wood supports and balustrade. The wood panel door and a tripartite picture window are located within the porch. To the north of the porch is a set of paired windows, while to the south lies a smaller window as well as another set of paired windows. An external slab chimney is located on the north elevation. There is synthetic siding in the gables ends. The foundation is concealed and a large shed roofed addition containing a garage extends to the rear of the building. A circa 1970 garage/multi-use building is located to the rear of Resource U/61/0082 and is not visible on the aerial photograph.

Resource U/61/0082 is located on Wisacky Highway, which is also S.C. Route 341. In this section of the project area, it is a relatively busy two-lane road. Development includes primarily single-family homes on generously sized lots as well as agricultural fields. Resource U/61/0082 is sited on a fairly large lot and has a setback of approximately 140 feet. Landscaping includes a grass lawn and deciduous trees. Although Resource U/61/0082 is a Linear Ranch House, it is not a distinctive or noteworthy example of this house type, which is common in South Carolina. It was not found to embody the distinctive characteristics of a style, period, or method of construction, and does not possess significance for its engineering or materials. It is not known to be associated with events or persons significant in the past. Therefore, the resource is recommended as not individually eligible for the NRHP under Criterion A, B, or C.

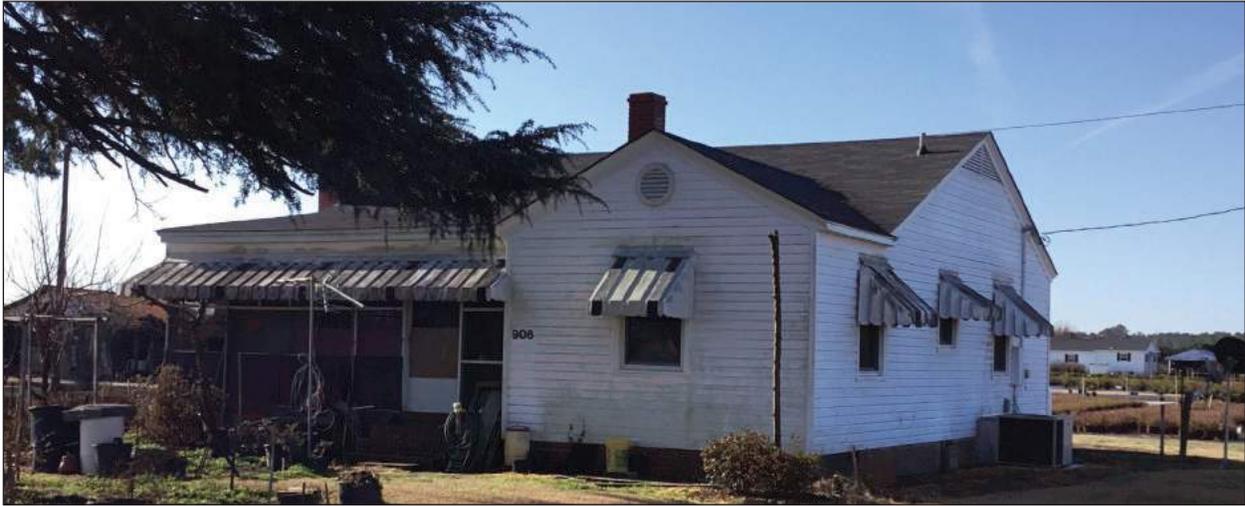
Figure 38.
Resource U/61/0083 – 906 Wisacky Highway

Resource U/61/0083 is a circa 1945 American Small House located at 906 Wisacky Highway. It faces east towards Wisacky Highway. The historic core is rectangular in plan. The house is one story tall with a lateral gable roof clad in composition shingles (Figure 38). The house is clad in synthetic siding. The windows are vinyl frame one-over-one double-hung sash replacements and are topped by vinyl awnings. A front gable is located on the north end of the front (northeast) elevation and contains a single window and a round louvered window in the gable end. A shed roofed porch covers the rest of the front elevation and has been filled in with a brick skirt wall and a band of windows. A brick chimney rises from behind the filled in porch. A second chimney is located on the exterior of the building on the south elevation. A shed roof addition has been made to the rear of the building. The foundation is composed of brick.

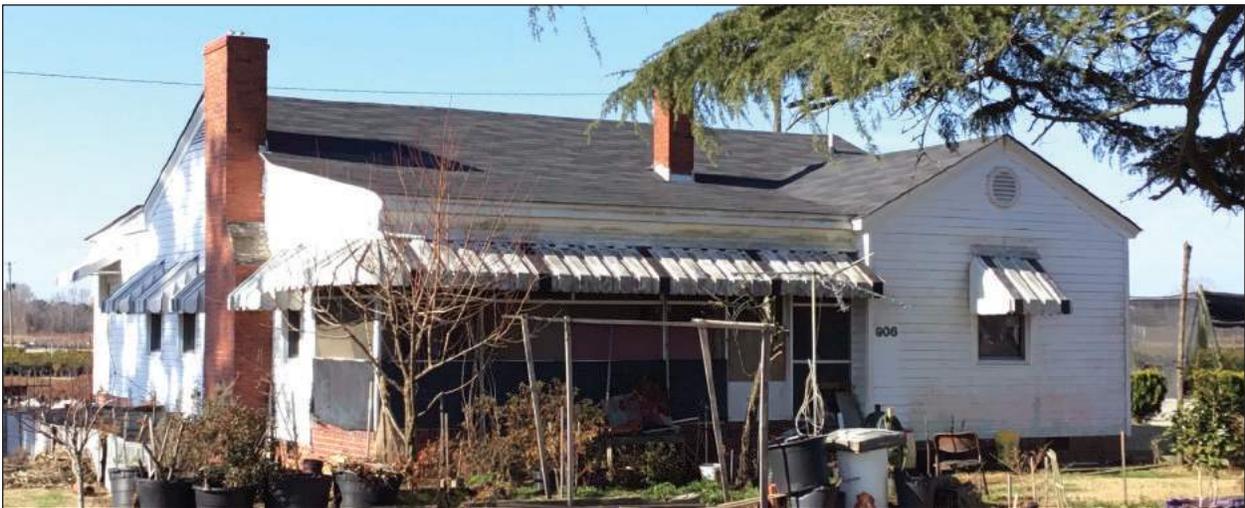
B. Southeast Oblique

Resource U/61/0083 is located on Wisacky Highway, which is also S.C. Route 341. In this section of the project area, it is a relatively busy two-lane road. Development includes primarily single-family homes on generously sized lots as well as agricultural fields. The resource is located on the City Nursery Farm Property, which is a large agricultural parcel with an area of over 60 acres. Resource U/61/0083 is at the very front edge of the property and has a setback of approximately 65 feet from Wisacky Highway. The area directly surrounding the resource contains grass lawn and ornamental bushes. Although Resource U/61/0083 is an American Small House, it is not a distinctive or noteworthy example of this house type, which is common in South Carolina. It was not found to embody the distinctive characteristics of a style, period, or method of construction, and does not possess significance for its engineering or materials. Its integrity is negatively impacted by modern alterations which are visible from the road as well as the use of replacement windows and siding. It is not known to be associated with events or persons significant in the past. Therefore, the resource is recommended as not individually eligible for the NRHP under Criterion A, B, or C.

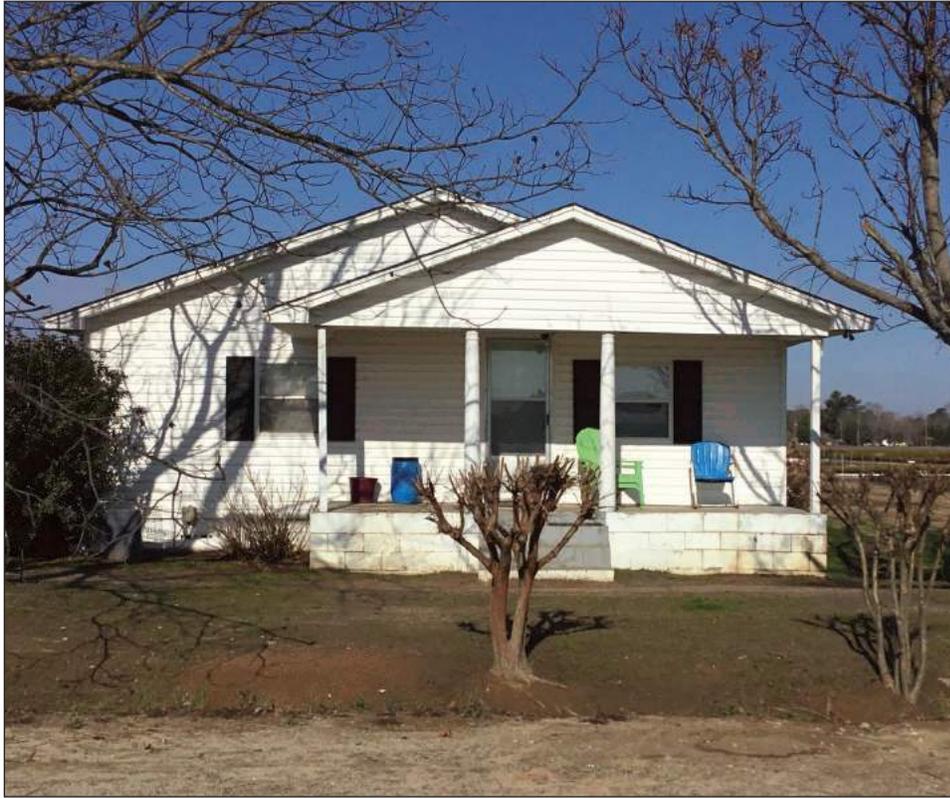
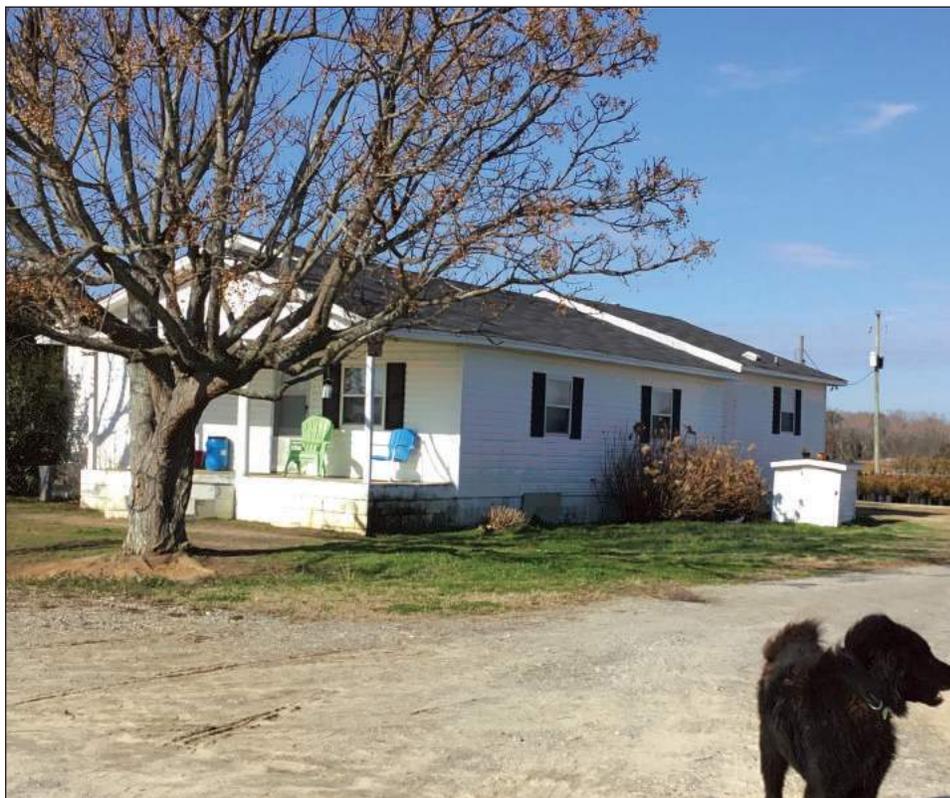
Figure 39.
Resource U/61/0084 – Wisacky Highway

Resource U/61/0084 is a circa 1930 Bungalow located on the City Nursery Farm property near the intersection of Wisacky Highway and Manton Road. It faces south. It is one story tall and is rectangular in plan with a front gabled composition shingle roof and synthetic siding (Figure 39). The windows are replacement vinyl one-over-one double-hung sash. The front (south) elevation is dominated by a front-gabled porch set asymmetrically towards the east side. The porch has a concrete block foundation, a poured concrete floor, and both square and columnar supports. A wood panel door and single window are sheltered by the porch and an additional window is partially under the porch to the west of the door. A front-gabled addition has been made to the rear of the house and the foundation is concrete block.

Resource U/61/0084 is located off of Wisacky Highway, which is also S.C. Route 341. In this section of the project area, it is a relatively busy two-lane road. Development includes primarily single family homes on generously sized lots as well as agricultural fields. The resource is located on the City Nursery Farm Property, which is a large agricultural parcel with an area of over 60 acres. It is located towards the center of the property and is set back from Wisacky Highway by approximately 700 feet. It is surrounded by a grass lawn, ornamental shrubs, and deciduous trees. Although Resource U/61/0084 is a Bungalow, it is not a distinctive or noteworthy example of this house type, which is common in South Carolina. Its integrity is further impacted by the replacement of its original siding and windows. It was not found to embody the distinctive characteristics of a style, period, or method of construction, and does not possess significance for its engineering or materials. It is not known to be associated with events or persons significant in the past. Therefore, the resource is recommended as not individually eligible for the NRHP under Criterion A, B, or C.
