APPENDIX O. BISHOPVILLE TRUCK ROUTE PROJECT DRAFT CULTURAL RESOURCES ASSESSMENT

RE: Bishopville Truck Routes Alternatives Analysis, Lee County, South Carolina

Reconnaissance-Level Archaeological Survey of Bishopville Truck Route Segments

Phase I Architectural Survey of
**BISHOPVILLE BYPASS
ALTERNATIVES**

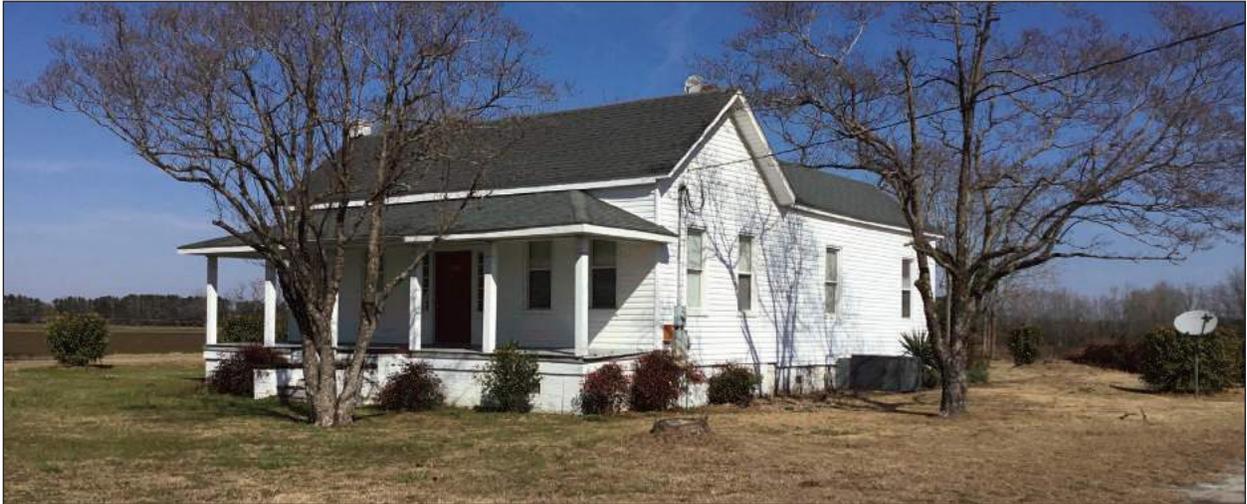
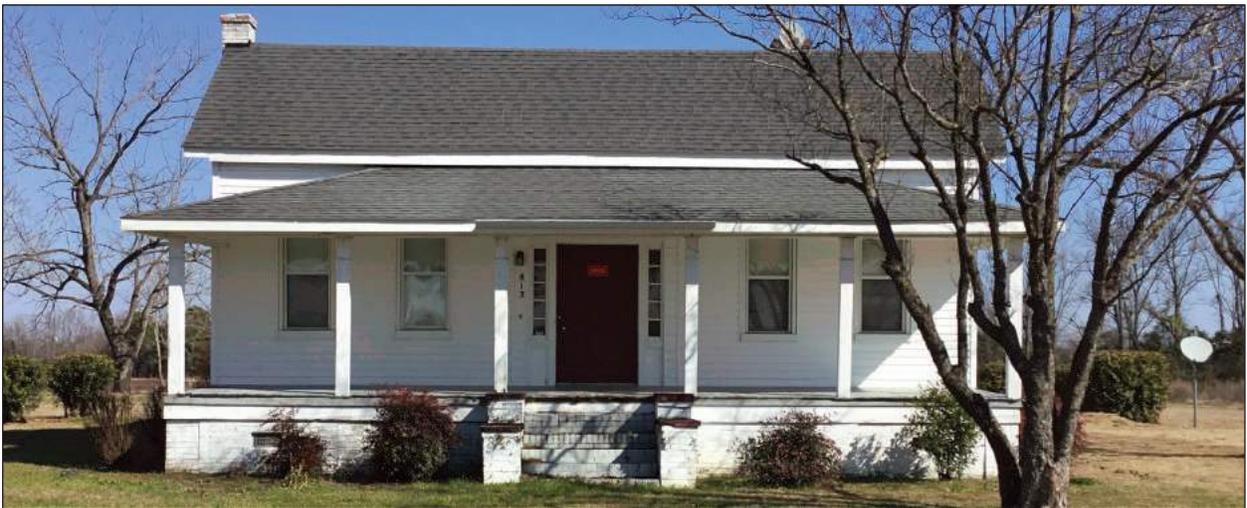
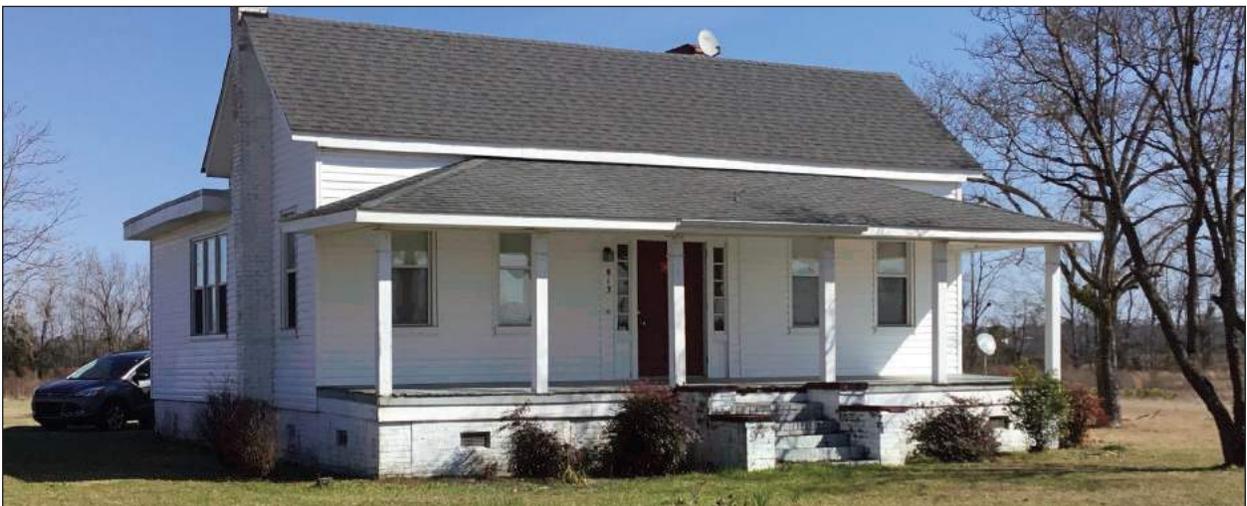
Figure 40.
Resource U/61/0085 – 813 Wisacky Highway

Resource U/61/0085 is a circa 1910 Central Hall House located at 813 Wisacky Highway. It faces west towards Wisacky Highway and is currently used as an office for the City Nursery Farm. It is one story tall with a rectangular historic core, a laterally gabled composition shingle roof, and synthetic siding (Figure 40). The windows are replacement one-over-one double-hung vinyl frame sashes. The front (west) elevation is symmetrical with a central wood panel replacement door flanked by wood frame sidelights. Two windows are located to either side of the door. A hipped roof porch extends across the full front façade and has square wooden supports. An exterior brick chimney is located on the north elevation. Two historic additions have been made to the rear of the house, including both a front-gabled and a shed-roofed portion. The foundation is brick pier with infill.

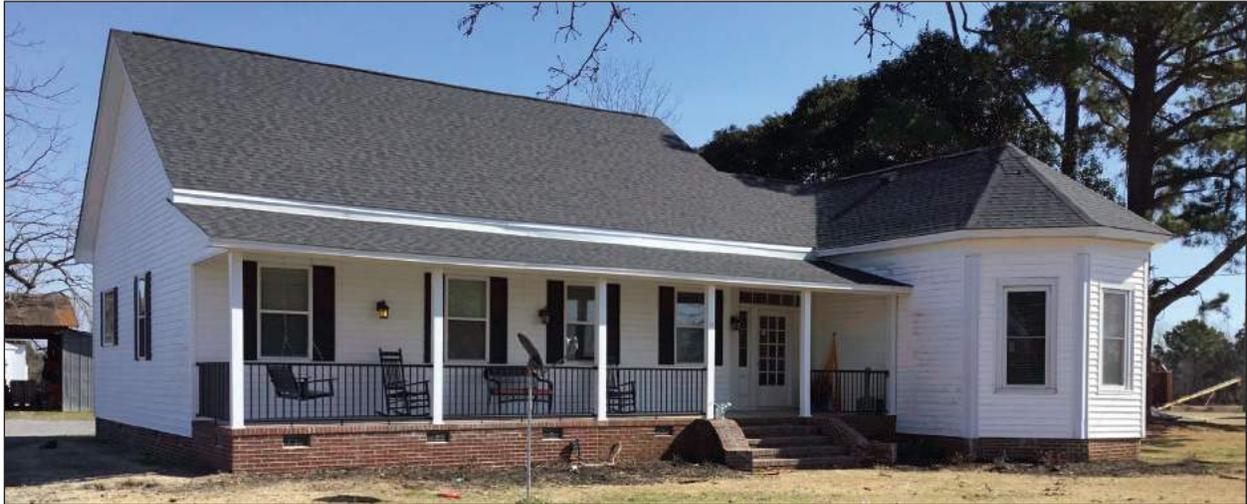
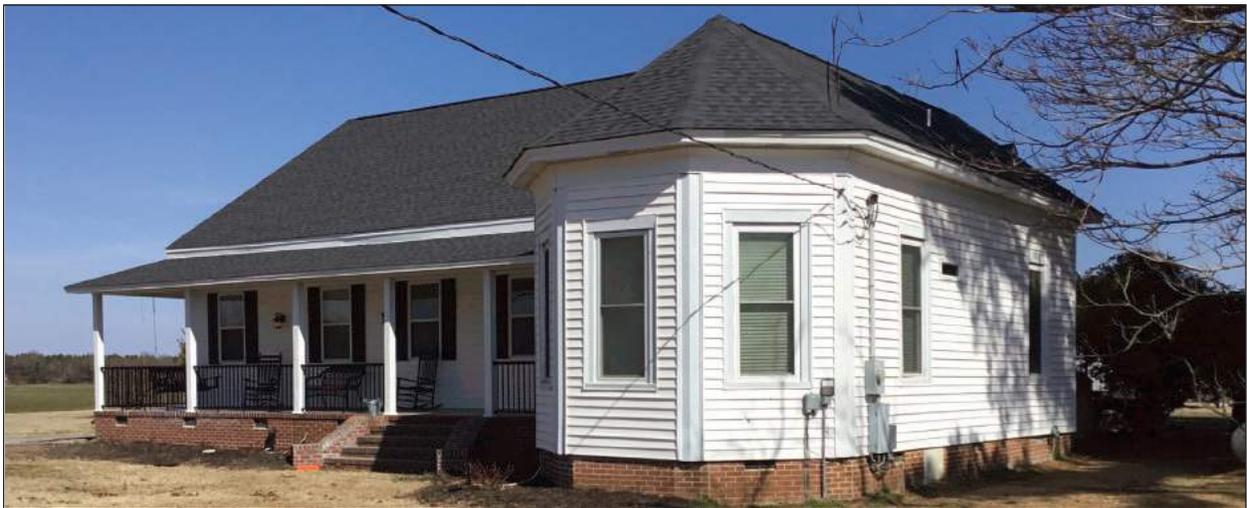
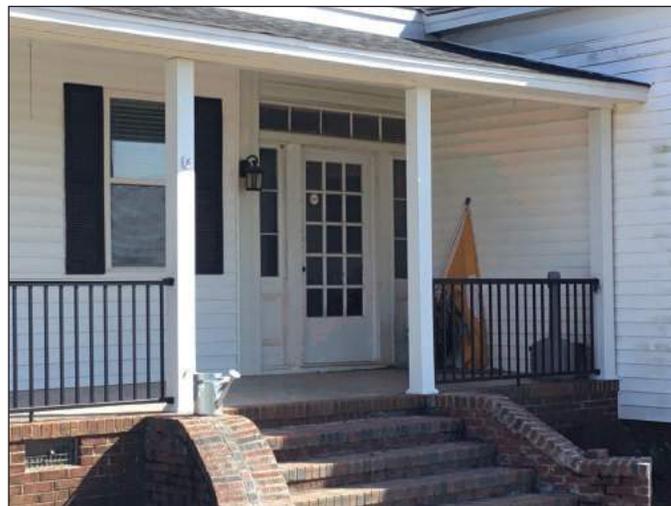
Figure 41.
Resource U/61/0086 – 100 Jordan Lane

Resource U/61/0086 is a circa 1920 house of no distinct style or type located at 100 Jordan Lane, a single lane driveway that extends from Wisacky Highway. The property is named Jordan Farms. Resource U/61/0086 faces west towards Jordan Lane and is one story tall with a rectangular historic core, a laterally gabled composition shingle roof, and synthetic siding. A 15-light wood panel door with sidelights and transom is located on the far south of the front (west) elevation of the historic core. To the north of the door are four single windows with shutters.

A shed roofed porch with square wooden supports shelters the full front elevation of the historic core. A gable with a projecting bay window and hipped roof has been added to the south of the front elevation. Two additions have been made to the rear of the house, including a shed-roofed enclosed portion and a front-gabled multi-car carport. The foundation is concealed by modern brick veneer (Figure 41).

Resource U/61/0086 was considered for the NRHP under Criterion C. It was not found to embody the distinctive characteristics of a type, style, period, or method of construction, and does not possess significance for its engineering or materials. Its integrity is impacted by the use of modern windows and siding as well as an addition on the front of the house. The six historic outbuildings do not individually possess qualities necessary for inclusion on the NRHP under Criterion C.

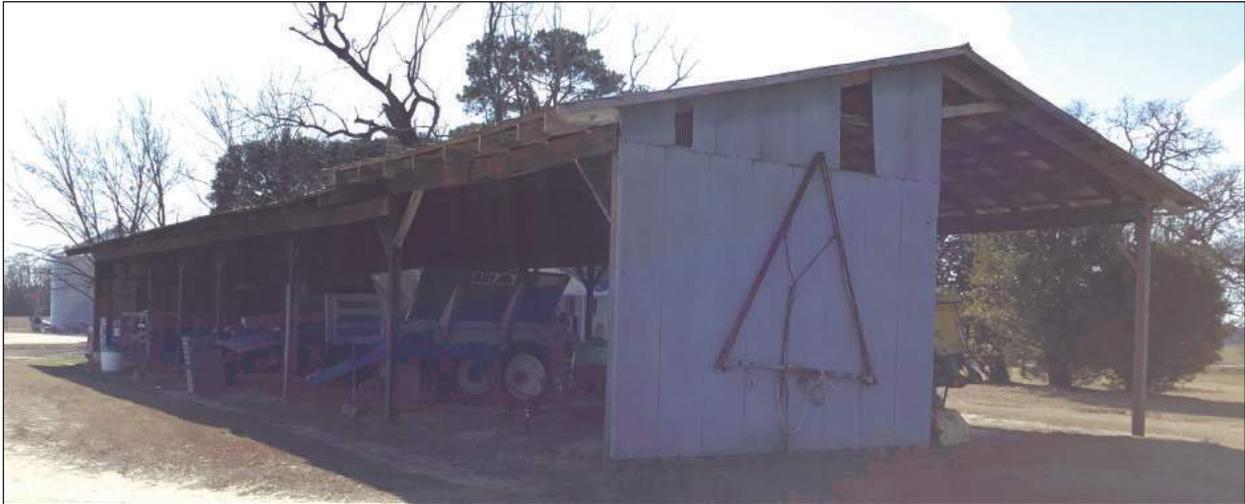
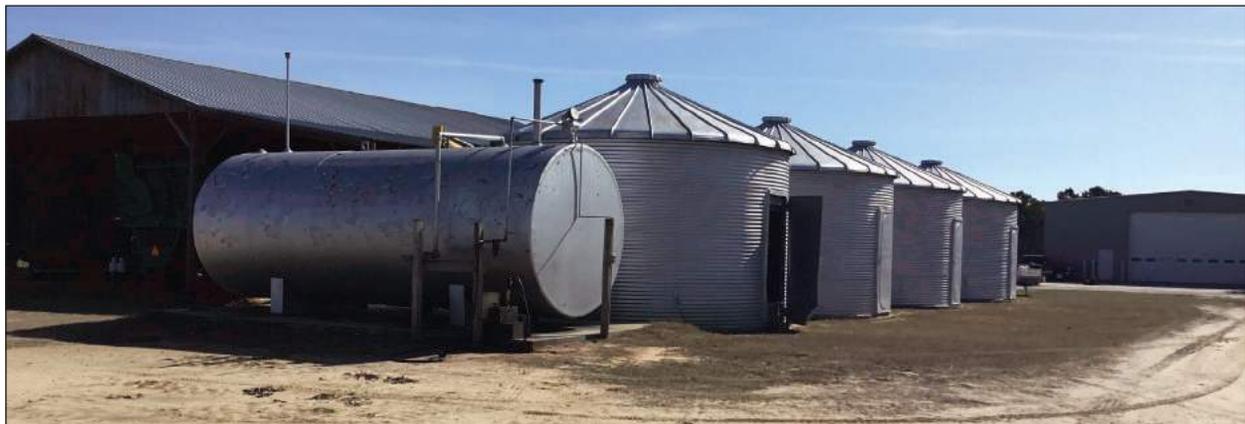
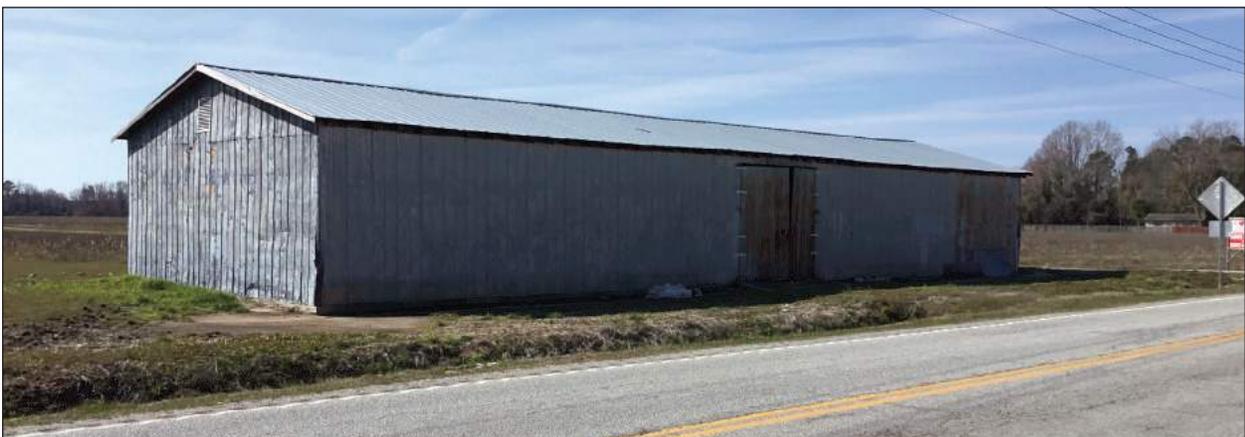
Figure 42.
Resources U/61/0086.01 – U/61/0086.06 – 100 Jordan Lane – Shed, Cylindrical
Sheds, and 1004 Wisacky Highway

Resource U/61/0086.01 is a circa 1950 one-story open shed with a gabled V-crimp metal roof (Figure 41). It is rectangular in plan and is of frame construction with exposed rafter tails. The square wooden supports have simple brackets. It is partially clad in plywood on the north and south end elevations and an addition has been made to the north elevation. Resources U/61/0086.02 through U/61/0086.05 are four identical circa 1965 cylindrical metal storage buildings located approximately 100 feet to the east of Resource U/61/0086 (see Figure 41). They are roughly one story tall and have conical sheet metal roofs. They are constructed of corrugated metal sheets and each small building has a metal door facing east. There are no visible foundations. Resource U/61/0086.06 is a circa 1960 warehouse of no distinct style or type located at 1004 Wisacky Highway, directly across Wisacky Highway from Jordan Lane. It faces east towards Wisacky Highway. It is one story tall and rectangular in plan with a laterally gabled V-crimp metal roof, V-crimp metal siding, and rectangular louvered windows in the gable ends (Figure 42). It is accessed via a set of large metal double doors on the east elevation. The foundation is not visible.

Resource U/61/0086 along with its outbuildings was considered collectively for the NRHP under Criterion C on the local level as an example of vernacular rural architecture. The complex retains integrity of location and setting, as it is sited on a 95-acre agricultural parcel surrounded by other agricultural properties. Integrity of materials and workmanship are negatively impacted by significant alterations to Resource U/61/0086, including a major addition and the replacement of windows and cladding. Resource U/61/0086.01 is similarly impacted by alterations and additions. Also of concern are the multiple modern outbuildings in close proximity to the historic buildings. These have a strong impact on integrity of design, feeling and association. The complex does not successfully convey significance as an example of mid-twentieth-century vernacular rural architecture due to the several modern buildings and alterations to the historic ones. The resources are not recommended collectively eligible for inclusion on the NRHP under Criterion C.

Resources U/61/0086 and U/61/0086.01 through U/61/0086.06 were also considered collectively for inclusion on the NRHP under Criterion A on the local level as an example of an early to mid-twentieth-century farmstead. Lee County was primarily rural and agricultural in the early twentieth century, with cotton being the primary crop (National Park Service 1985). The resources are in the ownership of a Bishopville-based family that has been farming in the area for three generations, and aerial photographs indicate that the 95-acre property has been used for agriculture for at least 60 years. However, the same integrity issues that affect the farm's qualification under Criterion C impact it under Criterion A. A combination of alterations and additions to the historic buildings coupled with significant modern infill prevents the complex from successfully conveying significance as an early to mid-twentieth-century farmstead. The resources are known to be associated with the Jordan family, who have been present in Lee County for three generations, but no individual within the family rises to a level of importance that would warrant inclusion in the NRHP under Criterion B. Therefore, the resources are recommended as not individually or collectively eligible for the NRHP under Criterion A or B.

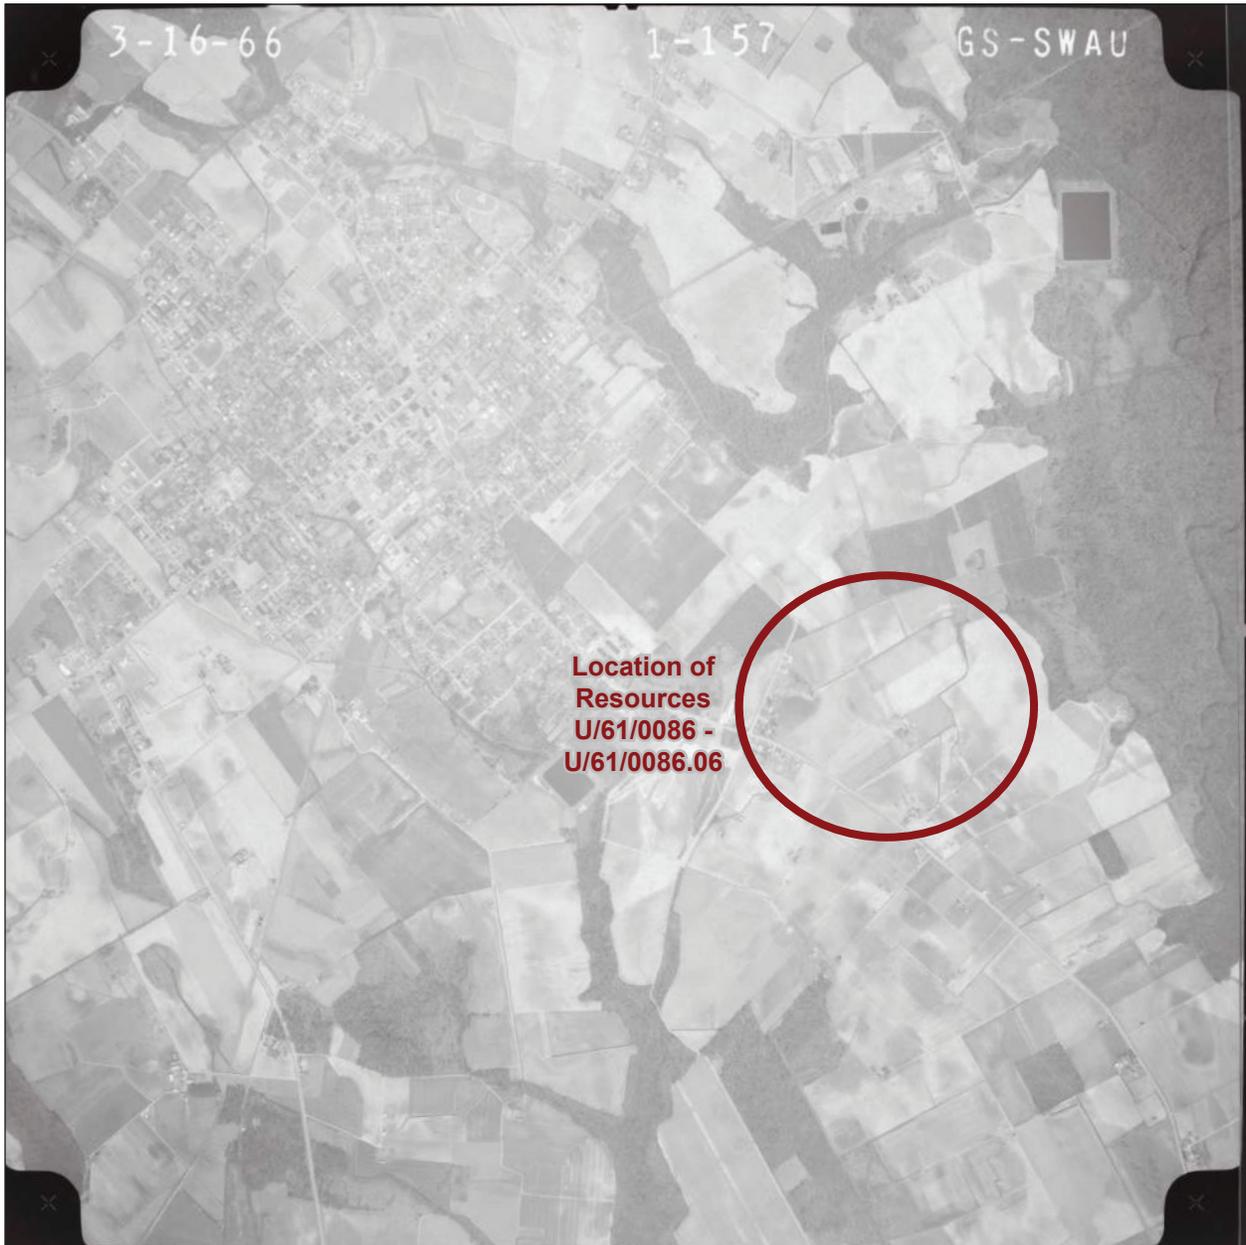
Figure 43.
1966 USGS Aerial Photograph

Jordan Farms is a working farm. While its major crop has been cotton, it has also produced wheat, soybeans, corn, and sorghum over the past 20 years (Environmental Working Group 2018). Historic aerial photographs indicate that the fields have been consistently cultivated and have retained their current configuration since at least the 1960s (Figure 43). However, the majority of the outbuildings are modern, having been constructed in the past 25 years.

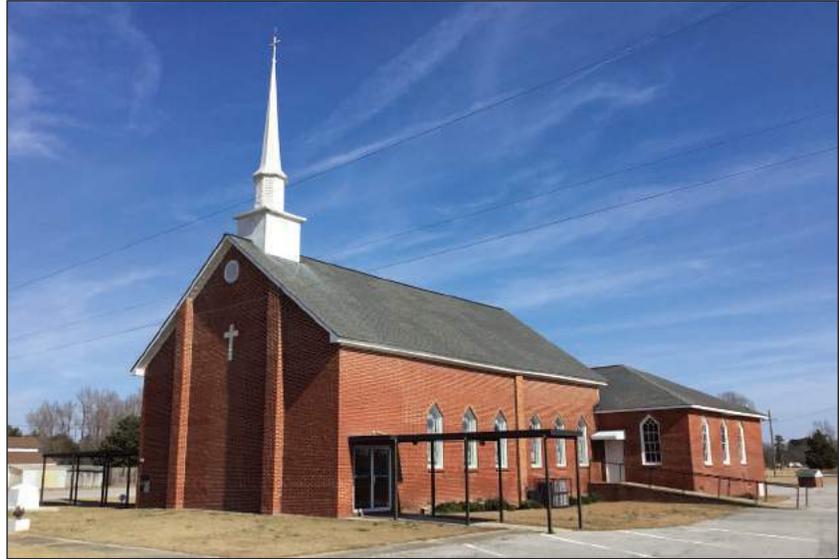
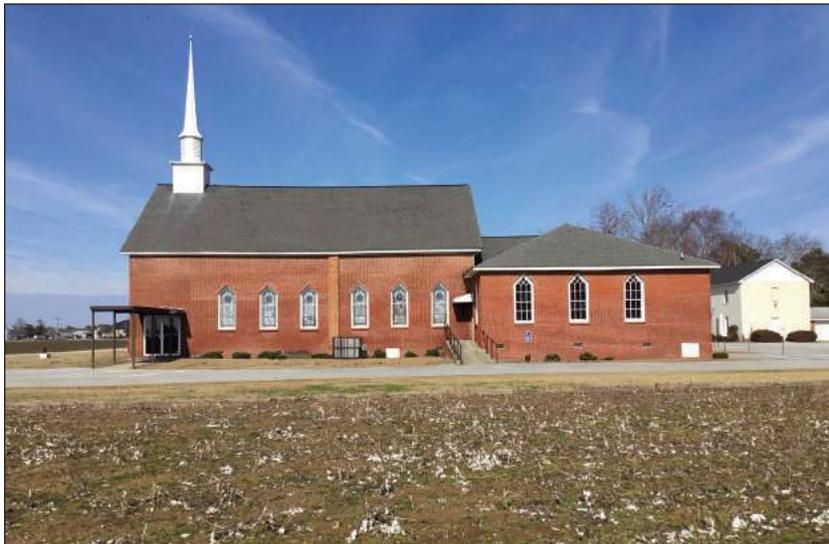
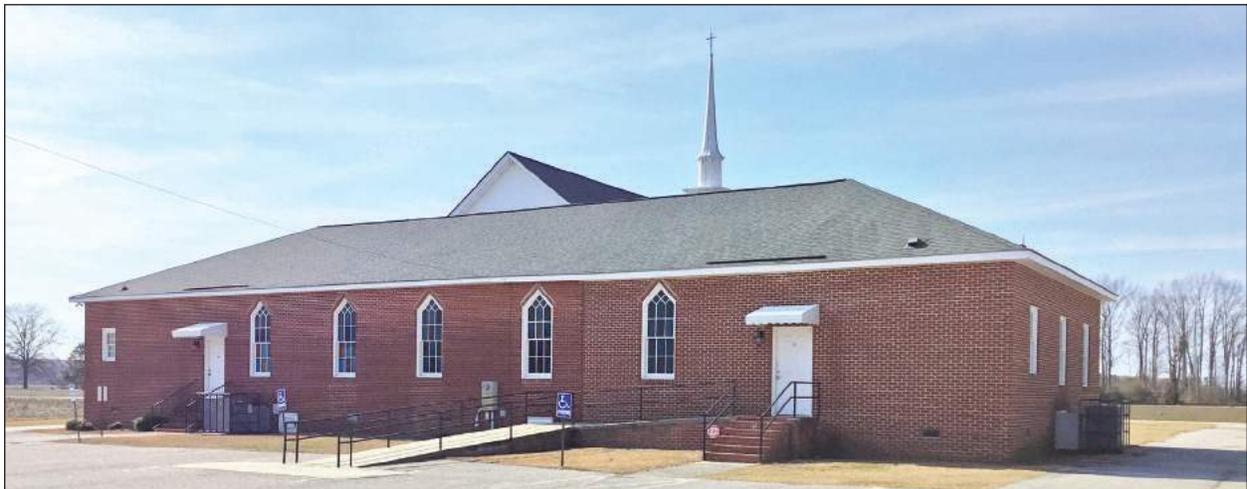
Figure 44.
Resource U/61/0087 – Liberty Hill Missionary Baptist Church (55 Dove Lane)

Resource U/61/0087 is a circa 1913 church with extensive renovations that is located at 55 Dove Lane (Figure 44). It is named the Liberty Hill Missionary Church and is visible on a 1966 aerial photograph as well as on a 1958 topographic map as “Liberty Church.” The T-shaped brick veneer building faces north towards Dove Lane. The historic core of the church is one oversized story tall with a front gabled composition shingle roof and a white steeple rising from the roofline at the front of the building. The north elevation is void of windows and doors, and is decorated with two brick faux buttresses flanking a brick cross. A louvered window is located in the gable end. The building has two identical entrances on the east and west elevations near the front (north) end of the building. These sets of double glass and metal doors are sheltered by flat-roof metal walkways with square supports. Fenestration along the east and west elevations of the historic core is symmetrical and consists of the entrances and six windows. The windows are peaked wood frame stained glass and are historic.

A one-story hipped roof section has been added to the rear of the building. The addition is not visible in the 1966 aerial photograph and a plaque on the church indicates that the building was rebuilt in 1979. The addition likely dates from this period. The addition is clad in brick veneer and has double-hung sash windows that appear to be historic. The windows are peaked wood frame nine-over-six that correspond with the stained glass windows on the historic core. The addition is fenestrated with a wood panel door and one window on the west side of the north elevation and a wood panel door and three windows on the east side. The south elevation of the addition has five bays of peaked windows flanked by two wood panel doors. The side elevations of the addition contain three windows each. Those on the east elevation are regular six-over-six wood frame double-hung sashes. The foundation of the building is concealed.

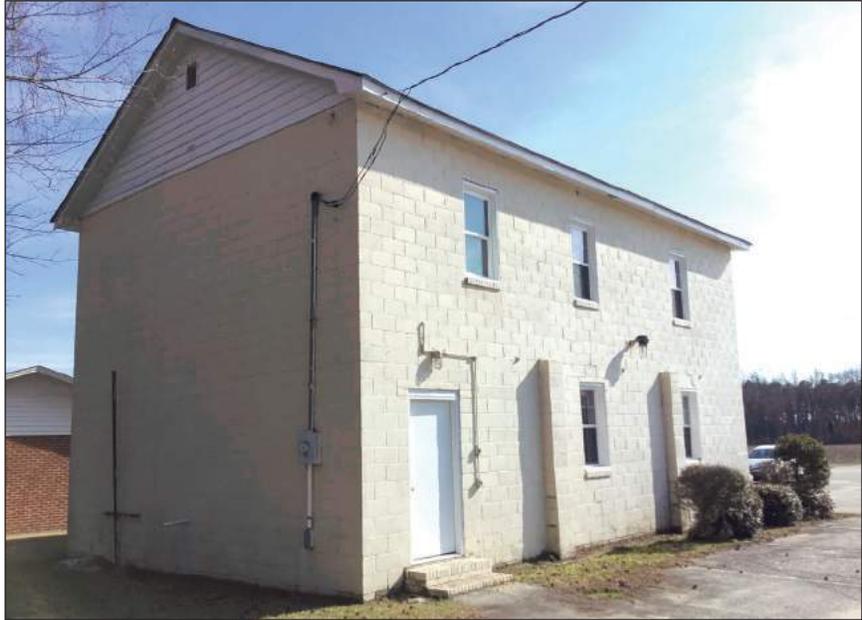
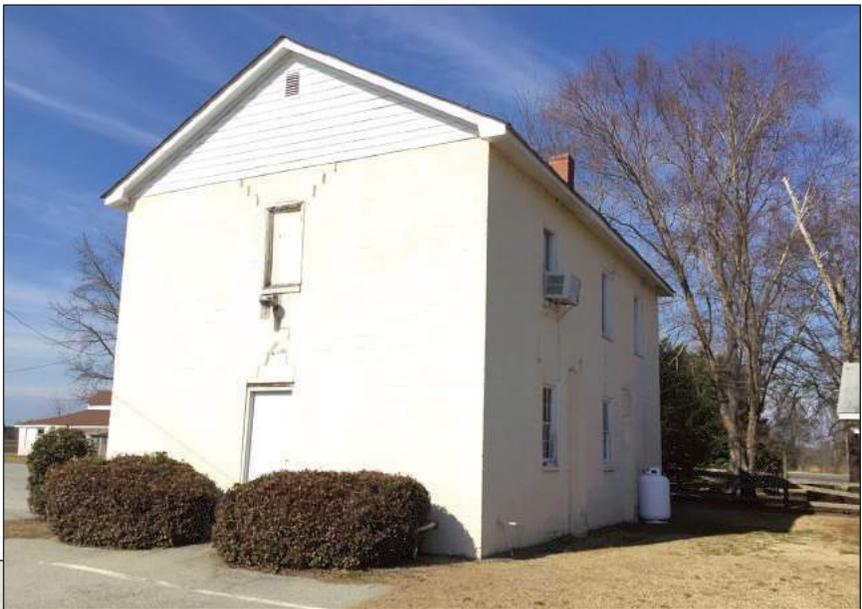
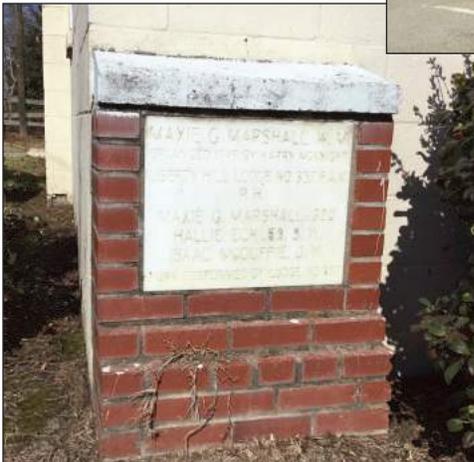
Figure 45.
Resource U/61/0087.01 – Liberty Hill Lodge No. 457 F.A.M. (55 Dove Lane)

Resource U/61/0087.01 is a civic building, the Liberty Hill Lodge No. 357 of the F.A.M. A plaque on the building indicates that it was constructed in 1945 although it is concealed by trees in historic aerial photographs (Figure 45). The building is roughly 70 feet northeast of U/61/0087 and faces west towards Dove Lane. It is a two-story rectangular building with a laterally gabled composition shingle roof. It is of concrete block construction with faux buttresses on the first floor only of the east and west elevations and irregularly spaced bays on the first and second floor. The building is accessed on the north side of the west elevation via a plain wood door. Six-over-six double-hung sash replacement windows separated by the two faux buttresses are to the south of the door. Fenestration for the second story stacks above the first and consists of three double-hung vinyl replacement sashes. The south elevation contains a second wood door with fenestration for a window above it, which has been enclosed. The building has vinyl siding in the gable ends and the foundation is concealed. It is surrounded by concrete parking areas, a lawn, and manicured bushes. The building was constructed for use as a Masonic Lodge and still functions as such.

Resources U/61/0087 and U/61/0087.01 were considered for the NRHP under Criterion C. Resources U/61/0087 and U/61/0087.01 were not found to embody the distinctive characteristics of a type, period, or method of construction, and do not represent the work of a master or possess high artistic value. Resource U/61/0087 has been altered to such a degree that it is difficult to determine what, if any, portions of the building are historic. The resources are recommended not eligible under Criterion C either individually or collectively.

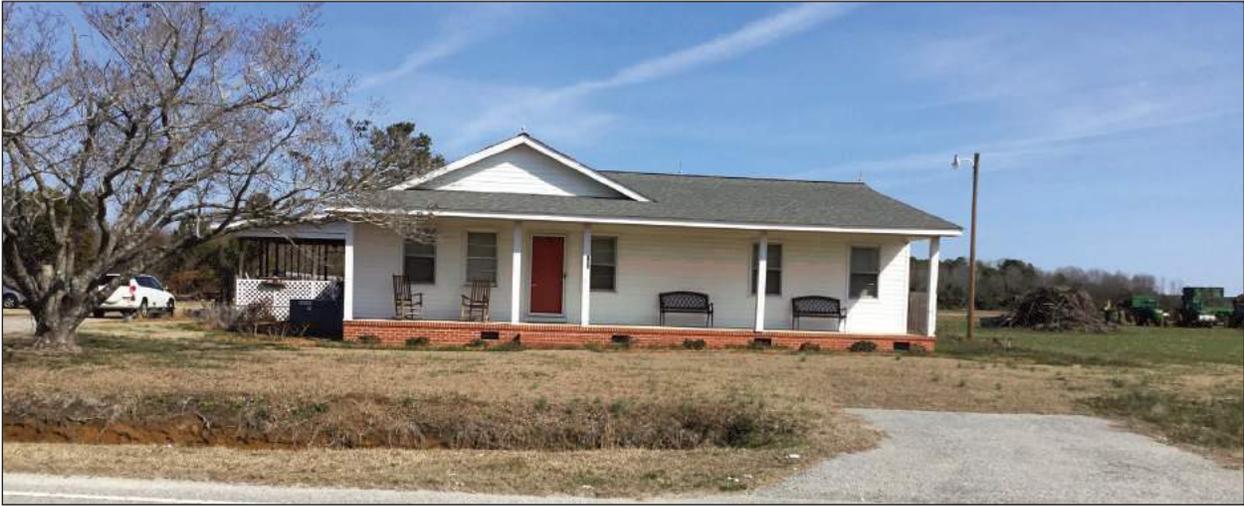
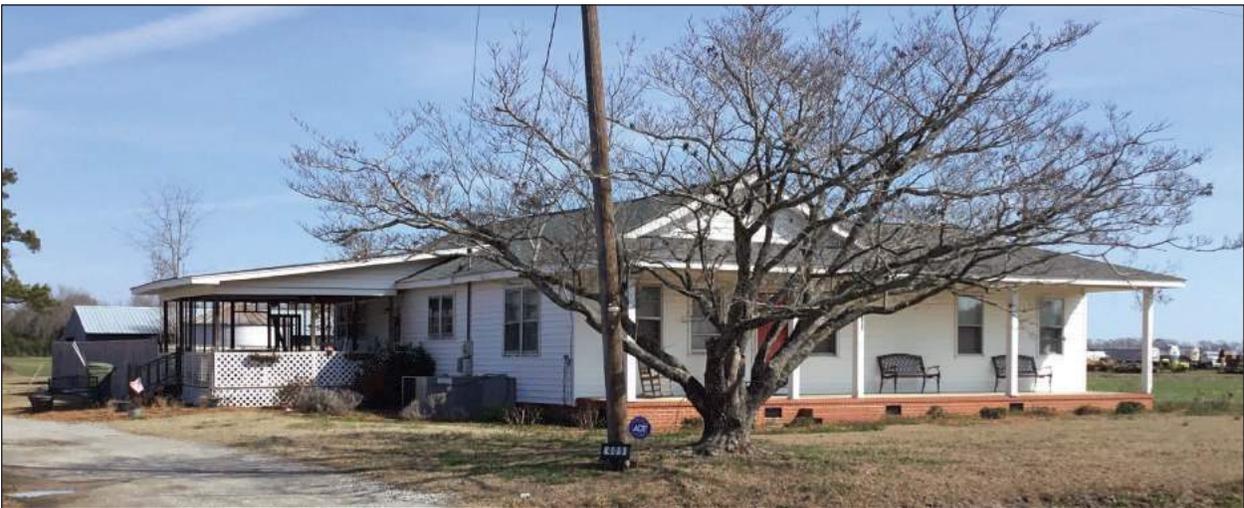
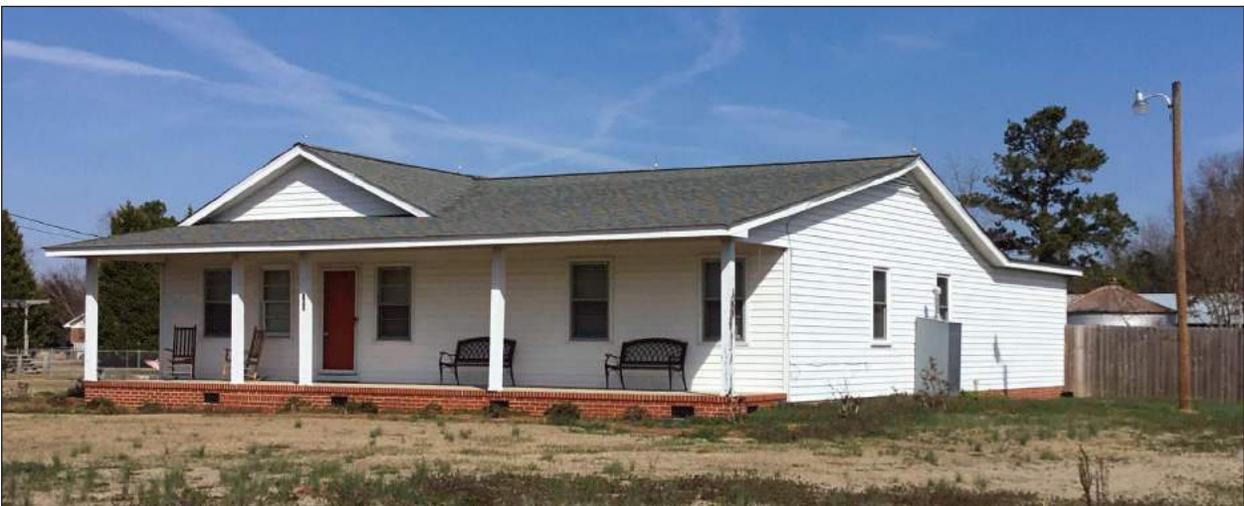
Figure 46.
Resource U/61/0088 – 409 Saint Charles Highway

Resource U/61/0088 is a circa 1925 Bungalow located at 409 Saint Charles Highway, facing west towards Saint Charles Highway. It is one story tall with a rectangular historic core, a cross-gabled composition shingle roof, and synthetic siding (Figure 46). The windows are horizontal two-over-two wood frame double-hung sashes. The front elevation of the historic core contained a wood panel door flanked by two windows to the north and one to the south. A large laterally gabled addition has been made to the south elevation of the house and a shed roof porch with square wooden supports runs across the full front elevation. A shed roof porch has been added to the north elevation of the house and a shed roof addition has been made to the rear. None of these additions are visible on a 1966 aerial photograph. The foundation is concealed by brick veneer.

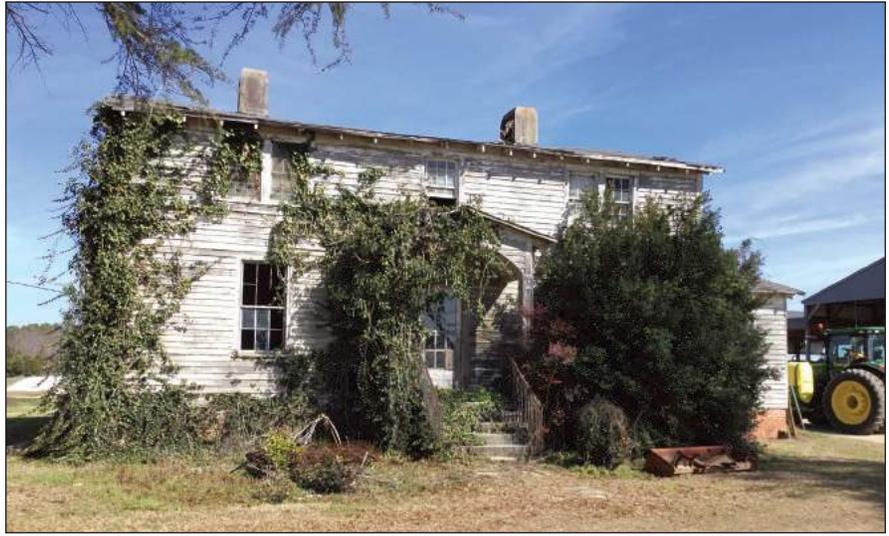
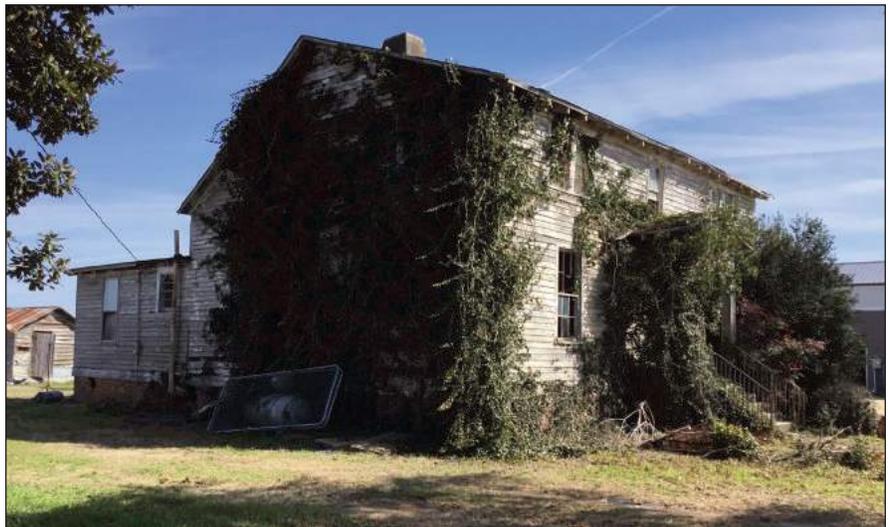
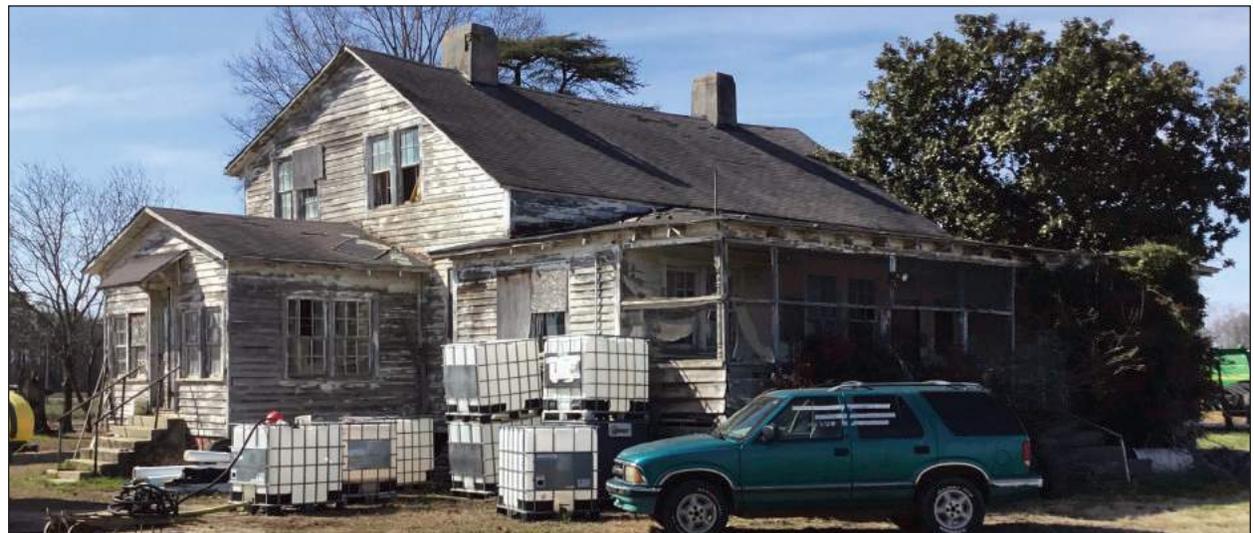
Figure 47.
Resource U/61/0089 – 441 Saint Charles Highway

Resource U/61/0089 is a heavily modified circa 1855 Side-Gabled Cottage located at 441 Saint Charles Highway, facing west towards Saint Charles Highway. The construction date of circa 1855 was provided by the homeowner. The historic core is rectangular in plan, symmetrical, and one story tall with a laterally gabled composition shingle roof with exposed rafter tails (Figure 47). The house is clad in weatherboard and supported by a brick pier with infill foundation. The windows are six-over-six wood frame double-hung sashes. The 12-pane three-quarter light wood panel front door is accessed via a set of poured concrete steps. A front-gabled porch with decorative arched pediment and square wood paneled supports shelters the door only. To the north and south of the door are two single windows while fenestration for the second story stacks above the first and consists of one single window flanked by two sets of paired windows. Two paired or stuccoed chimneys rise symmetrically from the roofline.

Multiple additions have been made to the house and most details and components, while historic, do not date to the 1850s. All additions are visible on a 1966 aerial photograph and appear to have been constructed around 1900. Most significantly, according to the homeowner, a second story was added to the house. It is likely that the front porch was added together with the second story. A single story laterally gabled portion has been added to the south elevation. This section is fenestrated with paired six-over-six windows and has exposed rafter tails in keeping with the rest of the house. A wood panel door is located on the south elevation and is sheltered by a shed roofed porch supported by simple brackets. A larger one story addition with a low-pitched shed roof is at the rear of the house. The addition is L-shaped and half-covered by a screened porch while the other half is completely finished. The porch is supported by turned wood columns. Fenestration on the addition includes single and paired six-over-six windows, and a smaller horizontal two-over-two wood frame double-hung sash window on the north elevation. The addition has exposed rafter tails. While the property is in use as a working farm, the house is vacant and is in a state of disrepair. Vegetation conceals much of the north elevation and portions of the front elevation. Window panes are missing and the siding, roof, and portions of the foundation are in disrepair. The area surrounding the house is used for the storage of modern farm equipment.

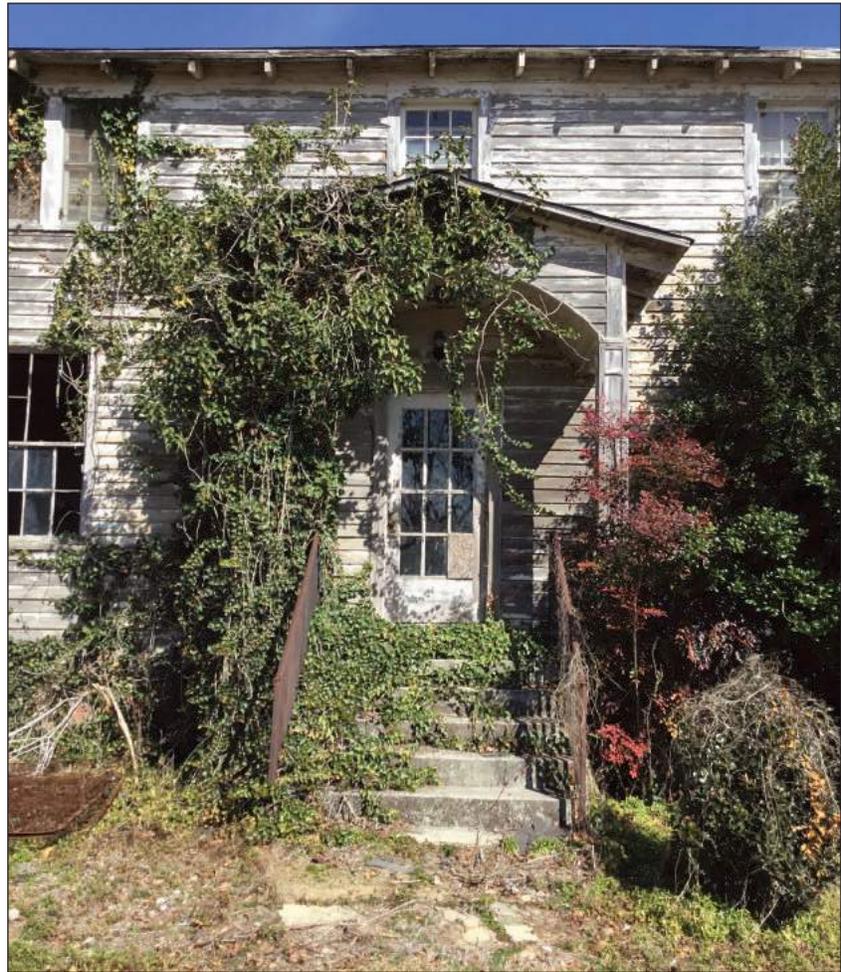
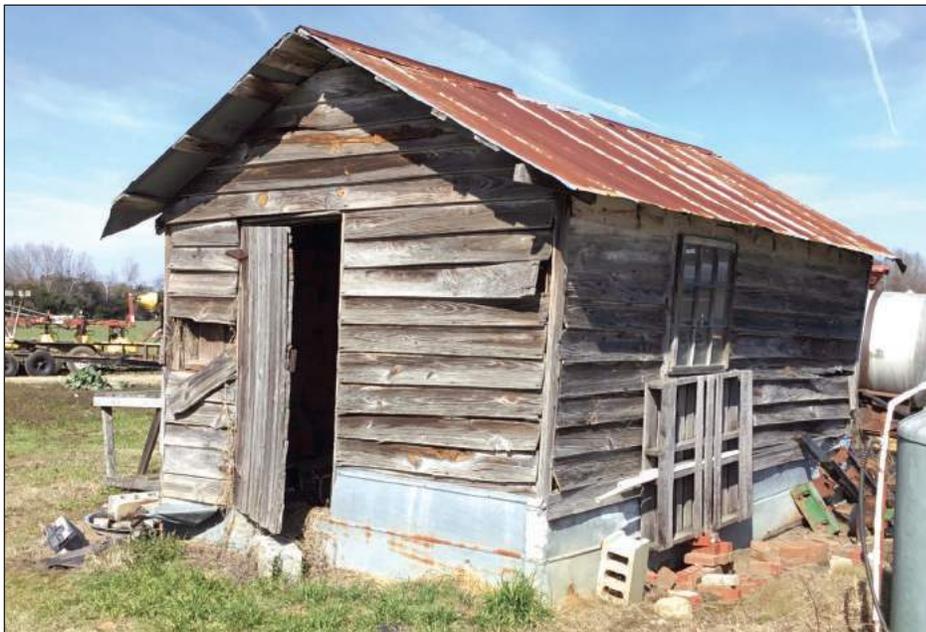
Figure 48.
Resources U/61/0089 and U/61/0089.01 – 441 Saint Charles Highway and Smokehouse

Resource U/61/0089.01 is a circa 1930 smokehouse located approximately 80 feet to the east of Resource U/61/0089 (Figure 48). It is a small one-story building with a front-gabled V-crimp metal roof. It is rectangular in plan and is clad in weatherboard. It has a vertical wood board door with strap hinges and is fenestrated with a fixed nine-pane wood frame window. It has exposed rafter tails and the foundation is concealed by metal siding but appears to be concrete. There are also a number of non-historic outbuildings on the property, including two large gabled storage buildings and seven cylindrical metal buildings.

It is unlikely that Resource U/61/0089.01 dates from circa 1855 and no clear construction date could be established through research. While it is historic, it does not date from the period of significance or help Resource U/61/0089 convey as a Georgian House. It does not rise to a level of importance that would warrant inclusion on the NRHP on its own under Criterion C. Resources U/61/0089 and U/61/0089.01 are recommended as not eligible for inclusion under Criterion C either collectively or individually.

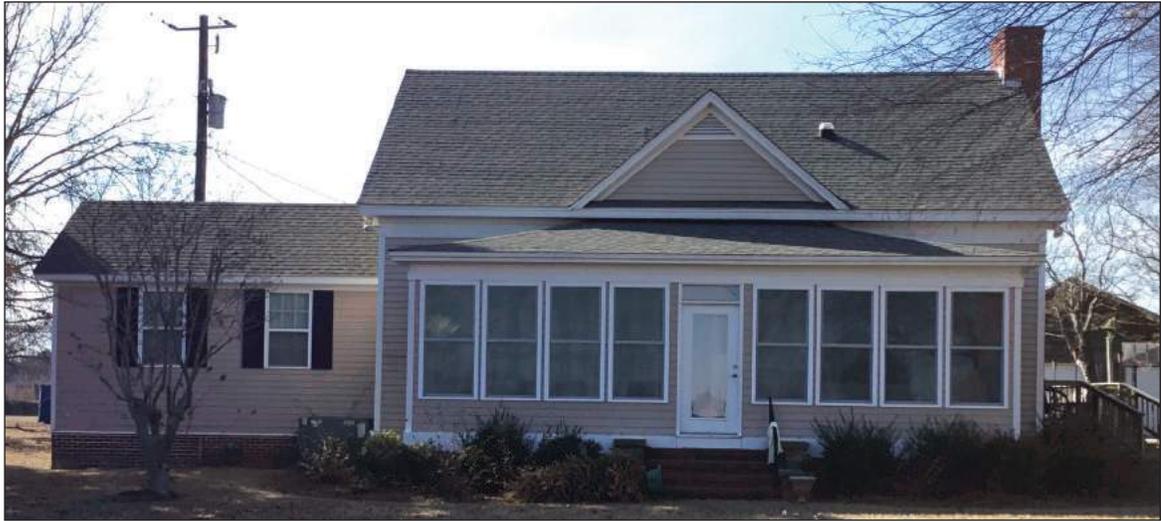
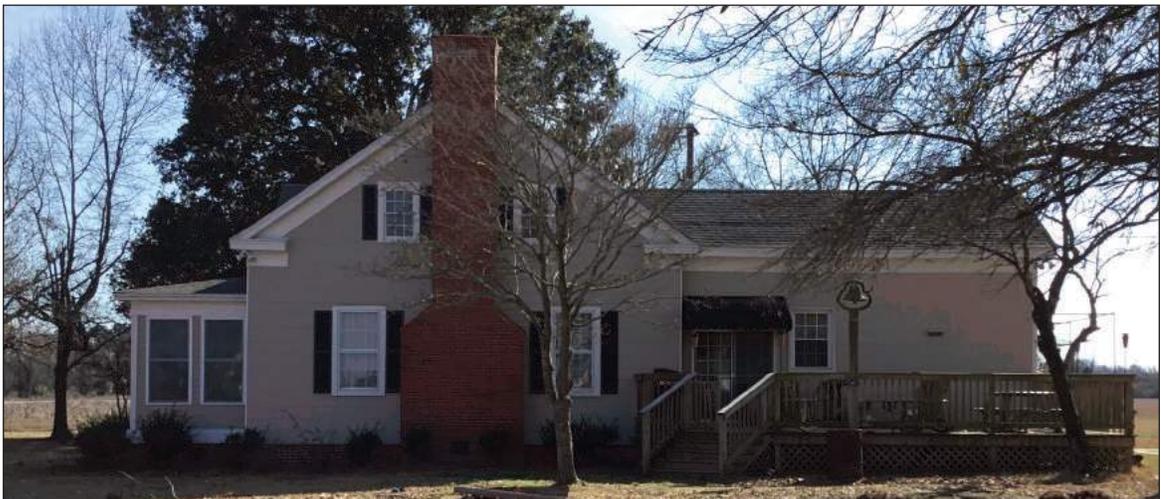
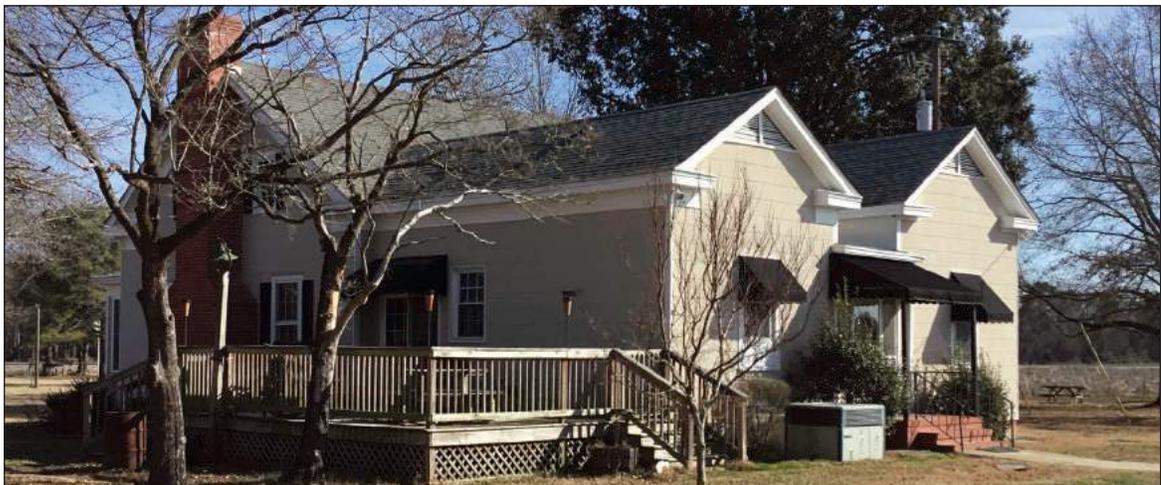
Figure 49.
Resource U/61/0090 – Dove Lane Farm – House

Resource U/61/0090 is a circa 1900 Central Hall House located on the west side of Dove Lane at the intersection of Dove Lane and Woodside Road. It is sited perpendicular to Woodside Road and faces roughly south. It is one story tall with a rectangular historic core, a laterally gabled composition shingle roof, and synthetic siding (Figure 49). The windows are replacement vinyl frame six-over-six double-hung sashes, some with louvered shutters. The front (south) elevation of the historic core is symmetrical and is dominated by a hipped roof porch which extends over all of the fenestration. This porch has been finished as a sunroom with two bands of four vinyl frame one-over-one double-hung sash windows. The front door is a modern full-light wood door with simple modern transom and a decorative front gable located above. An external brick chimney is located on the east elevation. Multiple historic additions have been made to the house and are visible on a 1966 aerial photograph including a laterally gabled section with two windows which has been added to the west elevation of the historic core. Additionally, two long and narrow front-gabled portions with a central shed roofed portion have been added to the rear of the house. These sections are clad in asbestos shingle siding. A large porch has been added to the east elevation. The foundation is brick pier with infill.

Resource U/61/0090 is sited on a large working farm and has fifteen outbuildings. Most are not historic. The non-historic outbuildings include six metal cylindrical storage buildings, three metal and concrete silos, two one-story weatherboard-clad sheds, a large two-car garage with carports on both side elevations, and a metal animal shelter. Two outbuildings are historic and are visible on a 1966 aerial photograph. Resource U/61/0090.01 is a circa 1960 two-story shed located approximately 200 feet to the east of Resource U/61/0090. It has a front-gabled corrugated metal roof and is clad in corrugated metal siding. Two shed roofed porches extend along the east and west side elevations. It is accessed via barn doors on the north elevation and an open doorway on the east elevation. Resource U/61/0090.02 is a circa 1950 shed located approximately 180 feet northeast of Resource U/61/0090. It is one story tall with a rectangular historic core and a front-gabled composition shingle roof. It is of concrete block construction with exposed rafter tails and two metal doors located on the east elevation. A front-gabled concrete block addition has been made to the west elevation. The addition is accessed via a wood panel door with shed roofed porch on the north elevation and is fenestrated with both one-over-one aluminum frame double-hung sash and aluminum frame sliding windows. There is a rectangular louvered window in the gable end. A frame animal pen has been added to the east elevation of the historic core. The pen is bisected by a concrete block wall and has a front-gabled V-crimp metal roof. The exterior walls are open and the roof has square wooden supports. The building has been vacant for some time and portions of the roof of both the historic core and the animal pen have started to collapse. A poured in place concrete trough is located directly to the north of the animal pen.
