APPENDIX O. BISHOPVILLE TRUCK ROUTE PROJECT DRAFT CULTURAL RESOURCES ASSESSMENT

RE: Bishopville Truck Routes Alternatives Analysis, Lee County, South Carolina

Reconnaissance-Level Archaeological Survey of Bishopville Truck Route Segments

Phase I Architectural Survey of
**BISHOPVILLE BYPASS
ALTERNATIVES**

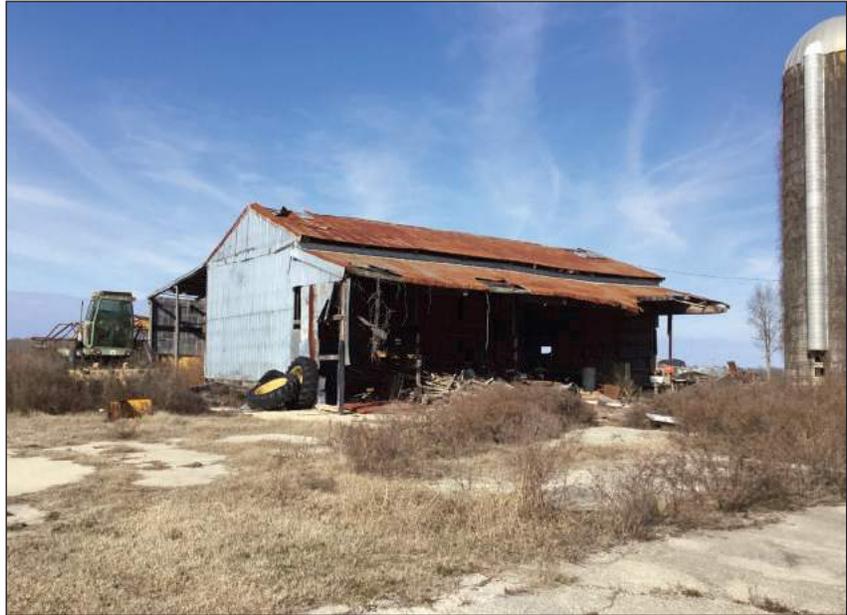
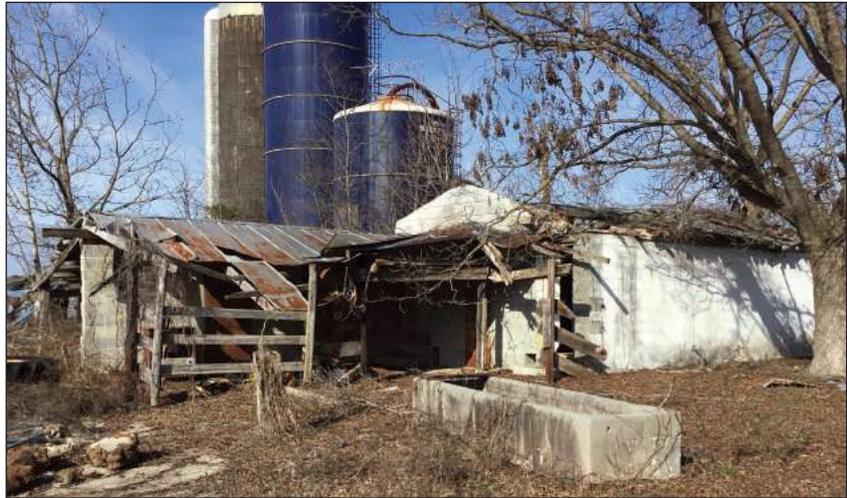
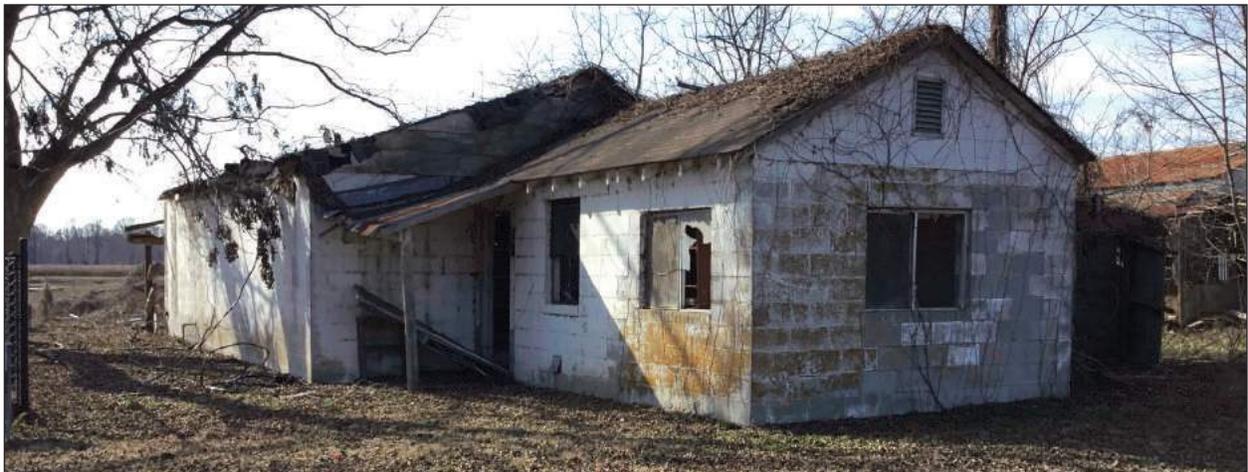
Resources U/61/0090.01 and U/61/0090.02 – Dove Lane Farm – Shed and CMU Shed

Resources U/61/0090, U/61/0090.01, and U/61/0090.02 were also considered for inclusion on the NRHP under Criterion A for agriculture as an early- to mid-twentieth-century farm. While the property retains integrity in location, setting, materials, and workmanship, its ability to convey as an early- to mid-twentieth-century farm is strongly affected by the addition of numerous modern buildings directly adjacent to the historic resources. Integrity of design, feeling, and association are all strongly impacted by the extensive modern infill. Resources U/61/0090, U/61/0090.01, and U/61/0089.02 are recommended as not eligible for the NRHP under Criterion A either individually or collectively. They are not known to be associated with any persons of importance and are recommended not eligible for inclusion under Criterion B.

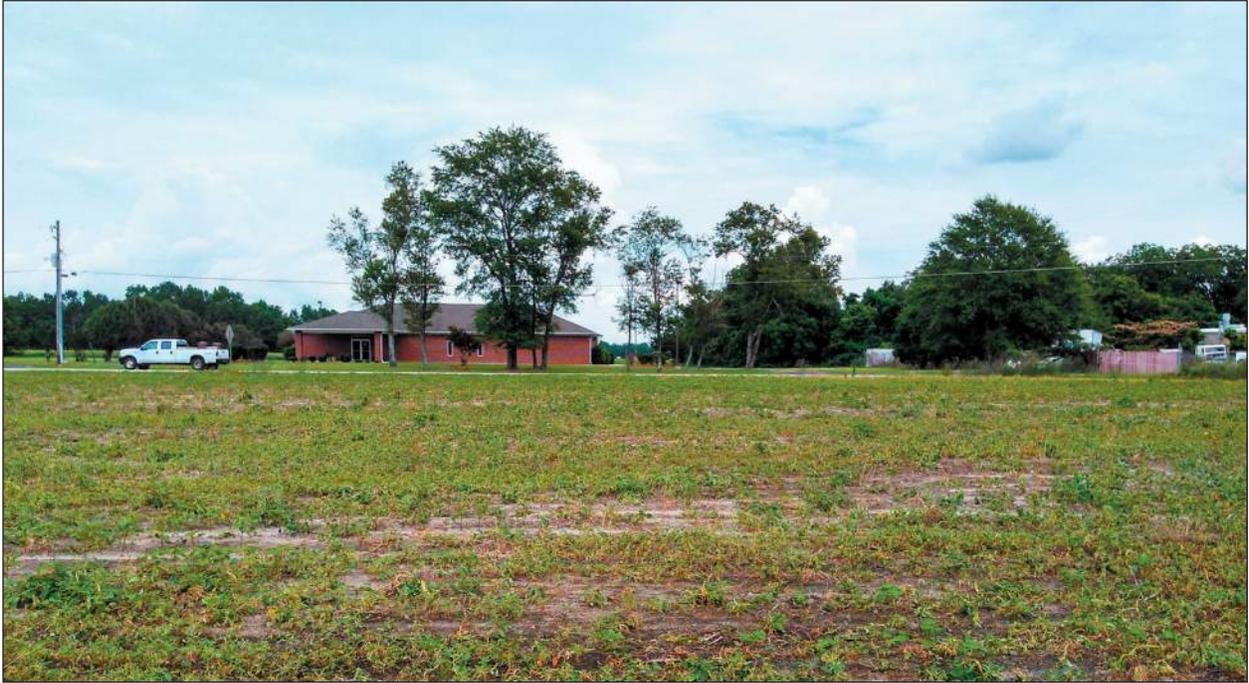
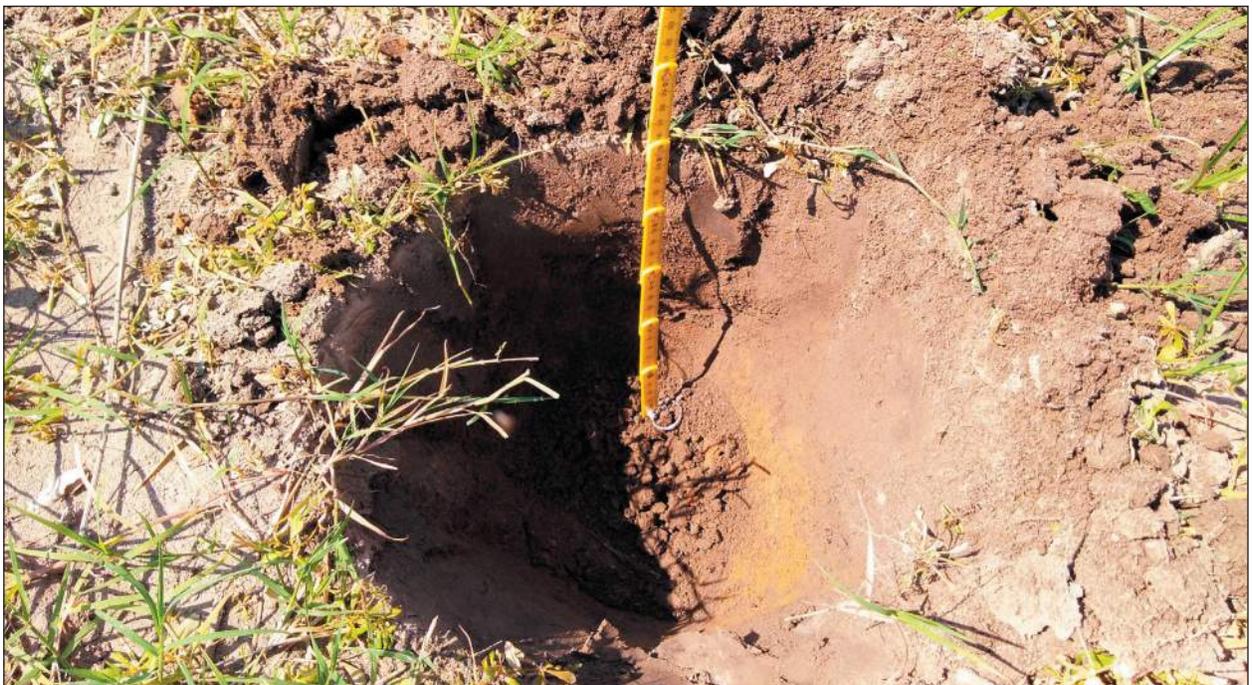
Figure 12.
Site 38LE1037 Photographs

A. Setting

B. Shovel Test Profile

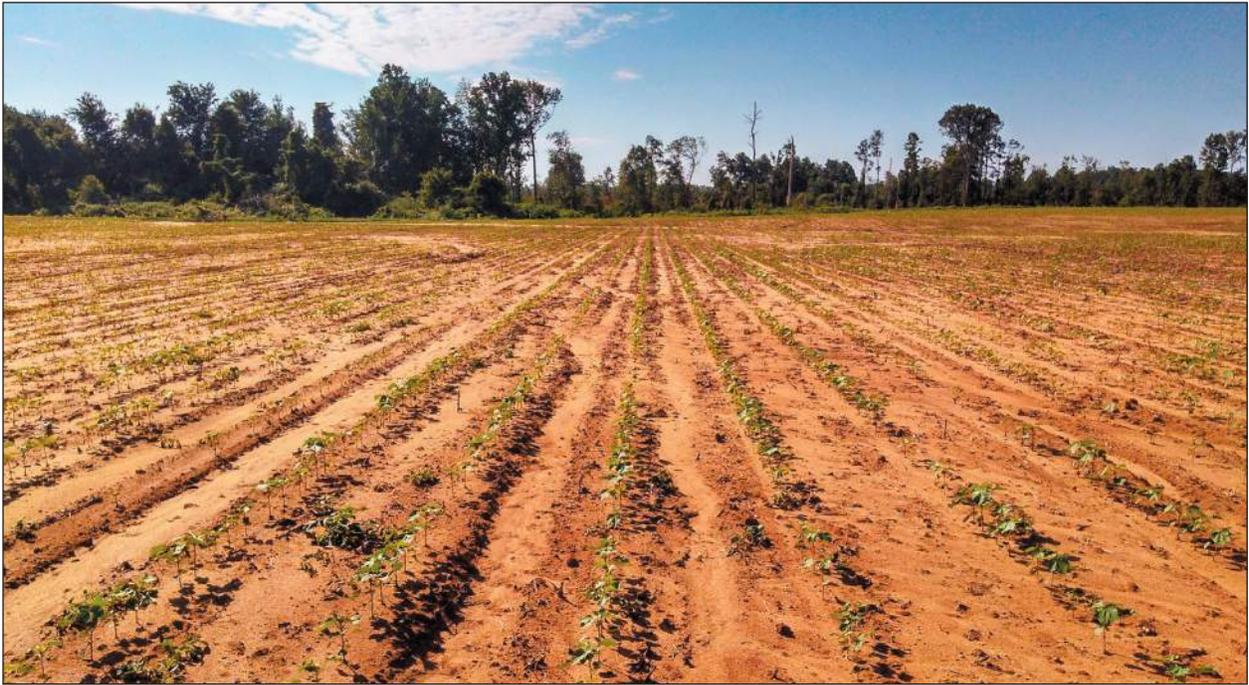
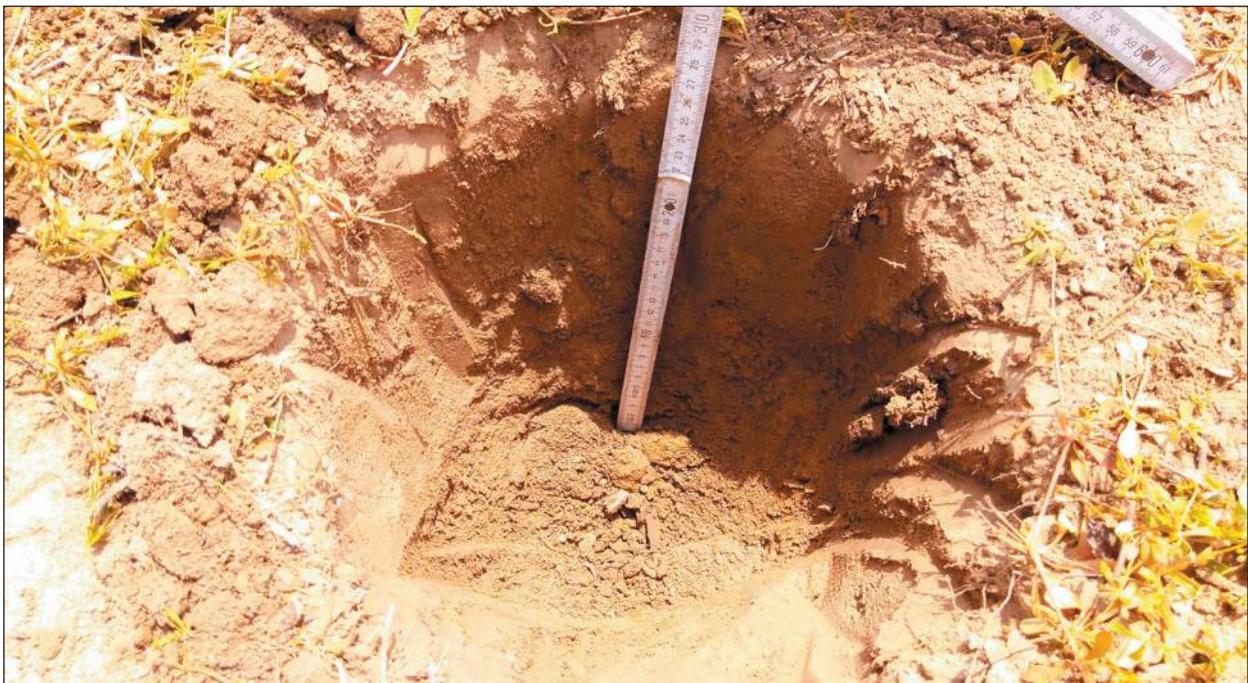
Figure 16.
Site 38LE1047 Photographs

A. Setting

B. Typical Shovel Test Profile

Twenty-eight 10-meter intervals were excavated across the surface scatter. (Figure 15). These tests generally revealed a 30-centimeter-deep brown (7.5YR 5/2) clayey sand plow zone underlain by a strong brown (7.5YR 5/8) clay subsoil (Figure 16). This disturbed soil profile shows that agricultural activity has completely disturbed the precontact and historic components of the site. Three tests, N510 E460, N 510 E430, and N510 E410, yielded artifacts (Figure 15). The three subsurface finds included a quartz flake, an olive green glass fragment, and a mid-nineteenth-century transfer-printed whiteware sherd (Miller 1991).

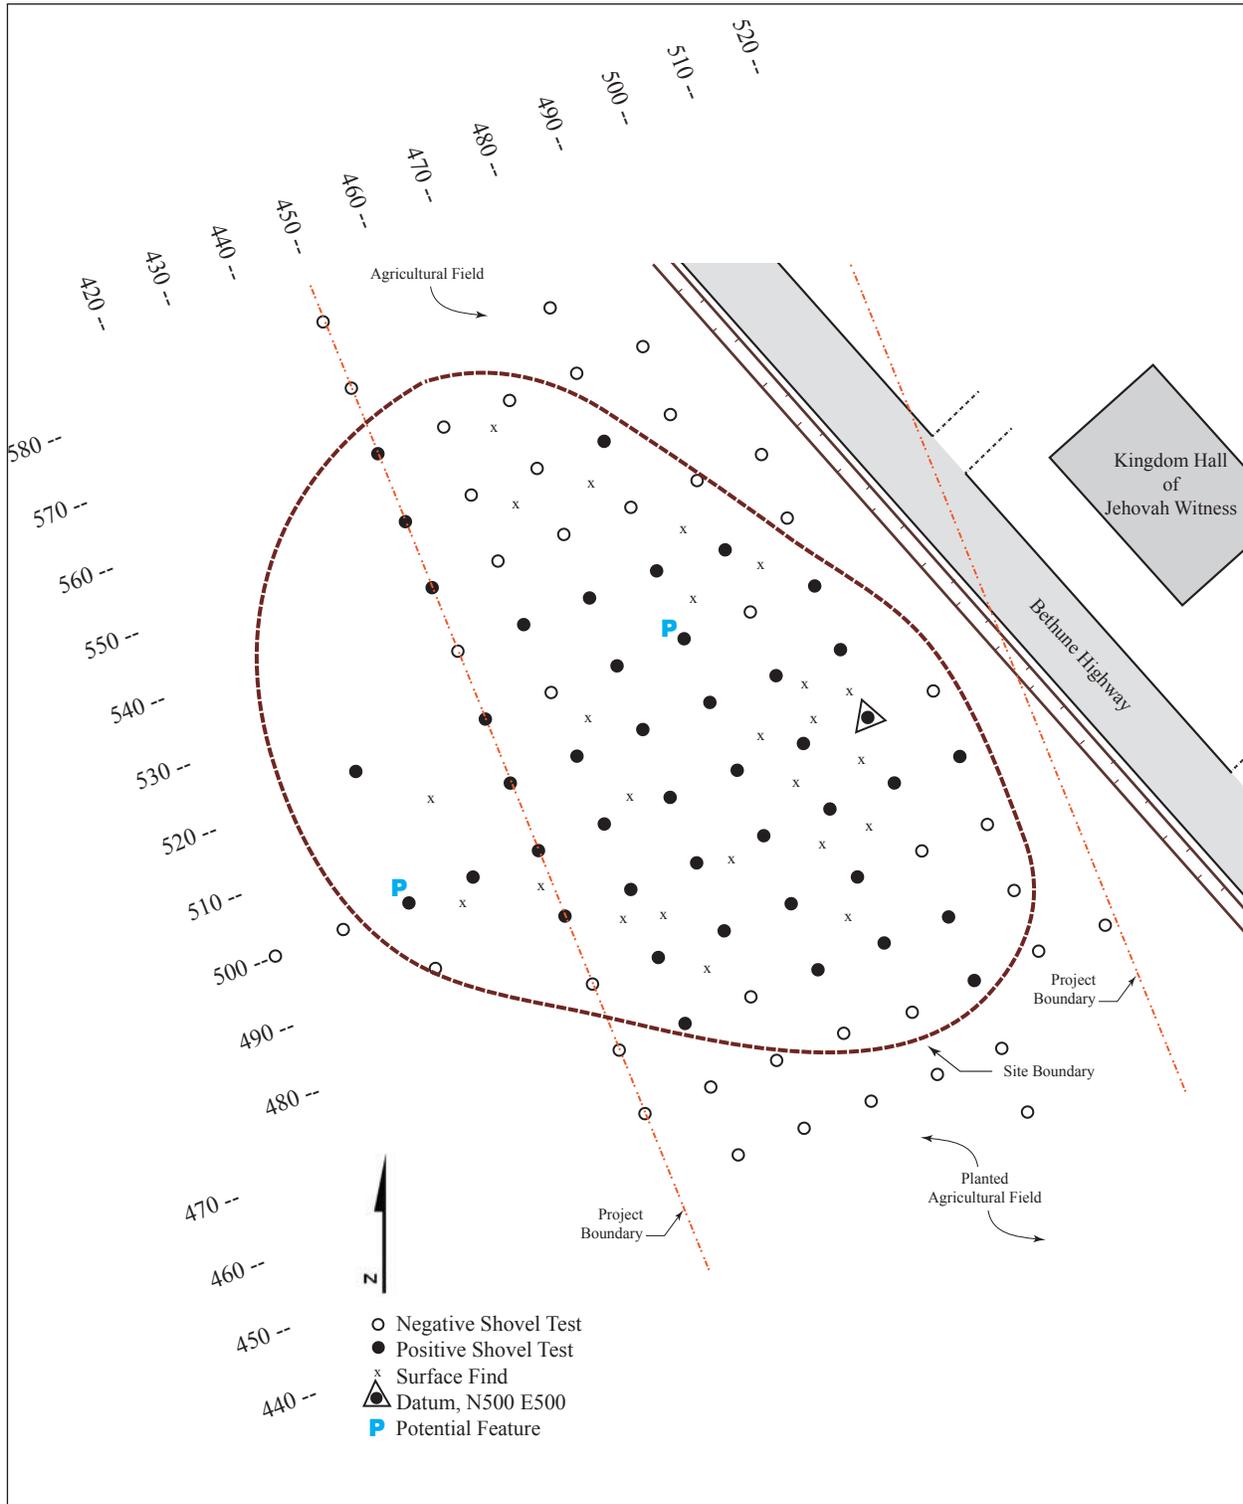
Figure 14.
Site 38LE1037 2012 Shovel Testing Results Map

The 2012 report included a density map of kitchen and architectural artifacts collected during the original site visit. Two concentrations of kitchen-related artifacts were apparent. The heaviest concentration was located at N510 E480. The second and smaller concentration was located at N480 E480 (Lockerman and Stephens 2012:92–93). The Architectural density map identified concentrations at N500 E500, N500 E460, N520 E480, and N540 E450 (see Figure 14).

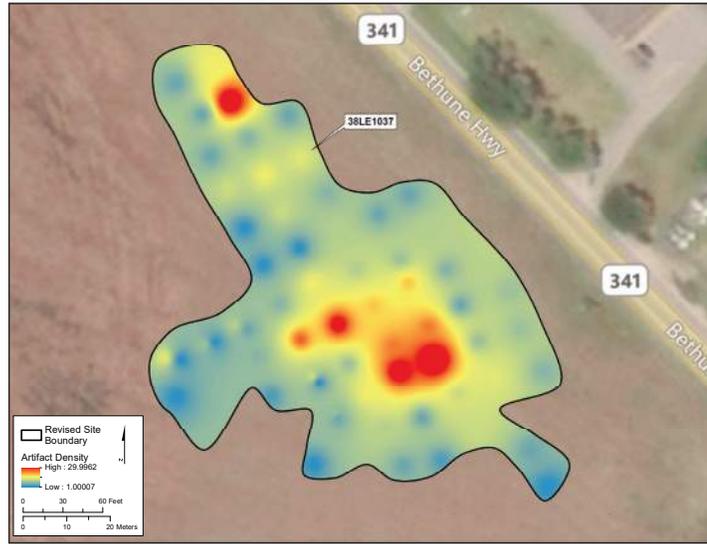
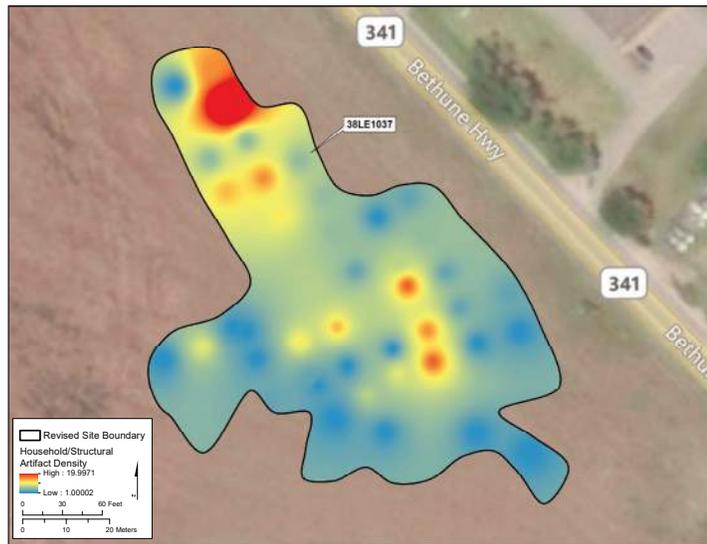
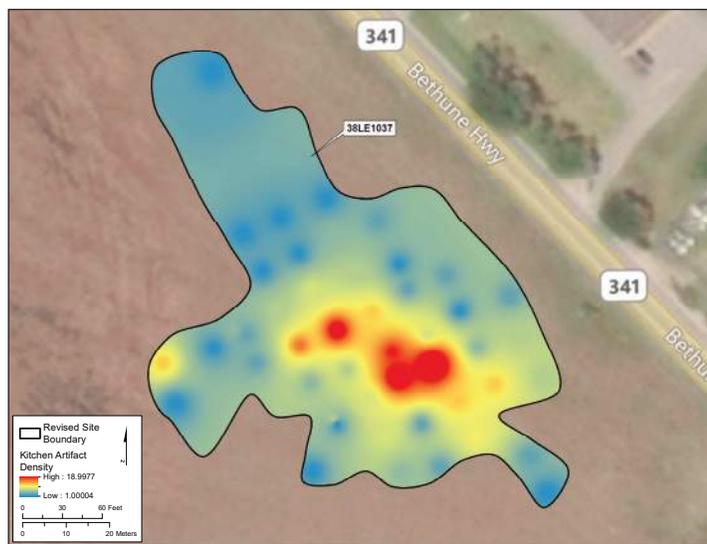
Figure 16.
Interpolation Maps of Artifacts Collected in 2020

Interpolation of shovel testing data identified general artifact concentrations near the center and northern end of the site (Figure 16). The central artifact concentration measured 30x30 meters, and the northern concentration was 10x10 meters. A comparison of the generalized data with density interpolations for the foodways and household/structural functional artifact categories show that the northern artifact concentration primarily comprises artifacts from the later category. The central concentration has a higher representation of food-related artifacts, with the greatest density near N490 E490.

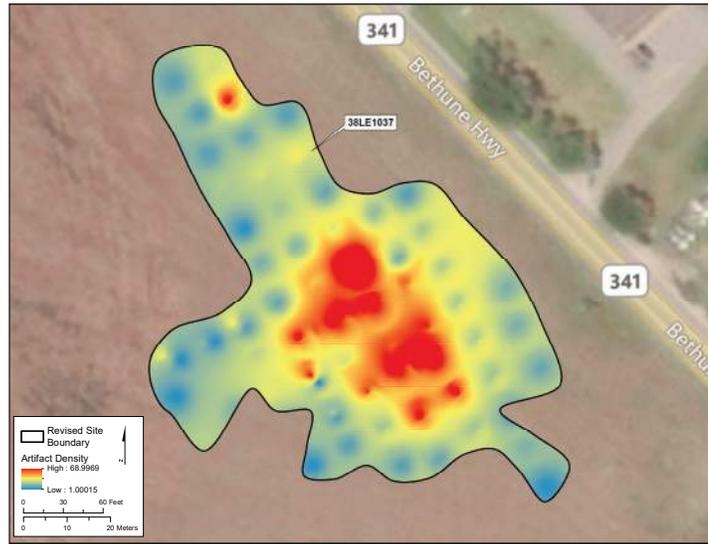
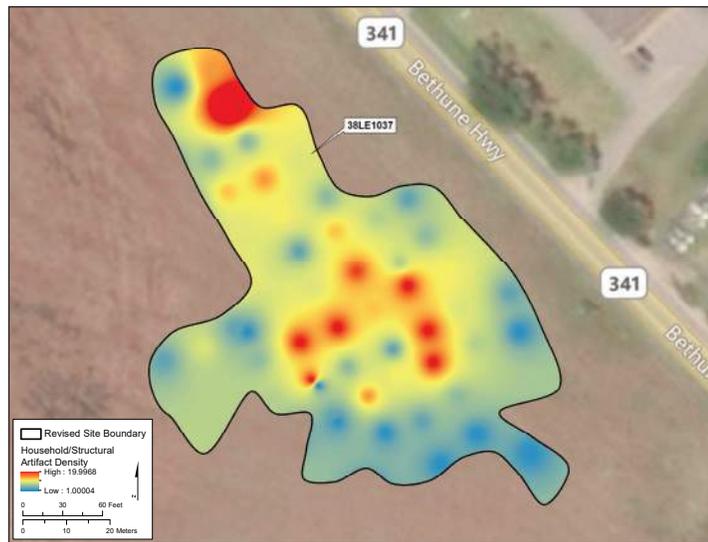
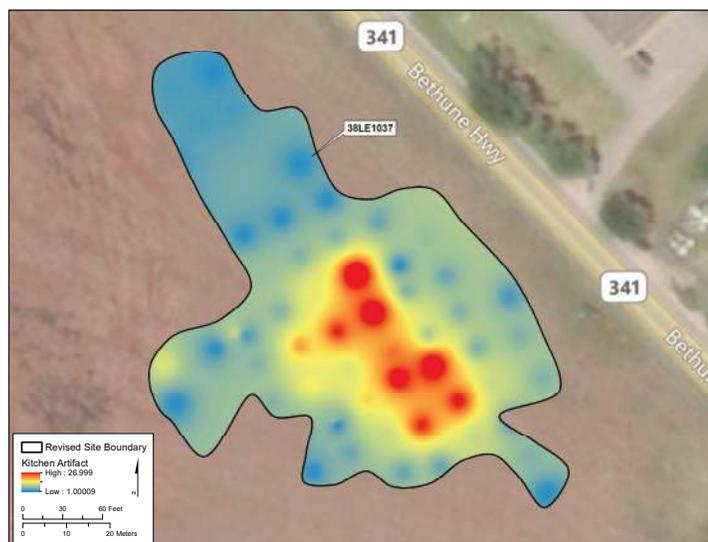
Figure 17.
Interpolation Maps of Artifacts Collected from 2012 and 2020 Shovel Tests

Combining the results of the 2012 and 2020 spatial analyses identified a central activity area measuring 47x23 meters (Figure 17). This area contains the majority of the site's food-related artifacts and elevated densities of household/structural artifacts. The noticeable absence of non-household/structural artifacts in the northern part of the site suggests that the building material was not part of a standing structure but more likely a low-lying dumping ground. Significantly, the 1961 aerial photograph shows no structures at the location, which supports this interpretation. The combined central artifact concentration overlaps with the house location shown on the 1961 aerial photograph (see Figures 13 and 17). However, at 47x23 meters, the artifact concentration is too broad to pinpoint an exact house footprint based on artifacts alone.

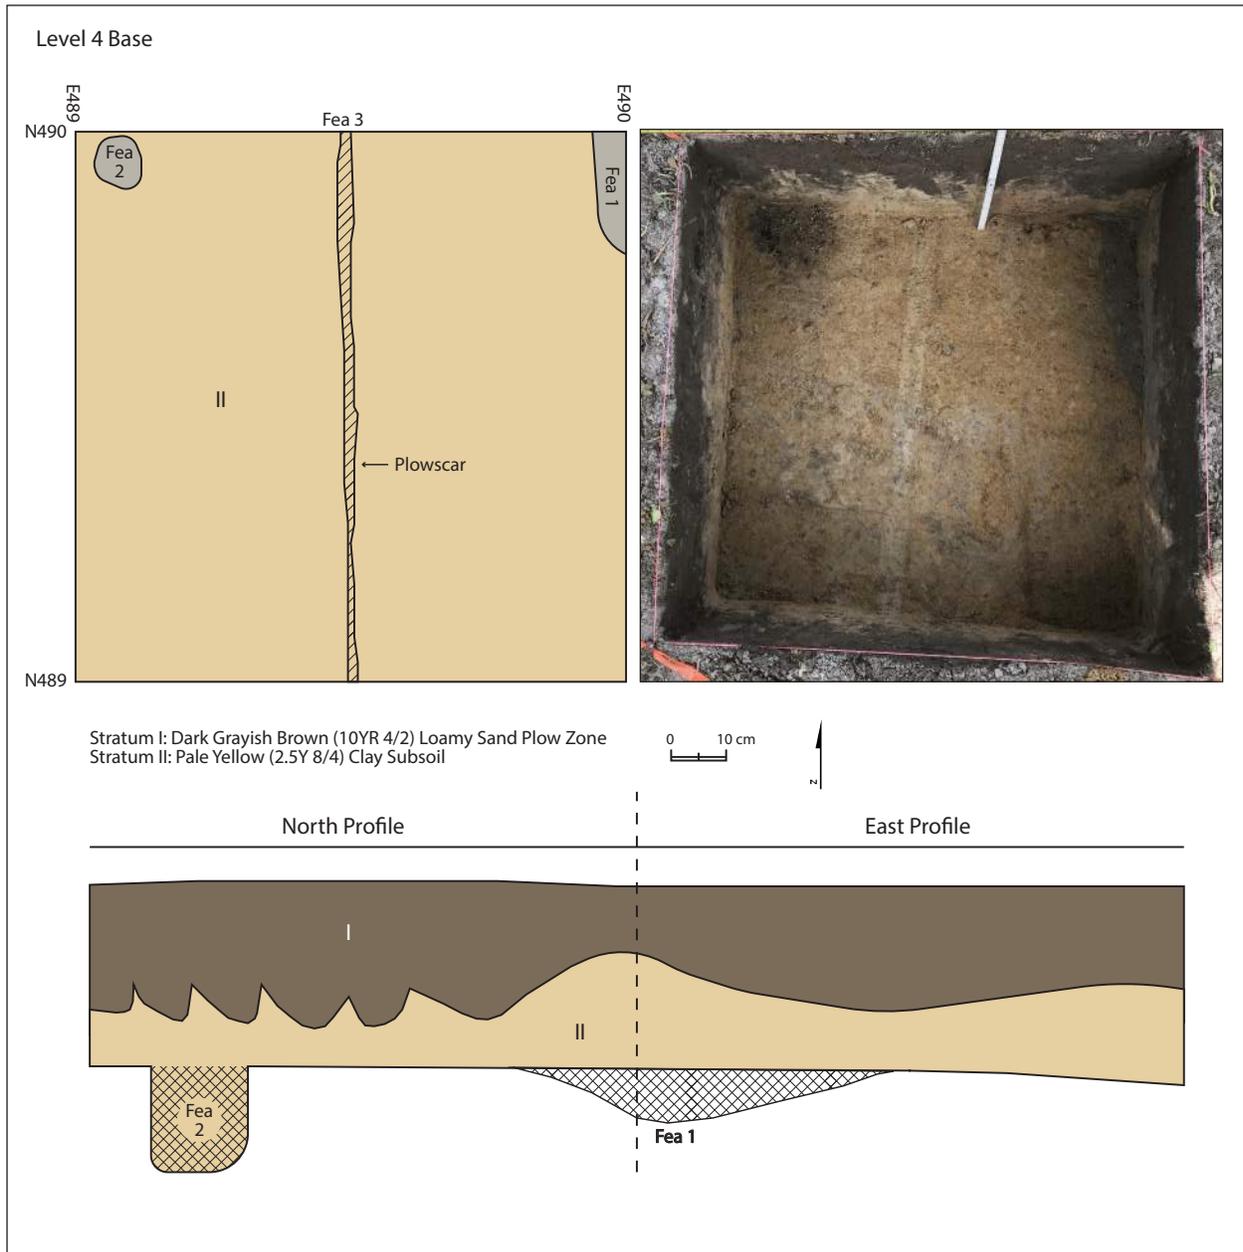
Figure 18.
Unit 1 Base of Level 4, 40 cmbs

The Phase II shovel testing identified three potential features, at N570 E480, N490 E490, and N550 E460. Excavation Units 1 and 2 were placed adjacent to the shovel tests at N490 E490 and N550 E460 (see Figure 15). Unit 1 was opened at N489 E489. This 1x1-meter unit was excavated in 10-centimeter arbitrary levels. The three uppermost levels (0–30 cmbs) were within a dark grayish brown (10YR 4/2) loamy sand plow zone. In profile, this Stratum had an undulating interface with Stratum II, consistent with the effects of agricultural discing (Figures 18 and 19). Level 4, at 30–40 cmbs, sampled Stratum II, a pale yellow (2.5Y 8/4) clay subsoil.

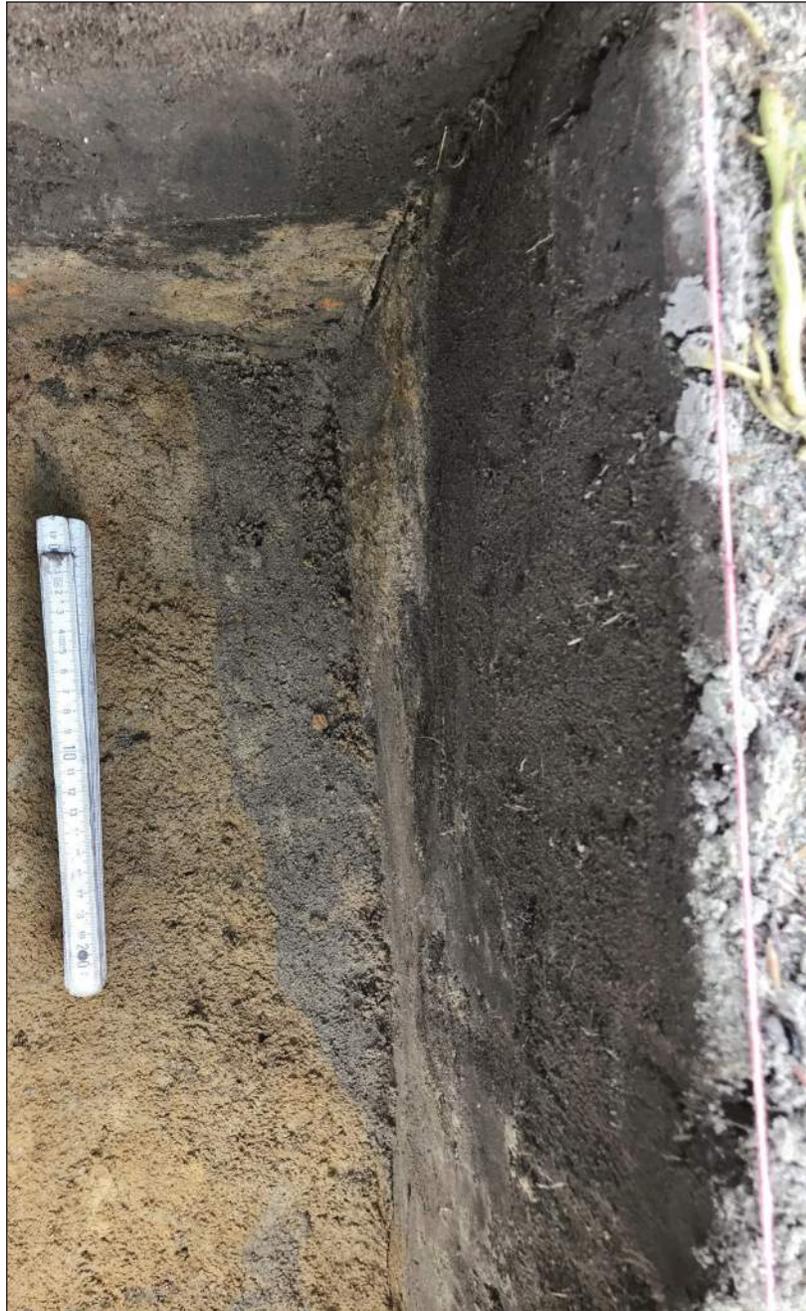
Figure 20.
Feature 1 Plan View Photograph

Three features were exposed at the base of Stratum I. Feature 1 was located in the northeast corner of the unit. This 40x9-centimeter light brownish gray (10YR 6/2) sandy clay feature corresponded to the potential feature uncovered in the N490 E490 shovel test. The feature tapered into the eastern wall of Unit 1 at a depth of 40 cmbs (Figure 20). Too little of this feature was exposed to ascertain its function. Feature 2, a weak red (2.5YR 4/2) sandy clay with large charcoal concentrations, was located in the northwestern unit corner.

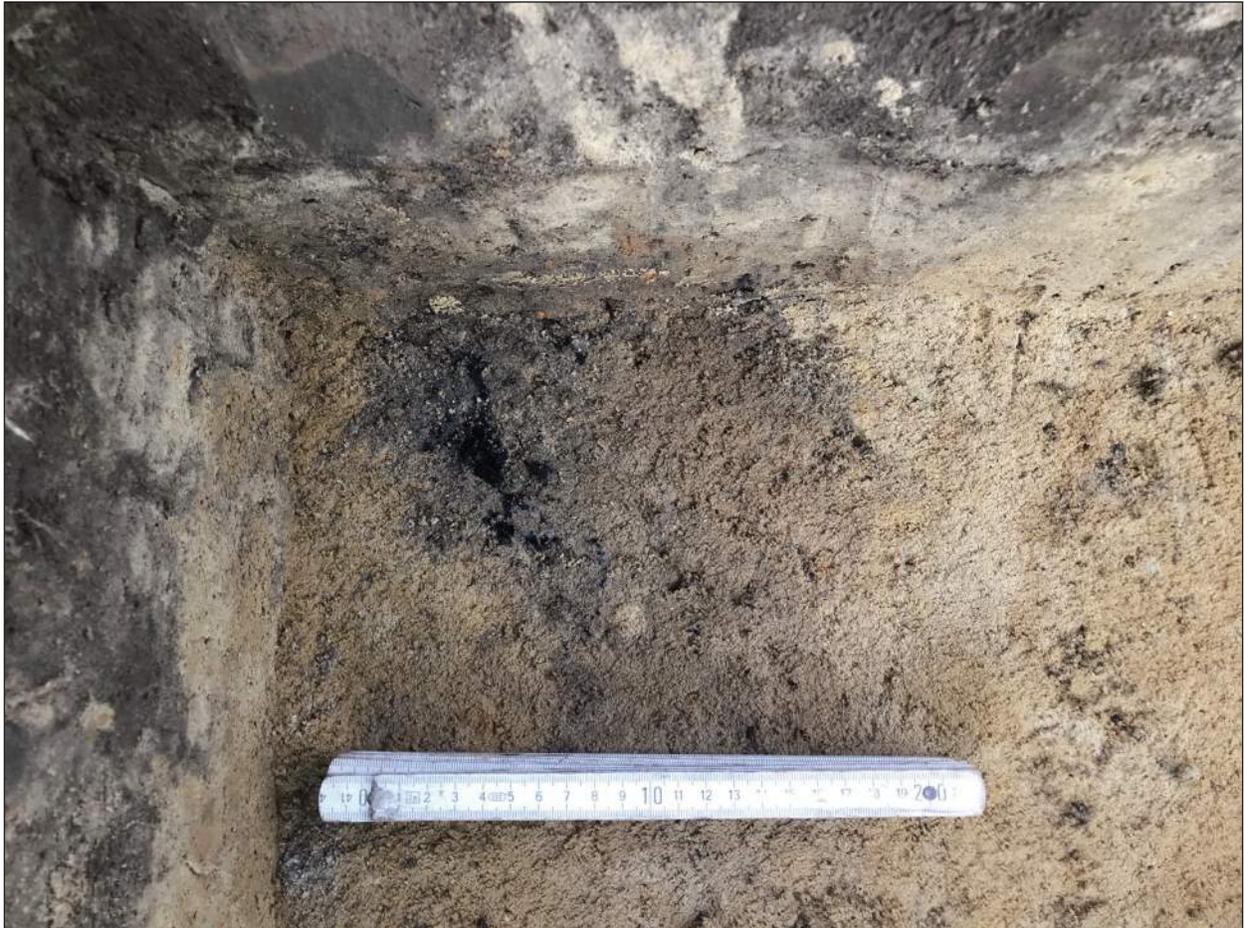
Figure 21.
Feature 2 Plan View Photograph

Feature 2 was a 12-centimeter-diameter post that extended to a depth of 60 cmbs (Figure 21). In profile, this feature was cylindrical with a flat base. Neither of the excavated features yielded artifacts. Feature 3, a plow scar running north-south through the center of Unit 1, was not excavated.

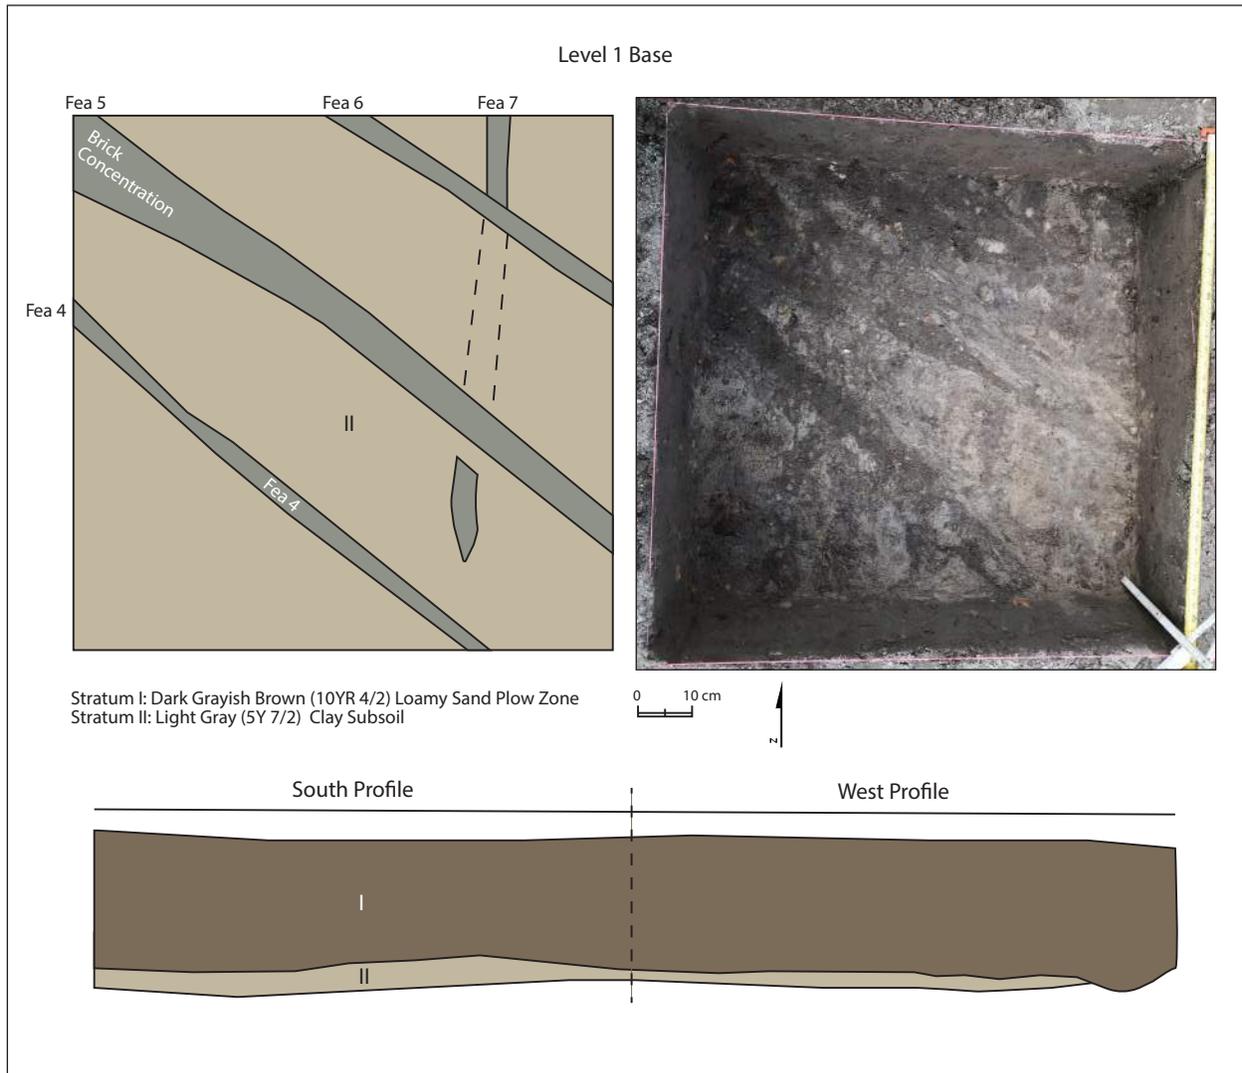
Figure 22.
Unit 2 Base of Level 1, 30 cmbs

Features 4, 5, 6 and 7 were exposed at the top of Stratum II, a light gray (5Y 7/2) clay (Figures 22 and 23). The first three features were 5-centimeter-wide plow scars spaced at regular 15-centimeter intervals. Brick fragments were embedded in all three plow scars. They were oriented northwest-southeast and cut through Feature 7, a north-south aligned plow scar. None of these features was excavated.
